# CE504 Slope Stability and Retaining Structures

## Failure of a Marginally Stable Hillslope: A Forensic Investigation

**Dr. Arindam Dey**

## Landslide at Calcom Cement Plant, Umrangso, Assam **Forensic Geotechnology**

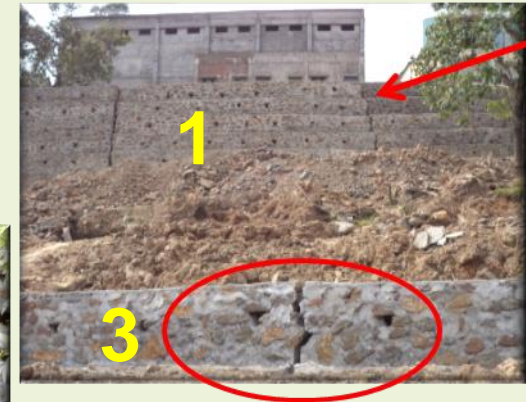
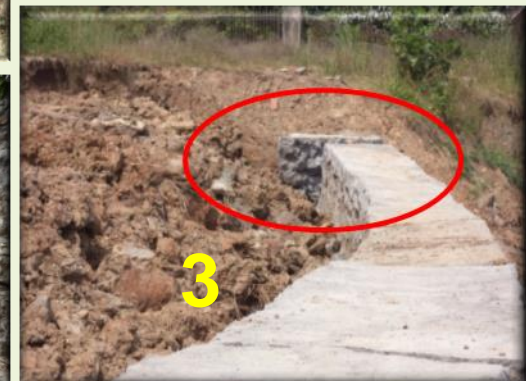
- ❖ *Pictures of damages in the protective retaining and boundary walls*

- Development of gaps and cracks in the retaining walls
  - Retaining wall 1: Between cement factory (workshop) and 24-Colony
  - Retaining Wall 3: Beside RCL road in front of 24 colony
  - Retaining wall 2: Frontal protection of 24-Colony (3 m)
  - Gaps in old boundary wall
  - Dislodgment of pavement and drains

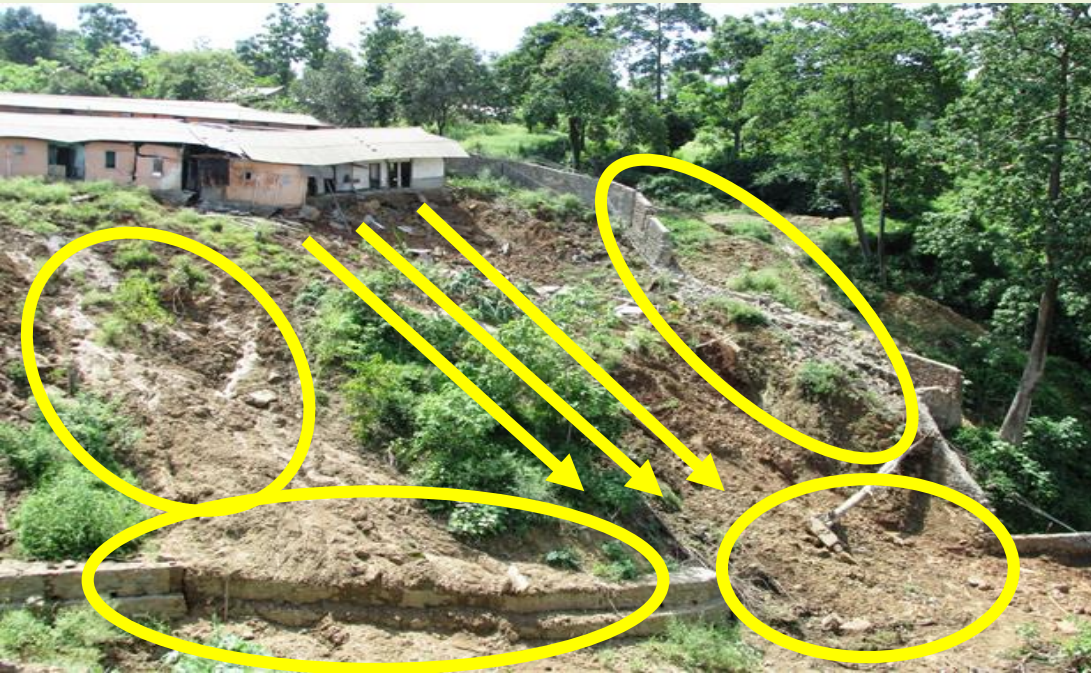
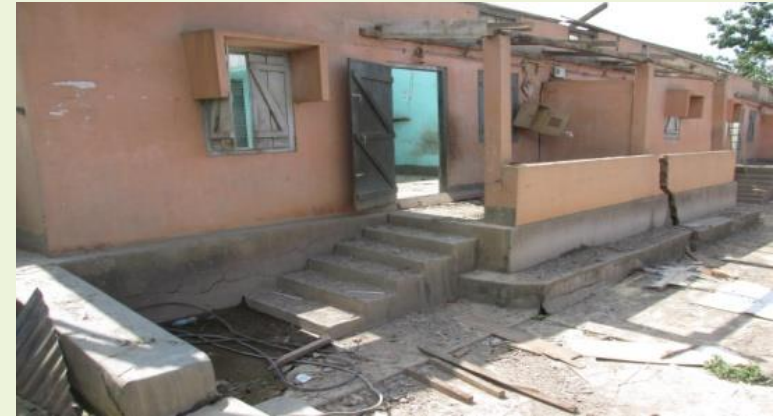
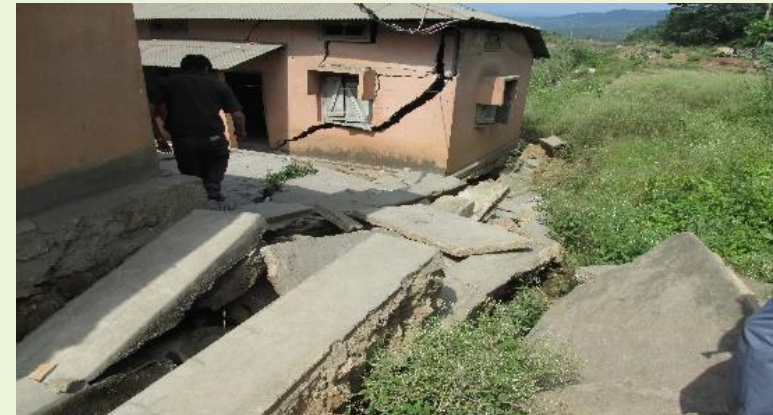
- Immense mass movement of soil
- Broken boundary wall
- Ejection of seeping water
- Overtopping of retaining wall
- Breakage of downhill protection wall

**Extensive damage in the  
24-Colony leading to  
relocation of workers**

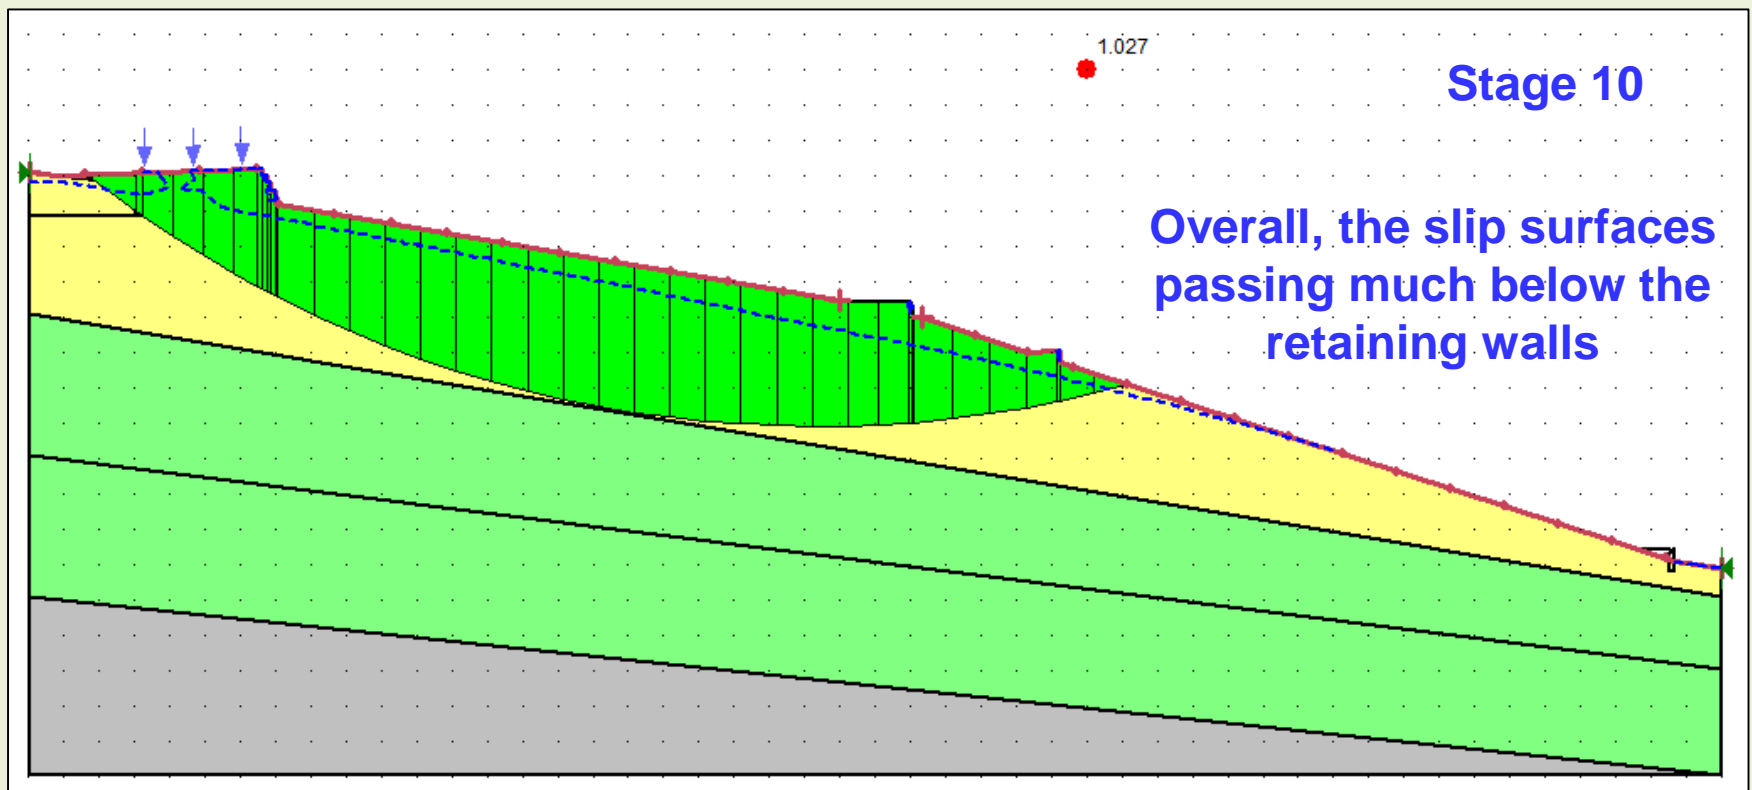
Retaining walls and backfills simply kept on adding weight to the system leading to more destabilization

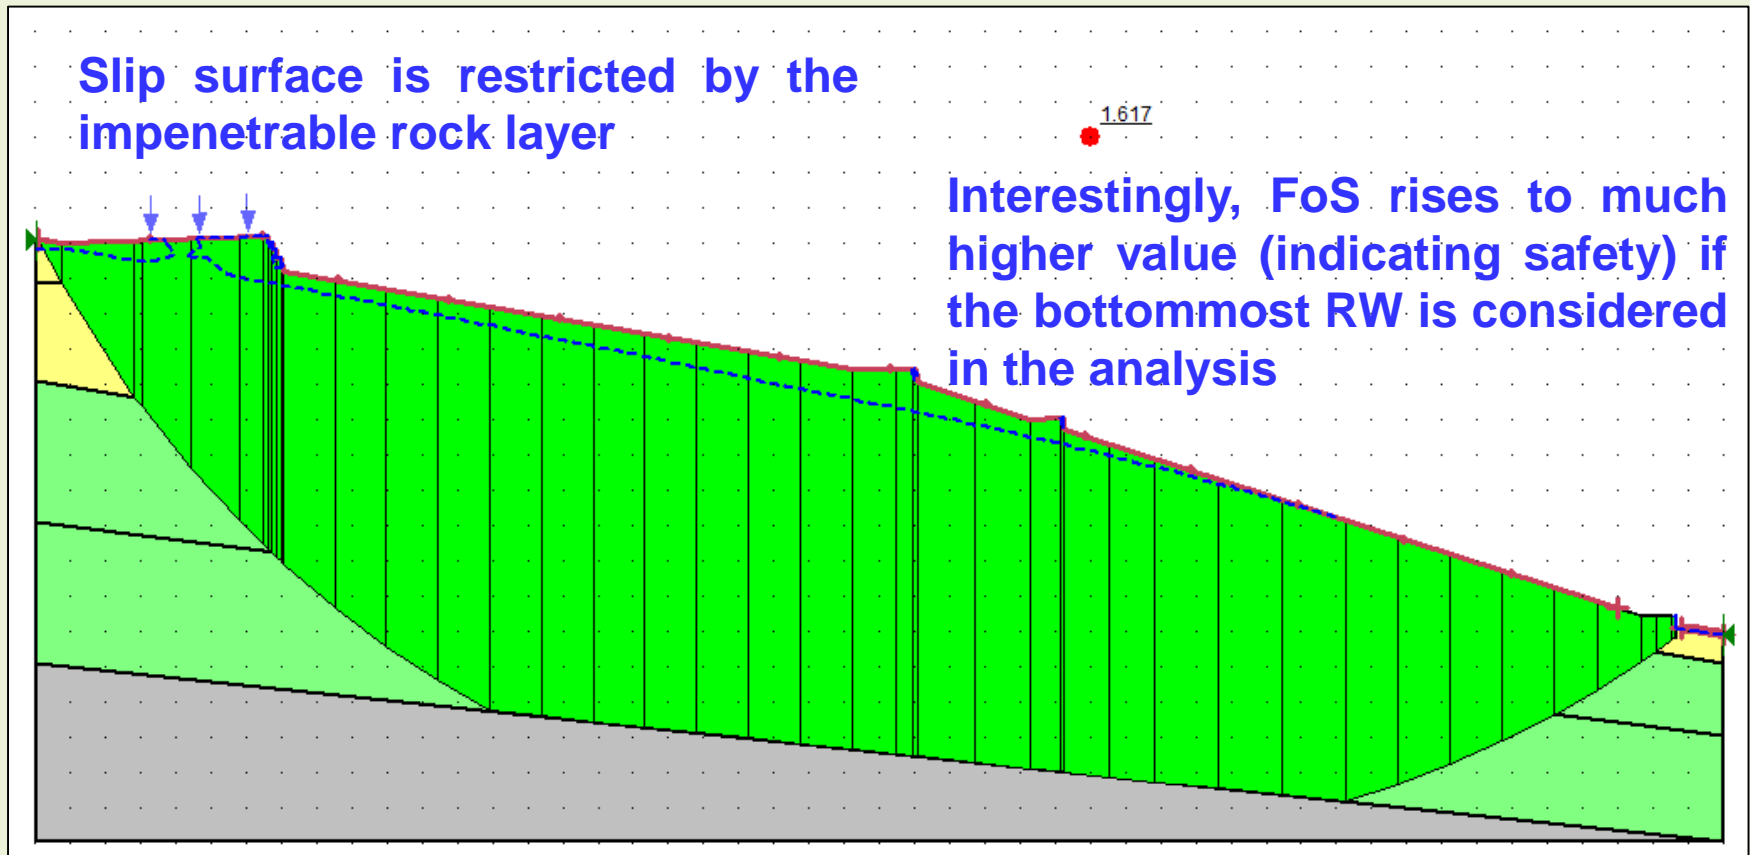
This did not happen in the field, RW4 was overtopped by mud and water → Necessity for further investigation

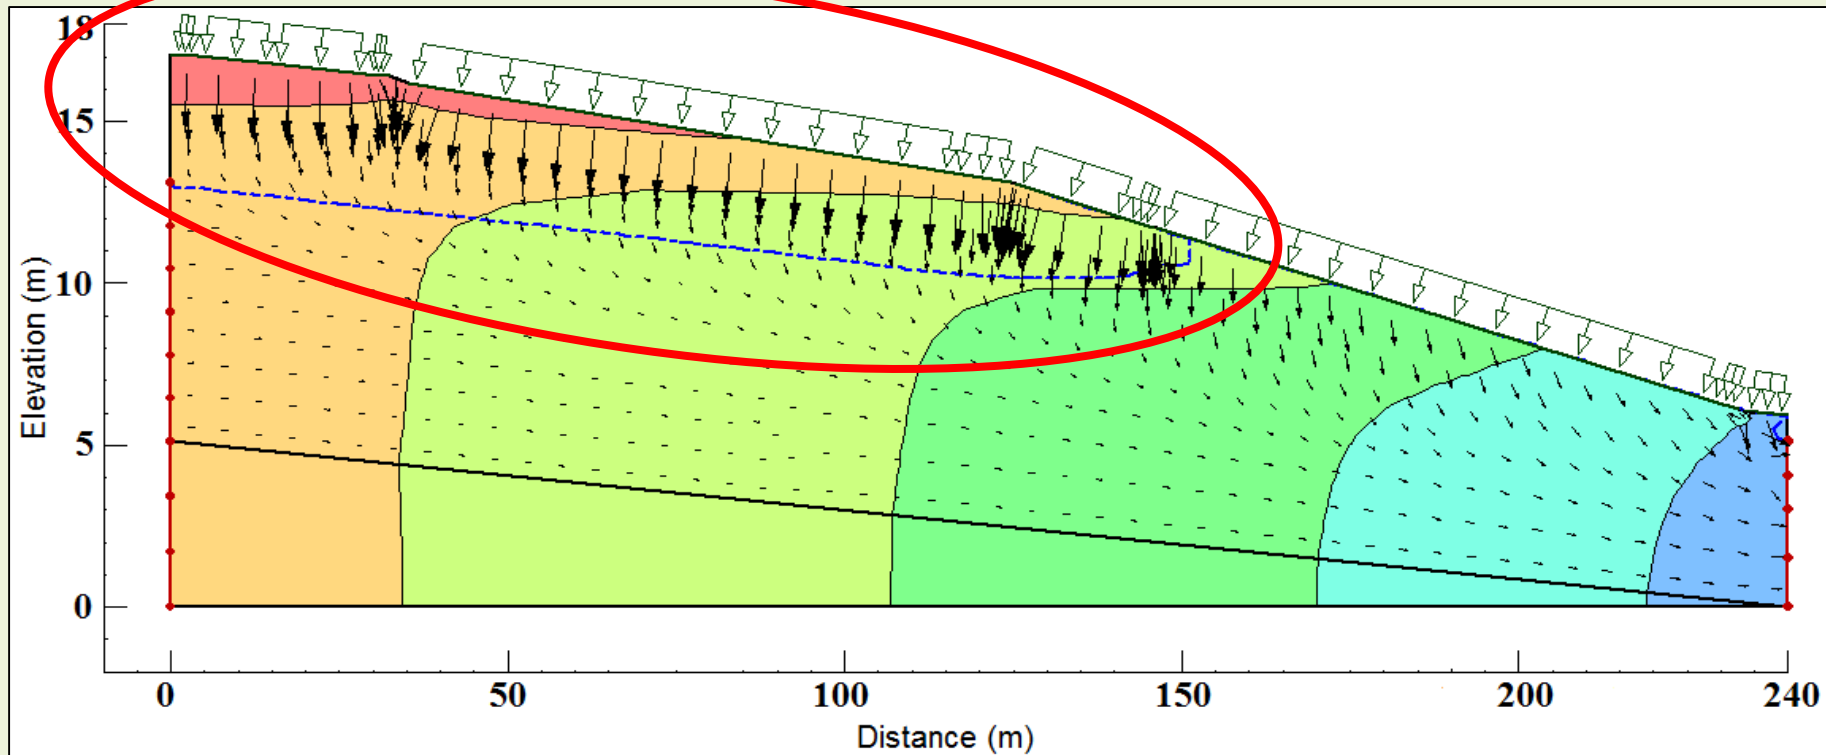
- Interesting inferences !!!
  - ❖ *Infiltration leads to the rise of the WT*
    - WT, upon rising, intersects the slope face near the 24 colony

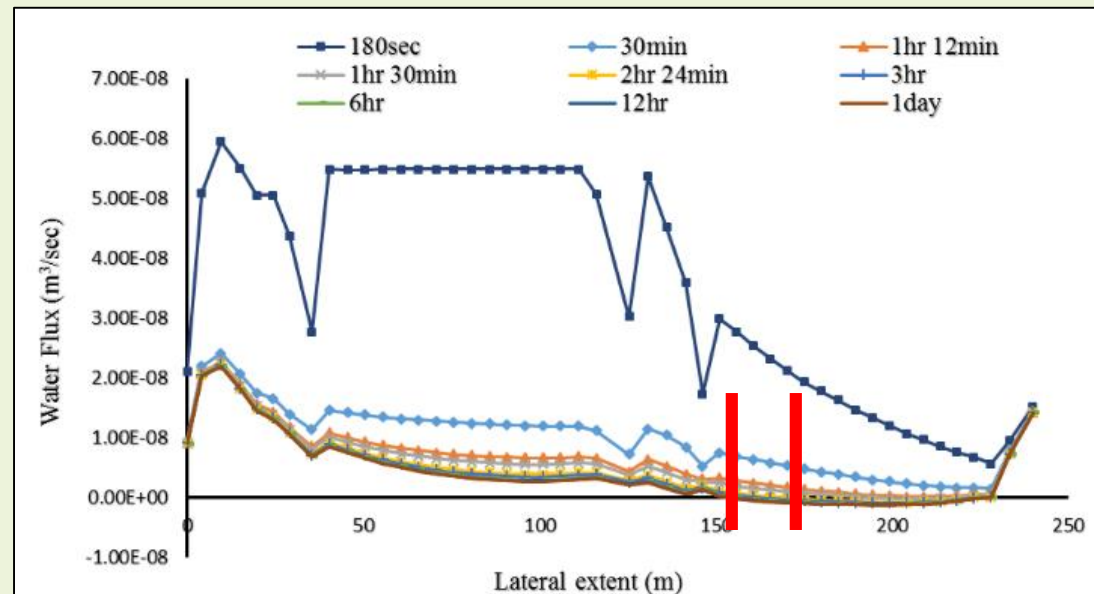
- ❖ *Intersection of WT at the slope face near the 24 colony (160-180 m from left)*

- Denoted by achievement of zero or negative water flux at the slope face
  - Water comes out of the slope face at the prescribed location
- Time duration of the rise of WT to intersect: Approximately 3-6 h of rain
  - Coincidentally, the same was reported from the field that the first slide behind the colony was noted after an initial 3-4 hr of rainfall around October 2015

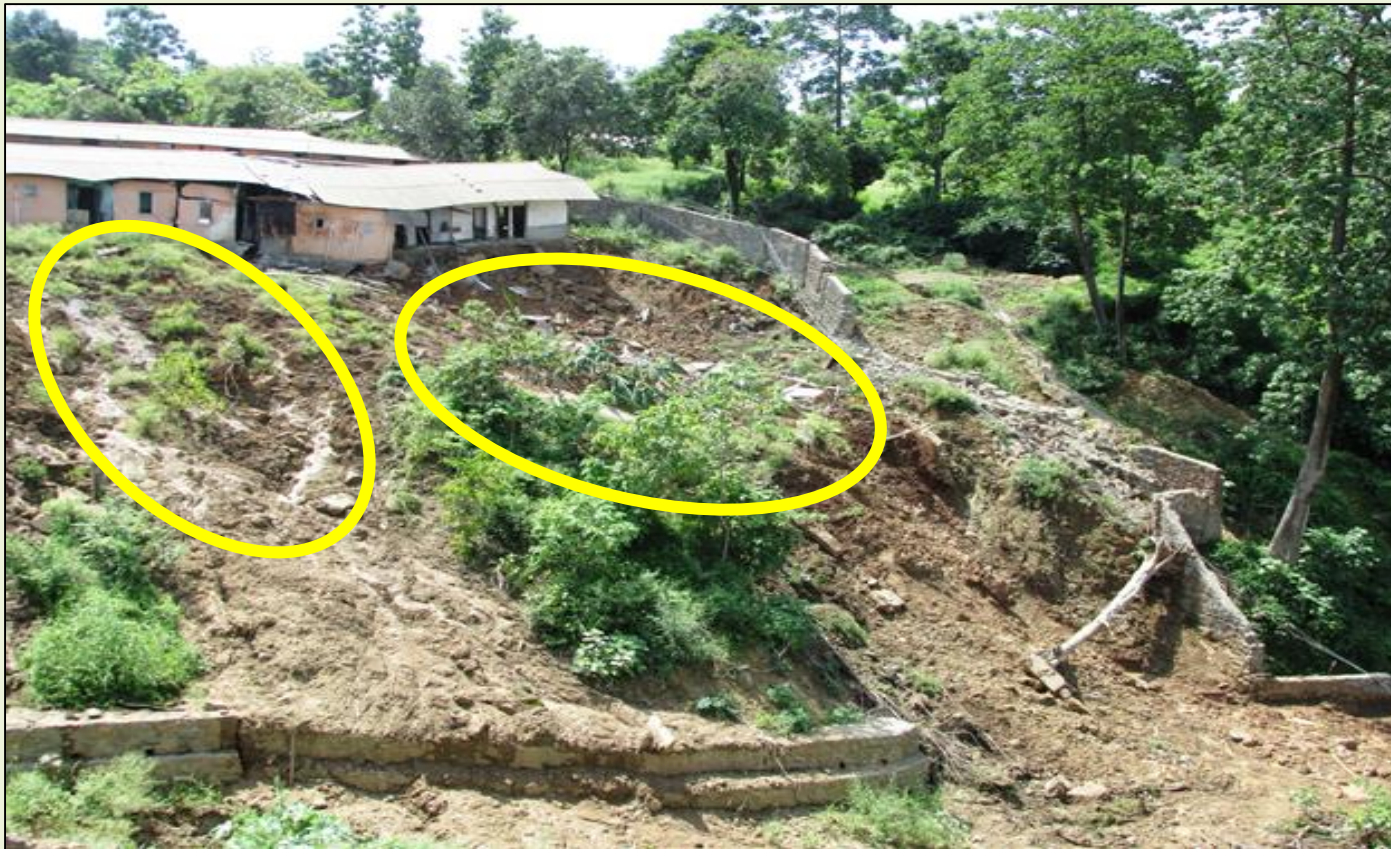
- Interesting inferences !!!
  - ❖ *Intersection of WT at the slope face near the 24 colony (160-180 m from left)*
    - Field observation of water emanating out of the slope face behind 24 colony

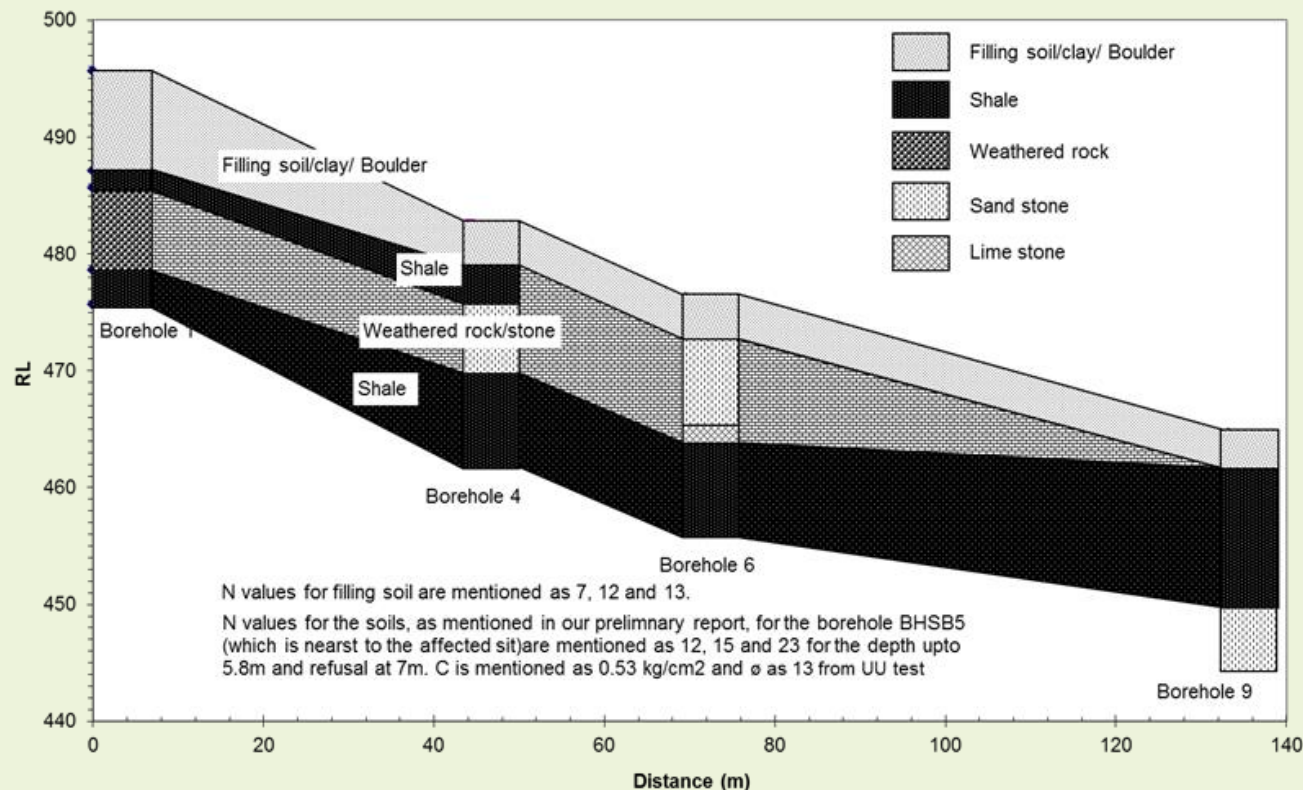
- A new understanding of the failure site
  - ❖ *Presence of thick cover of loosely deposited fill soil*
    - Deposited during construction of workshop and store
      - This information was completely missing in earlier discussions

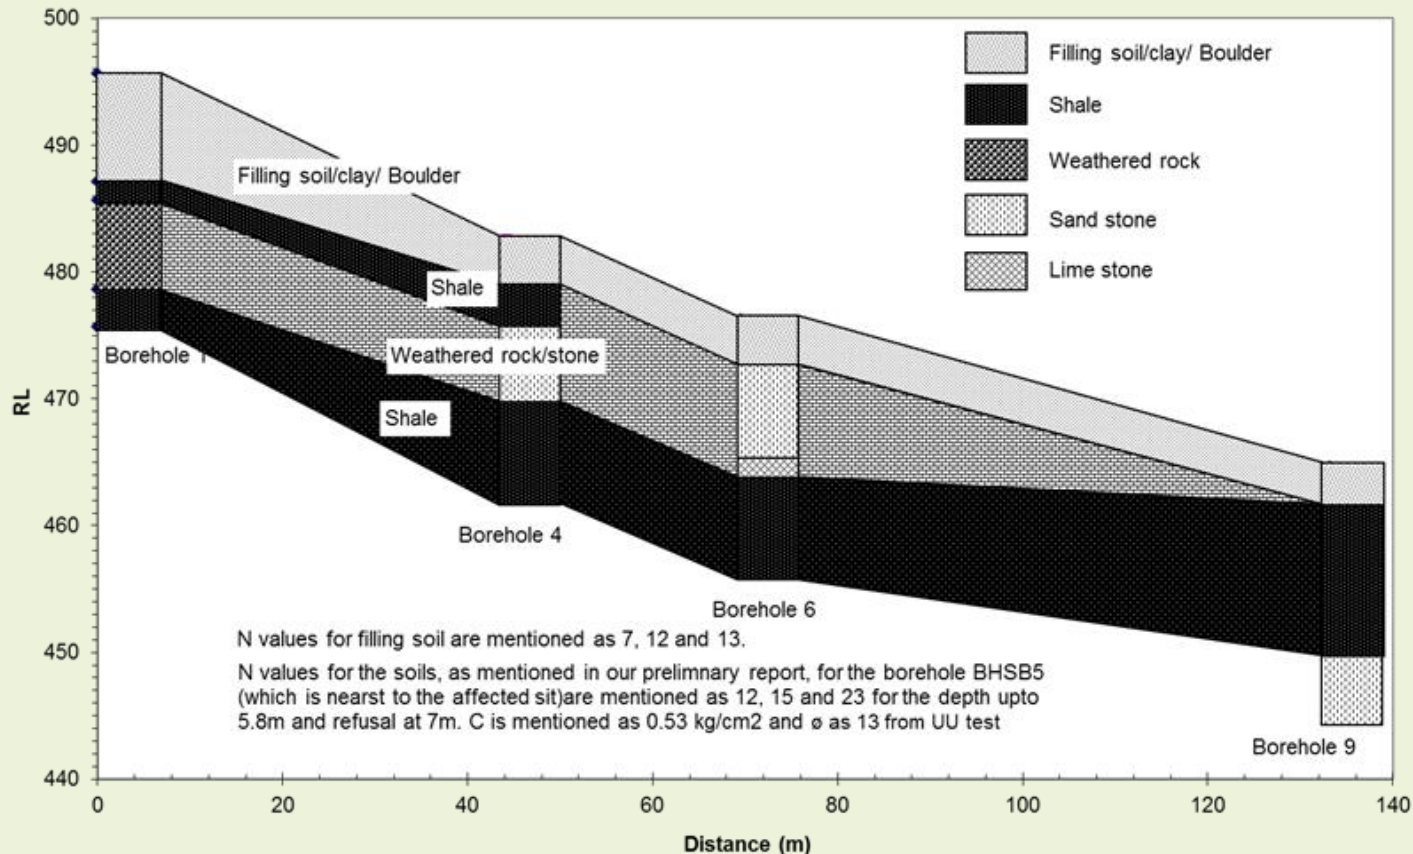
- ❖ *Presence of shale pockets*

- Offers shear surface when get wet due to infiltration and percolation of water

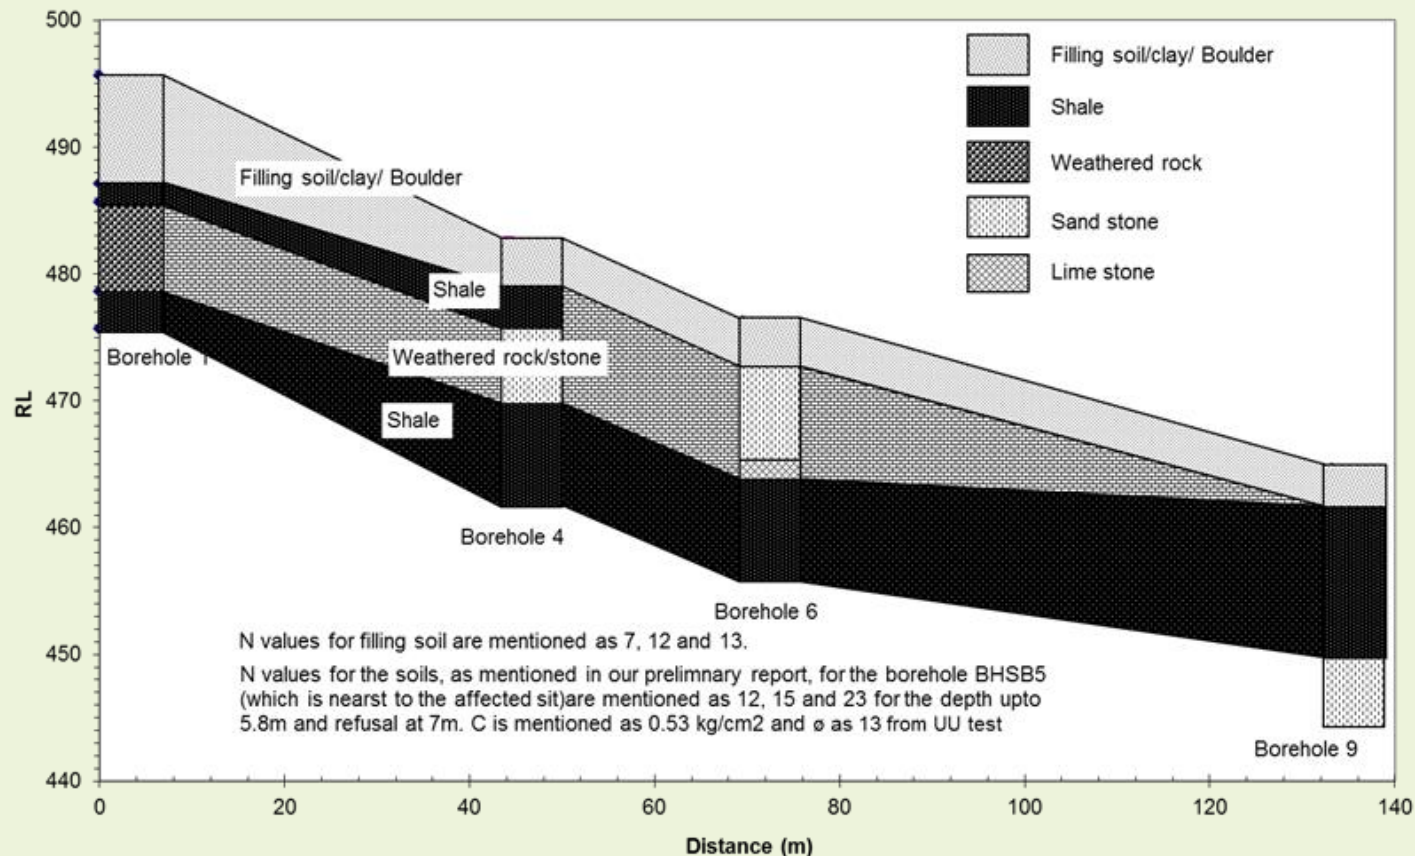
- A new understanding of the failure site
  - ❖ *Presence of weathered rock/stone*
    - Allows easy gradient-based migration of water beneath the slope surface

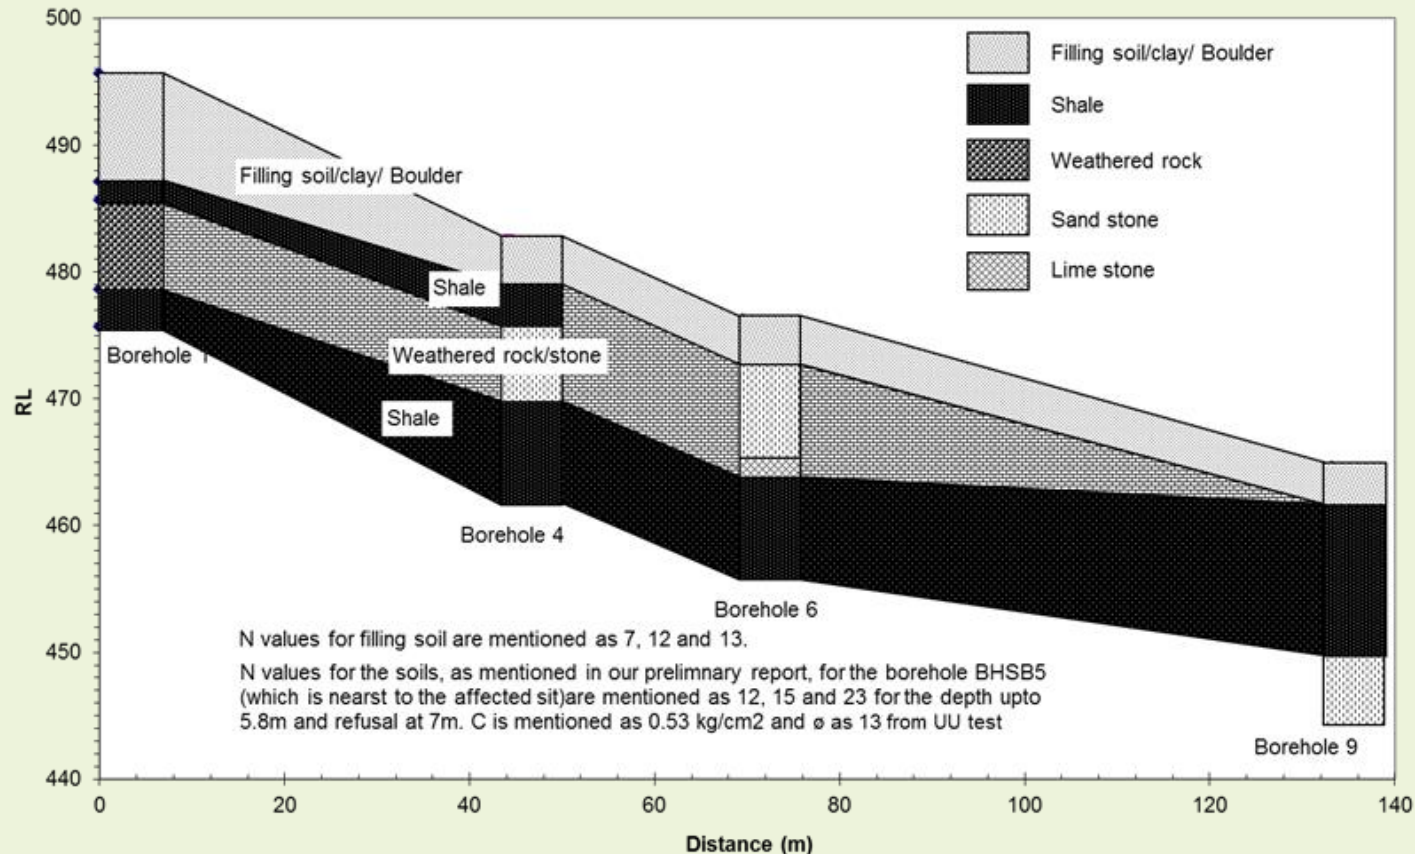
- A new understanding of the failure site
  - ❖ *Presence of thick deposit of shale*
    - May act either as bedrock when dry, or offer sliding surface when wet

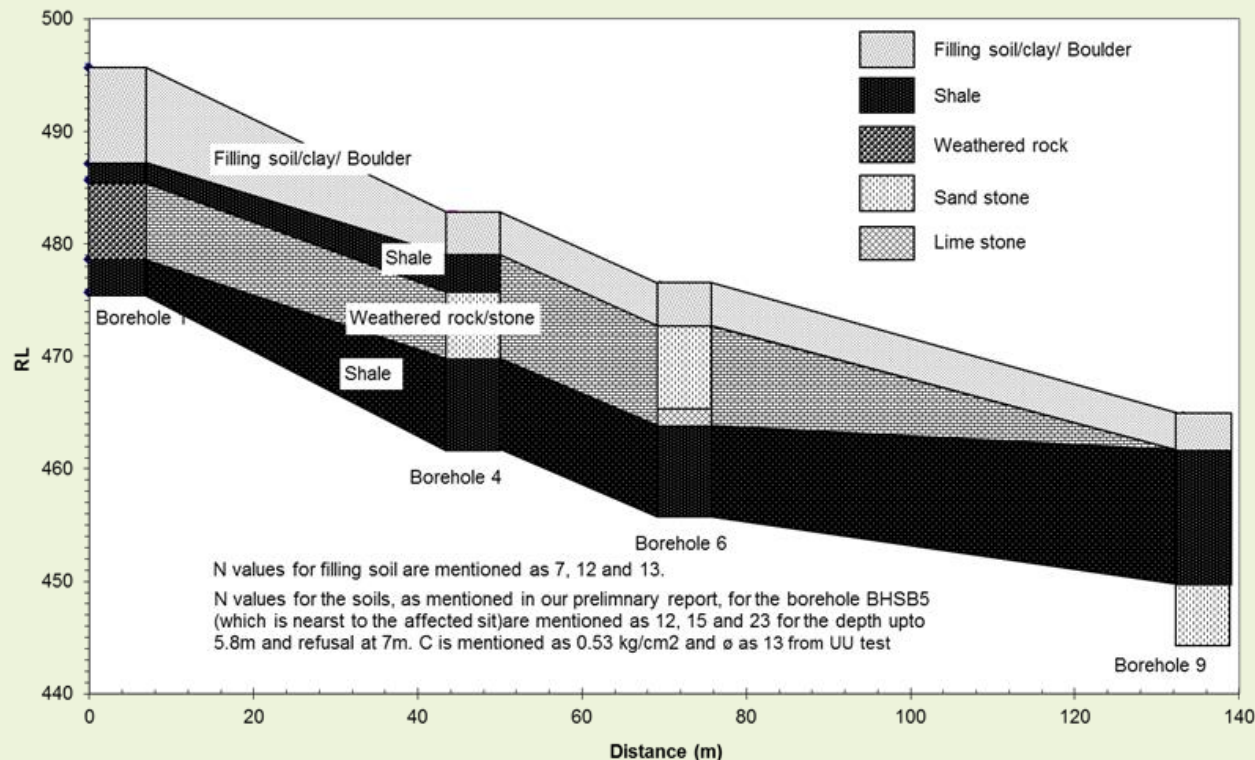
- A new understanding of the failure site
  - ❖ *A strong intuition developed that the failure is actually shallow slide due to the movement of the loose deposit itself*
    - All the retaining walls and workers colony were simply resting on the loose deposit

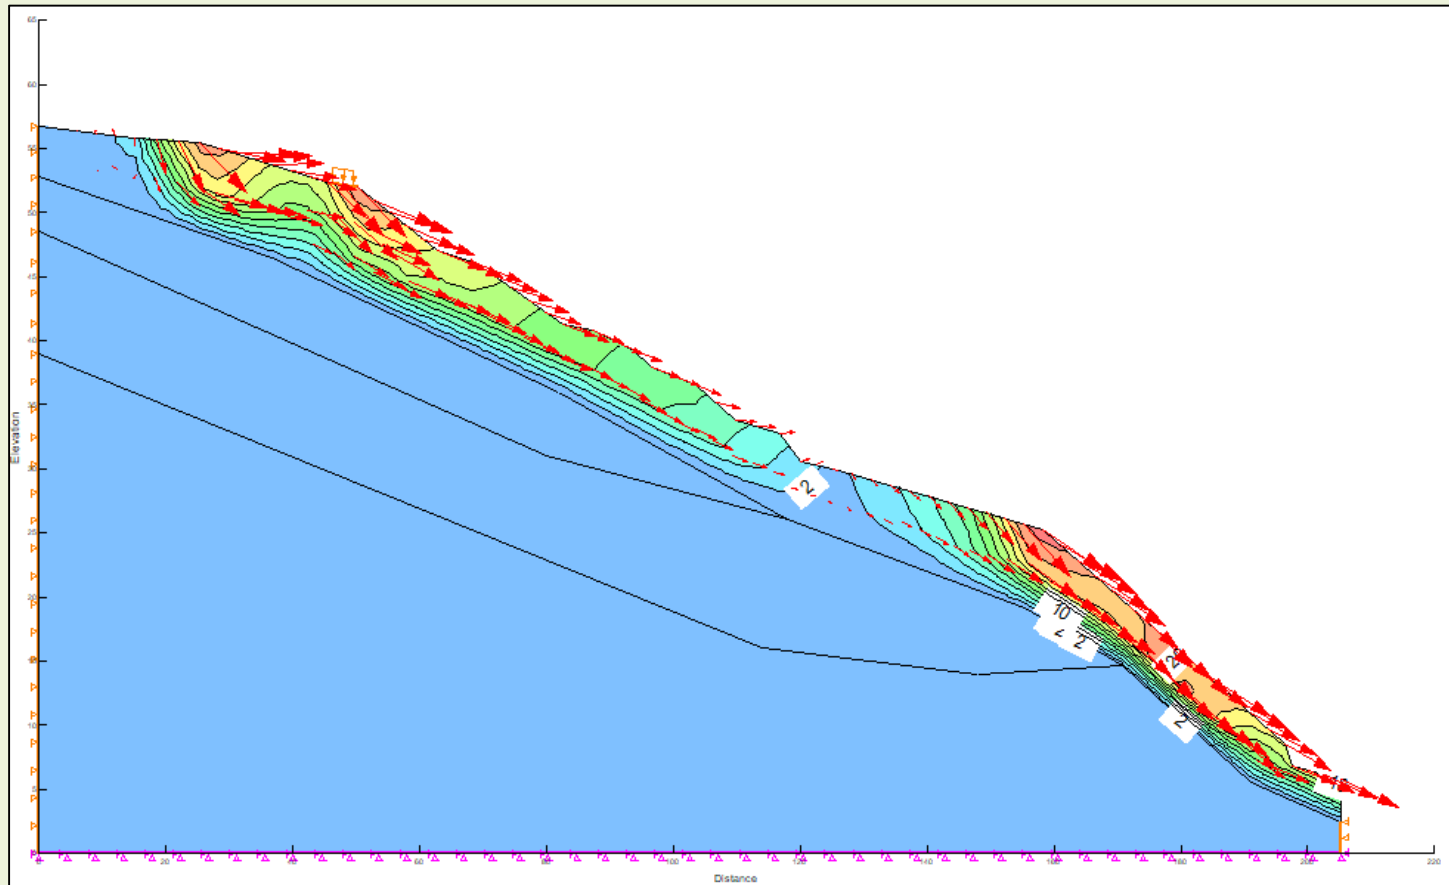
- Application of RW1
  - ❖ *RW1 placed on loose deposit*
    - Didn't help → Added more load to invoke enhancement of deformation zone

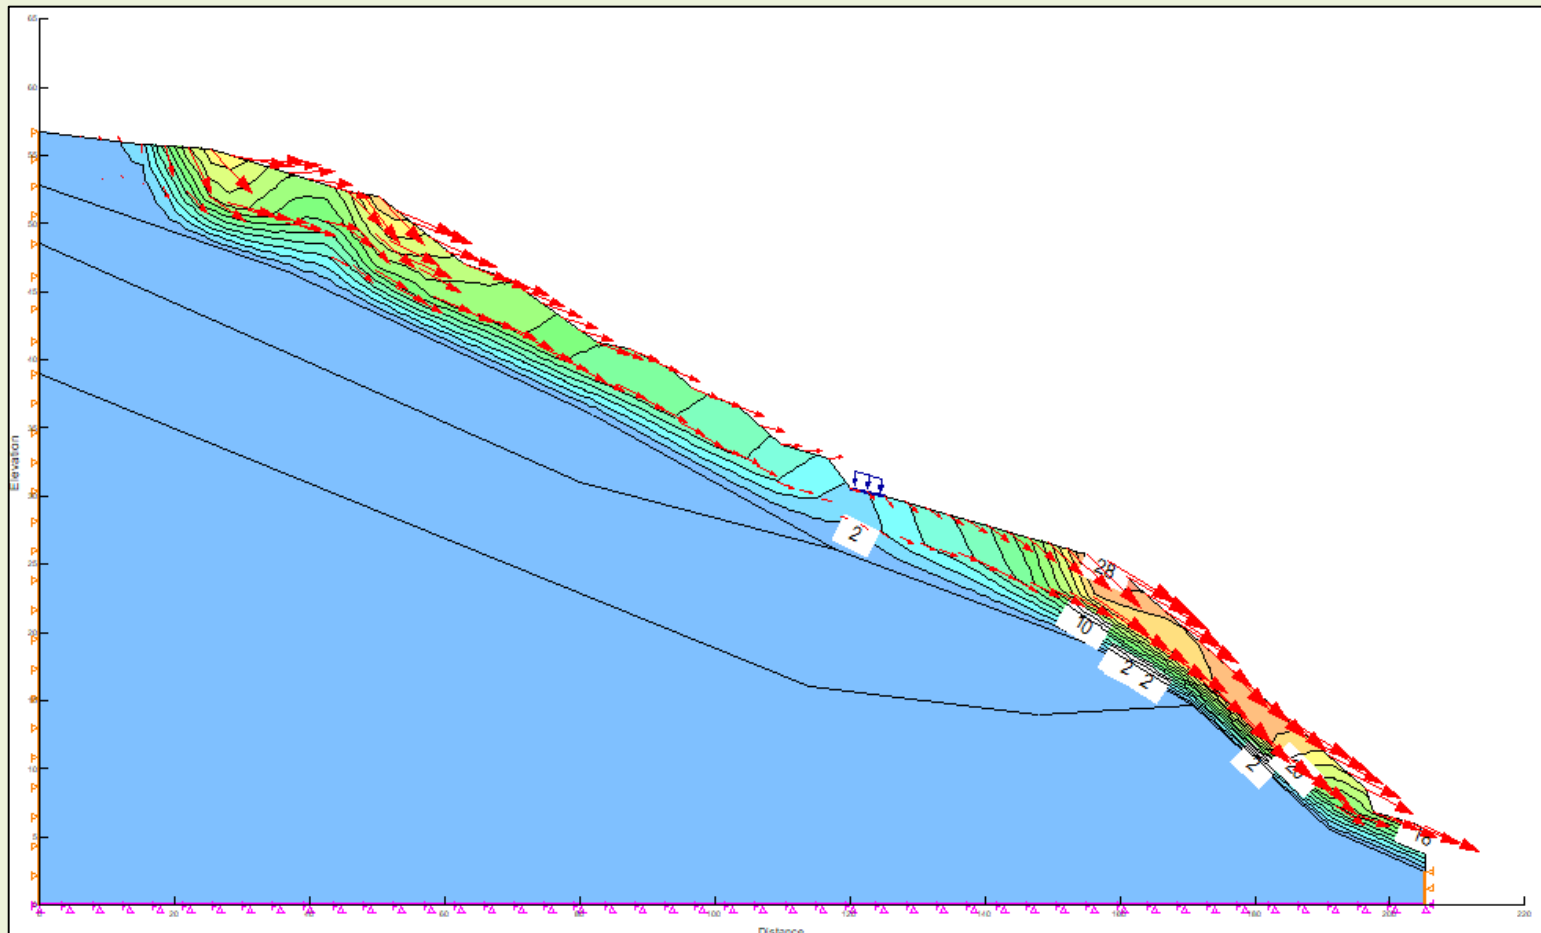
❖ *RW2 placed on loose deposit → Deformation zones start overlapping*

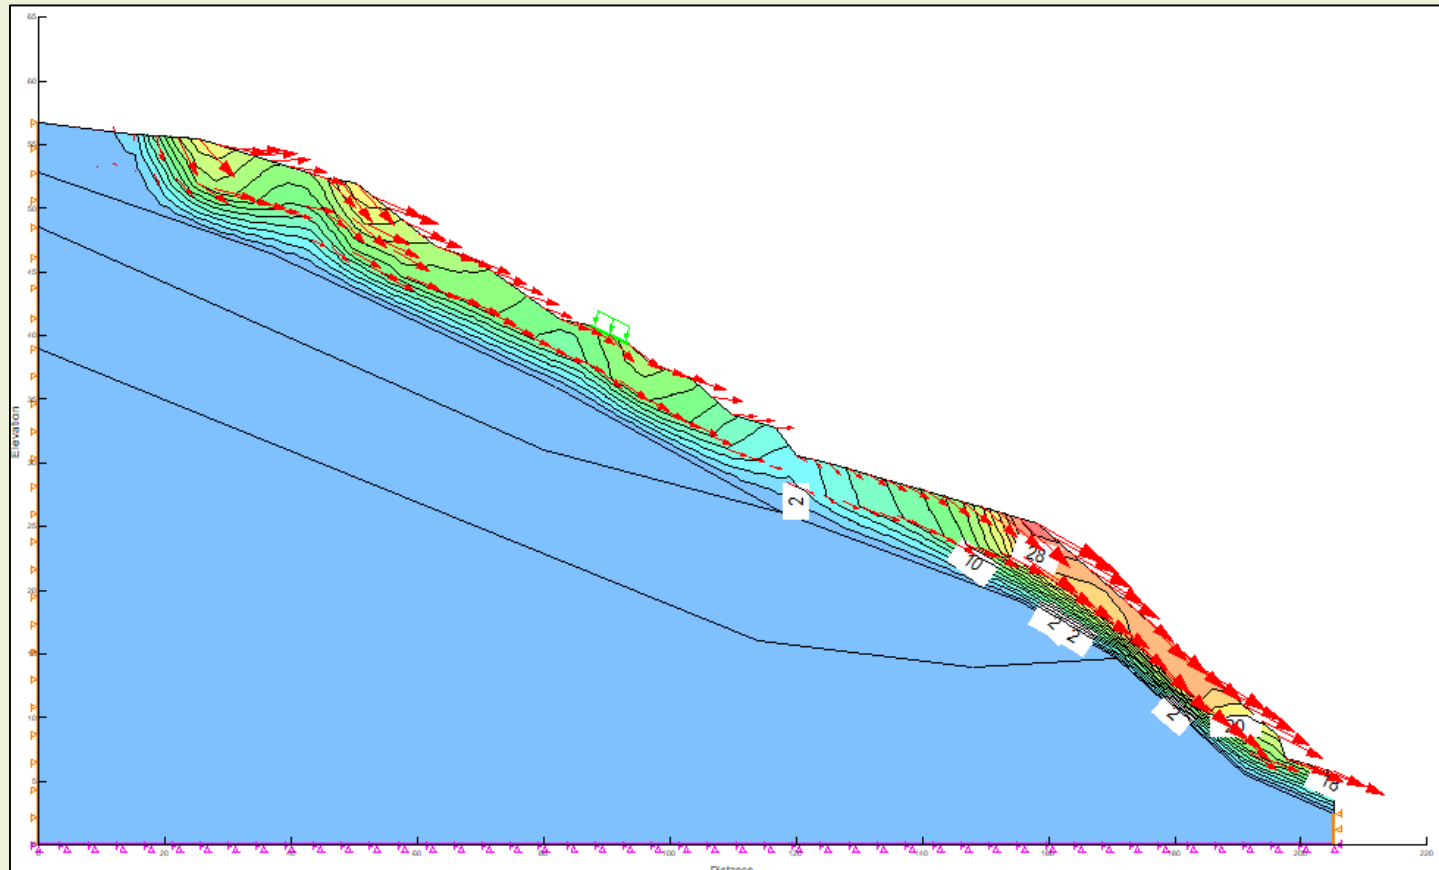
- Application of RW3
  - ❖ *RW3 placed on loose deposit → Deformation zones completely overlaps*
    - MASS MOVEMENT OF SOIL towards complete failure

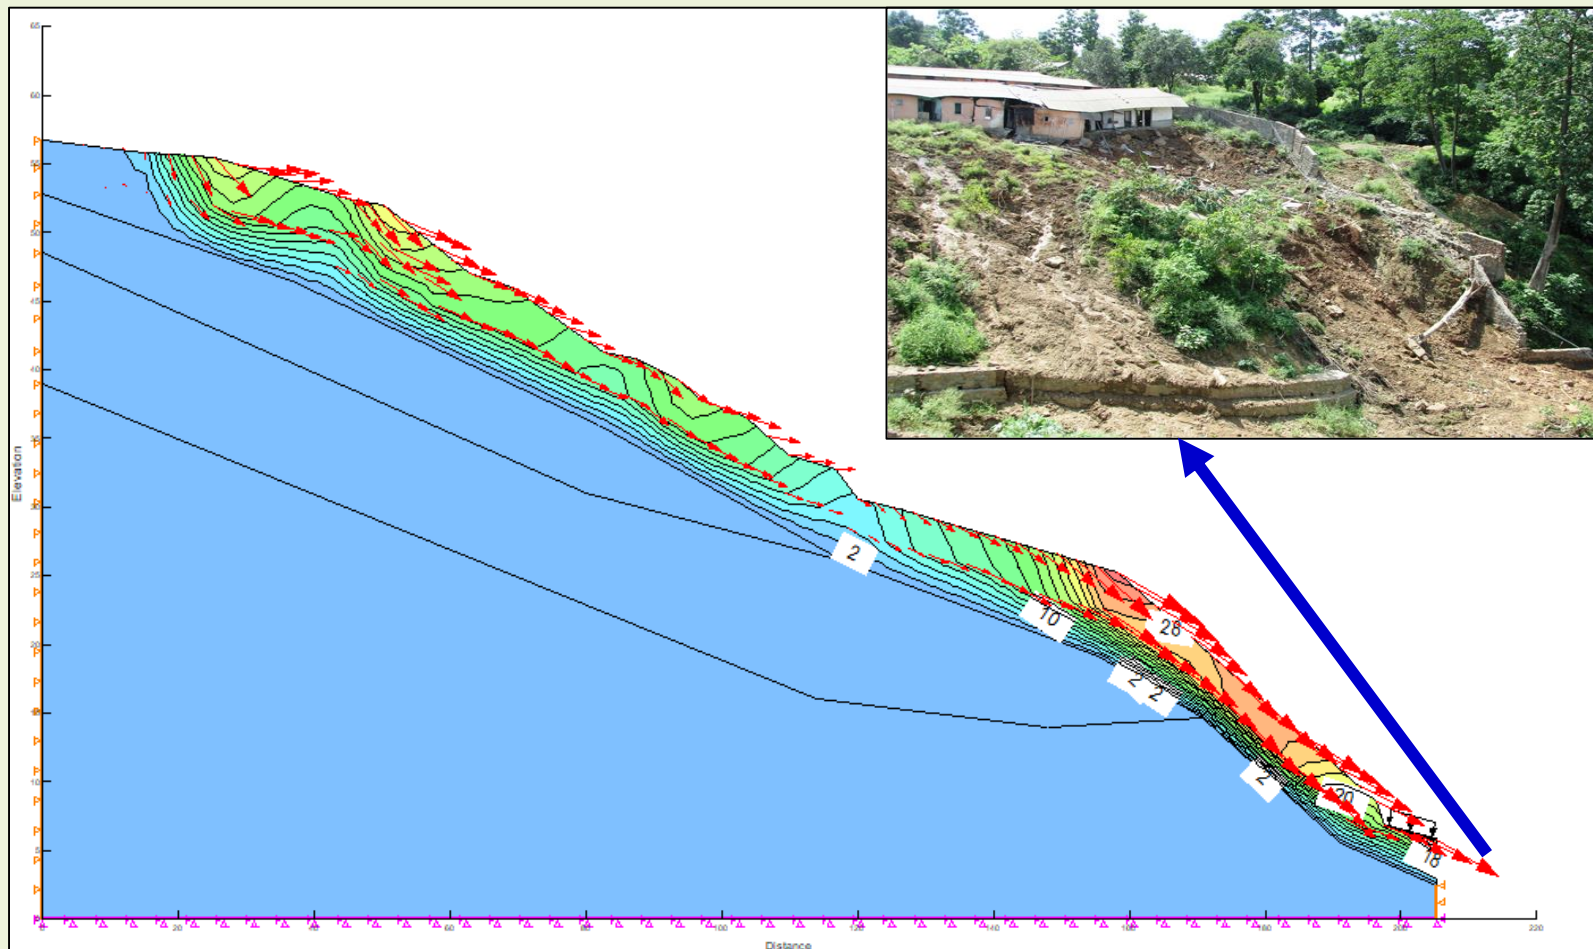
❖ *The bottommost barrier gets overtopped by excessively displacing soil*
