National Workshop on Importance of Disaster Risk Reduction and Resilience

Mizoram University, 10 April 2023

Recent Advances in Geotechnical Engineering Learning through Case Studies

Landslide at Calcom Cement Plant, Umrangso, Assam Forensic Geotechnology

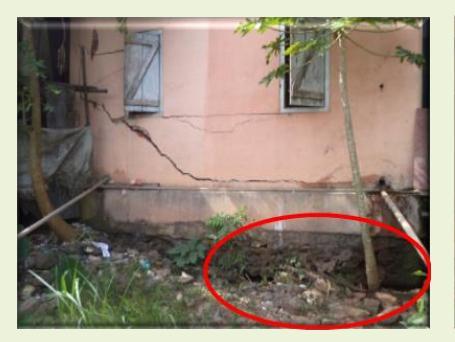
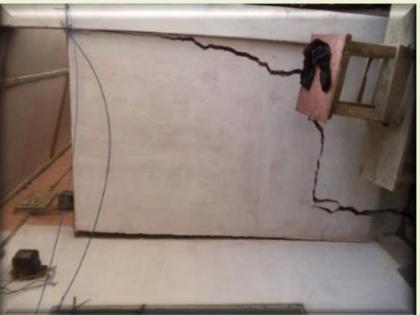
- 2nd November 2015: Meeting with the client
 - * Pictures of damages of the 24-Colony Residential Housing blocks
 - 2 rows of 12 quarters face-to-face: All extensively damaged
 - Wall and Floor cracking / See through cracks
 - Detachment of plasters
 - Abnormal sounds from cracking
 - Detachment in floors
 - Shifting of soil in plinth raft

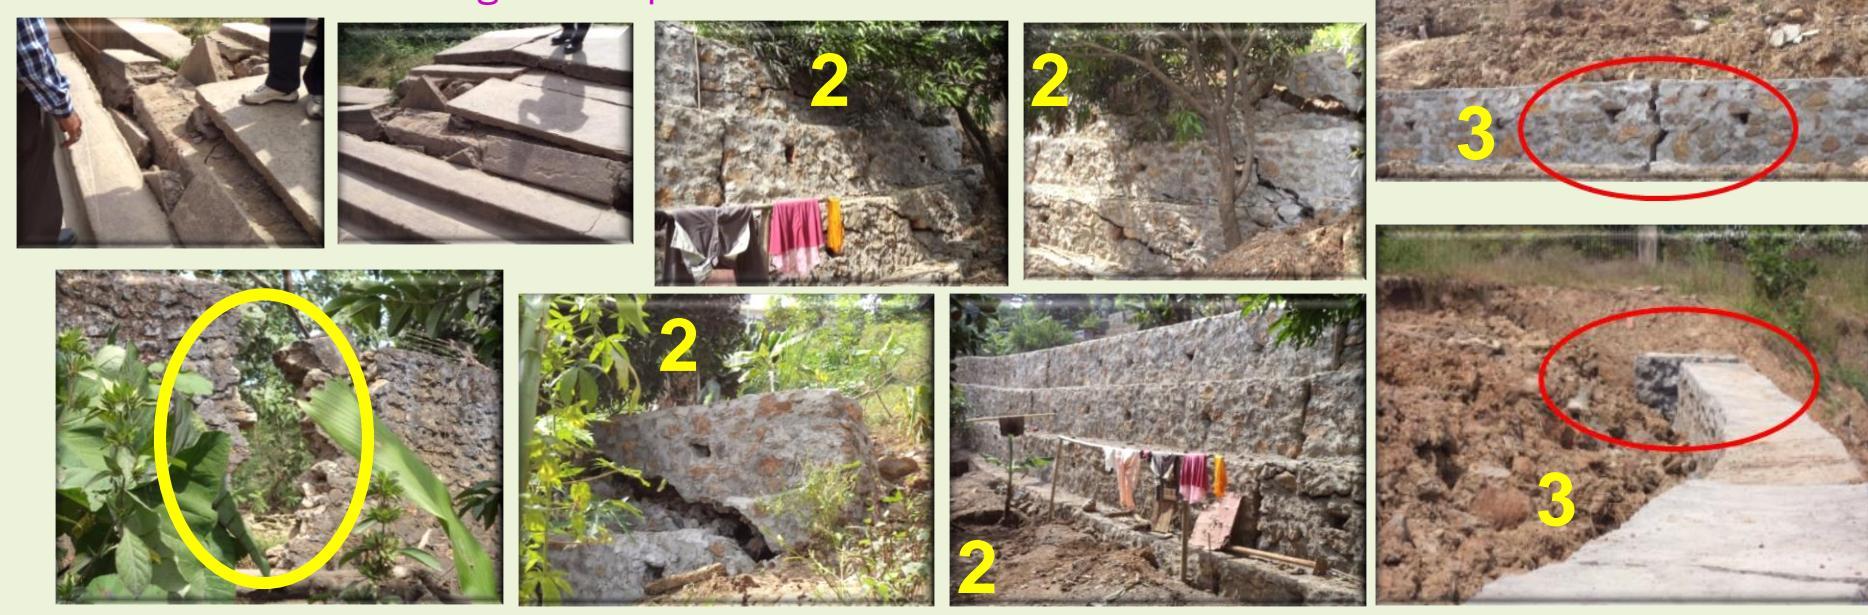
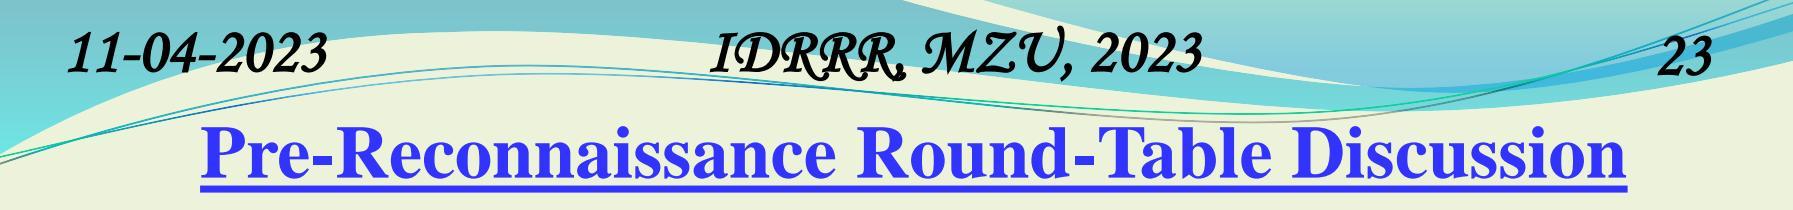
- 2nd November 2015: Meeting with the client, Dalmia Cements
 - * Pictures of damages in the protective retaining and boundary walls
 - Development of gaps and cracks in the retaining walls
 - Retaining wall 1: Between cement factory (workshop) and 24-Colony
 - Retaining Wall 3: Beside RCL road in front of 24 colony
 - Retaining wall 2: Frontal protection of 24-Colony (3 m)
 - Gaps in old boundary wall
 - Dislodgment of pavement and drains

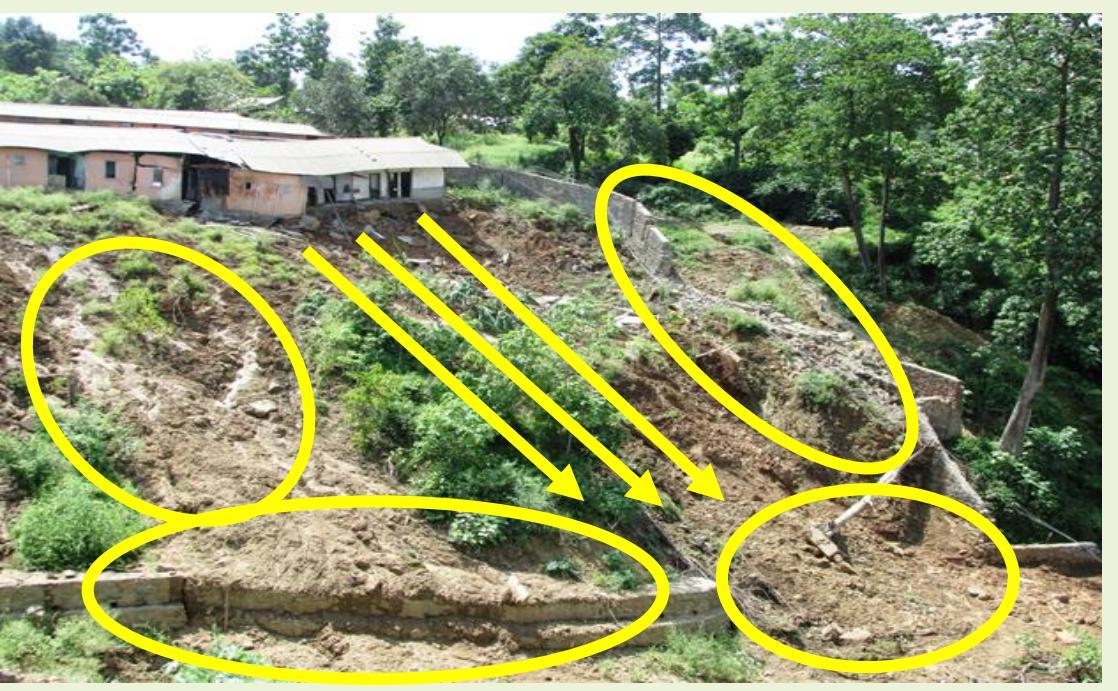
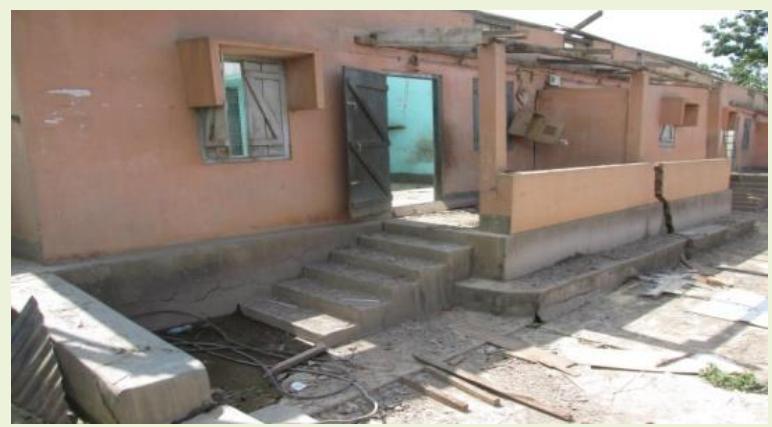
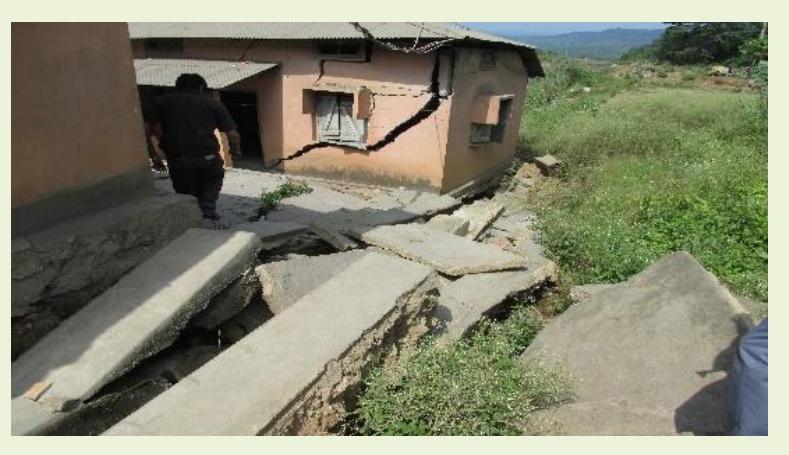
- Immense mass movement of soil
- Broken boundary wall
- Ejection of seeping water
- Overtopping of retaining wall
- Breakage of downhill protection wall

Extensive damage in the 24-Colony leading to relocation of workers

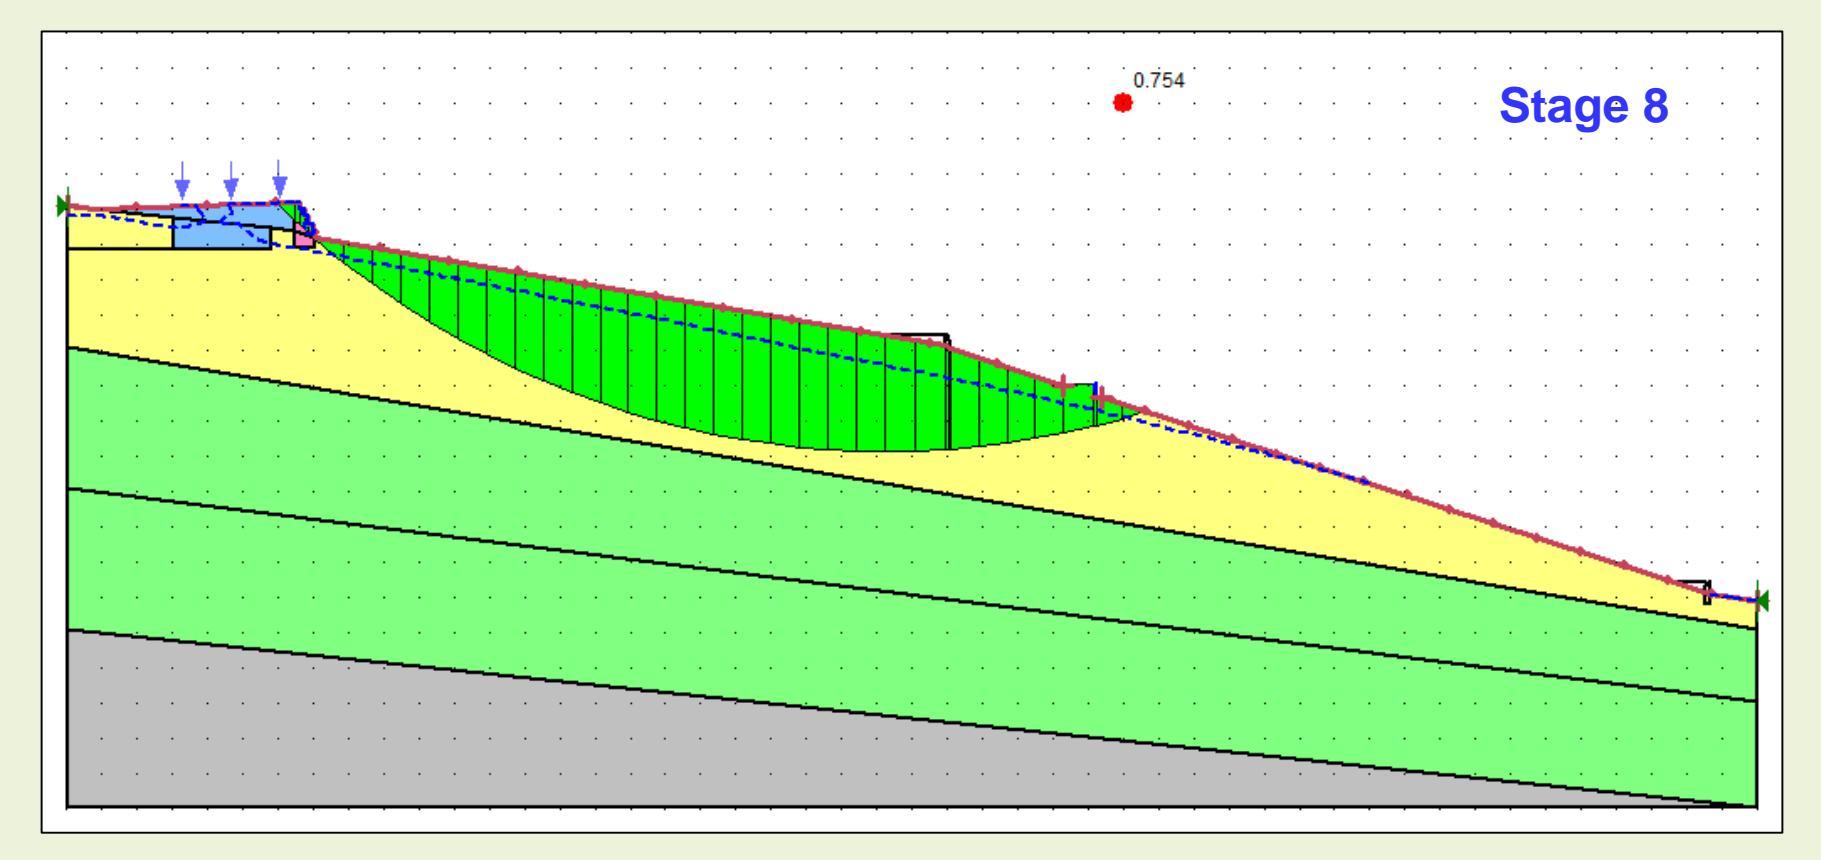
Retaining walls and backfills simply kept on adding weight to the system leading to more destabilization

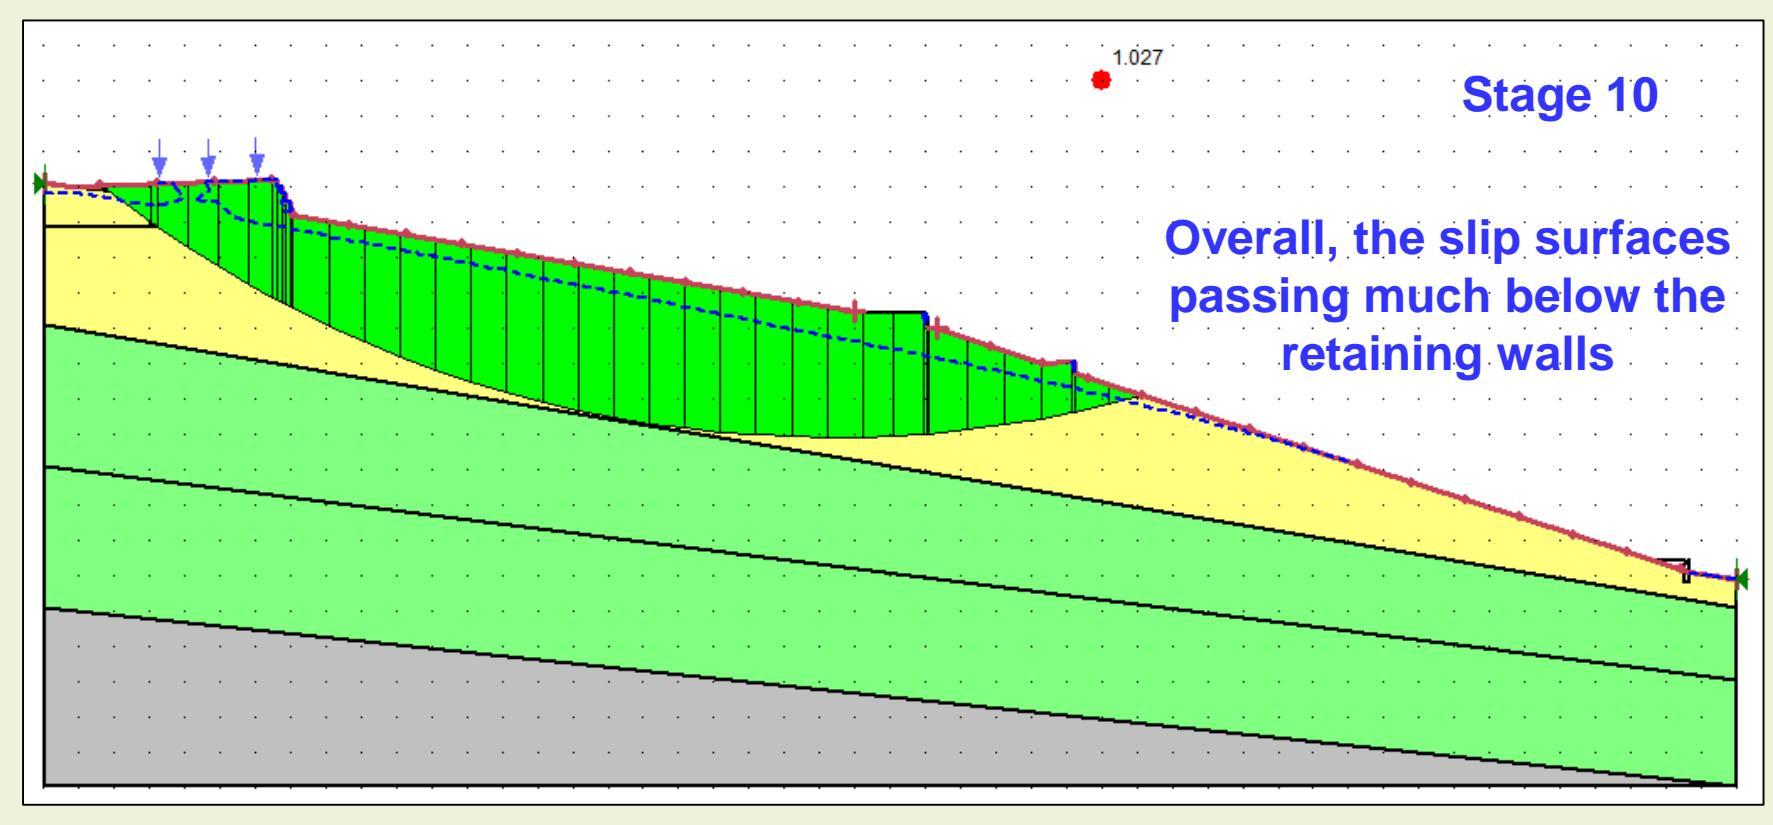
This did not happen in the field, RW4 was overtopped by mud and water \rightarrow Necessity for further investigation

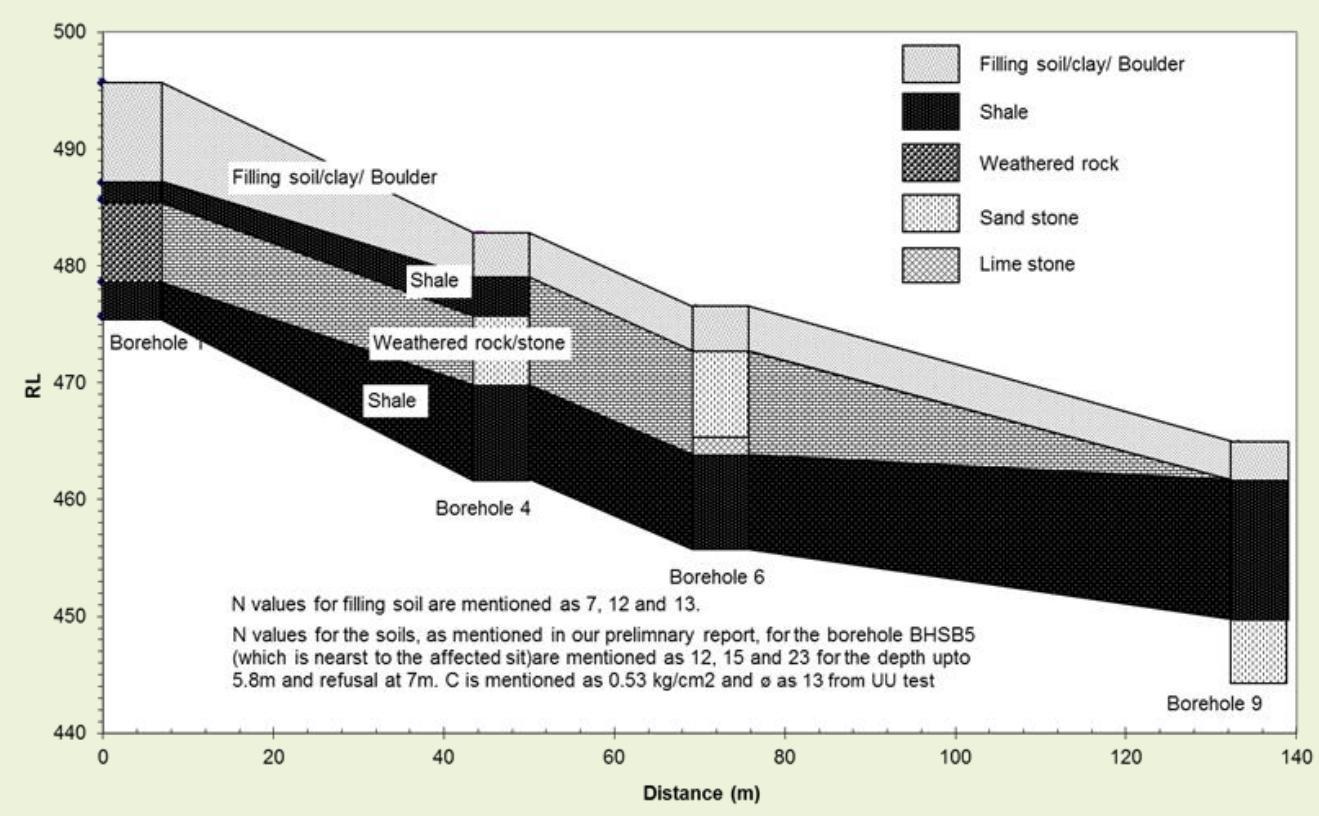
- A new understanding of the failure site
 - * Presence of thick cover of loosely deposited fill soil
 - Deposited during construction of workshop and store
 - This information was completely missing in earlier discussions

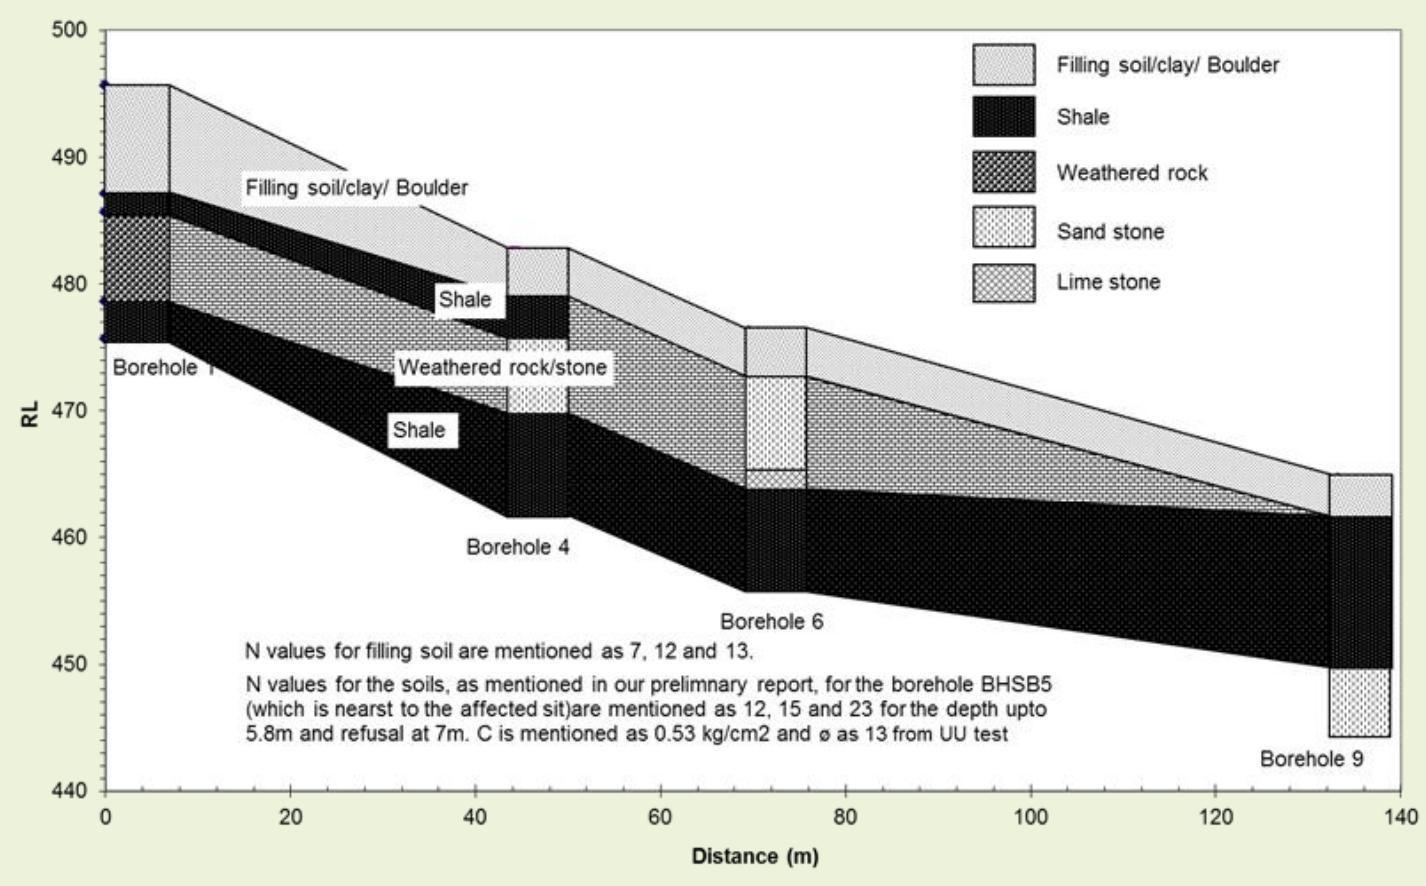
- A new understanding of the failure site
 - * Presence of shale pockets
 - Offers shear surface when get wet due to infiltration and percolation of water

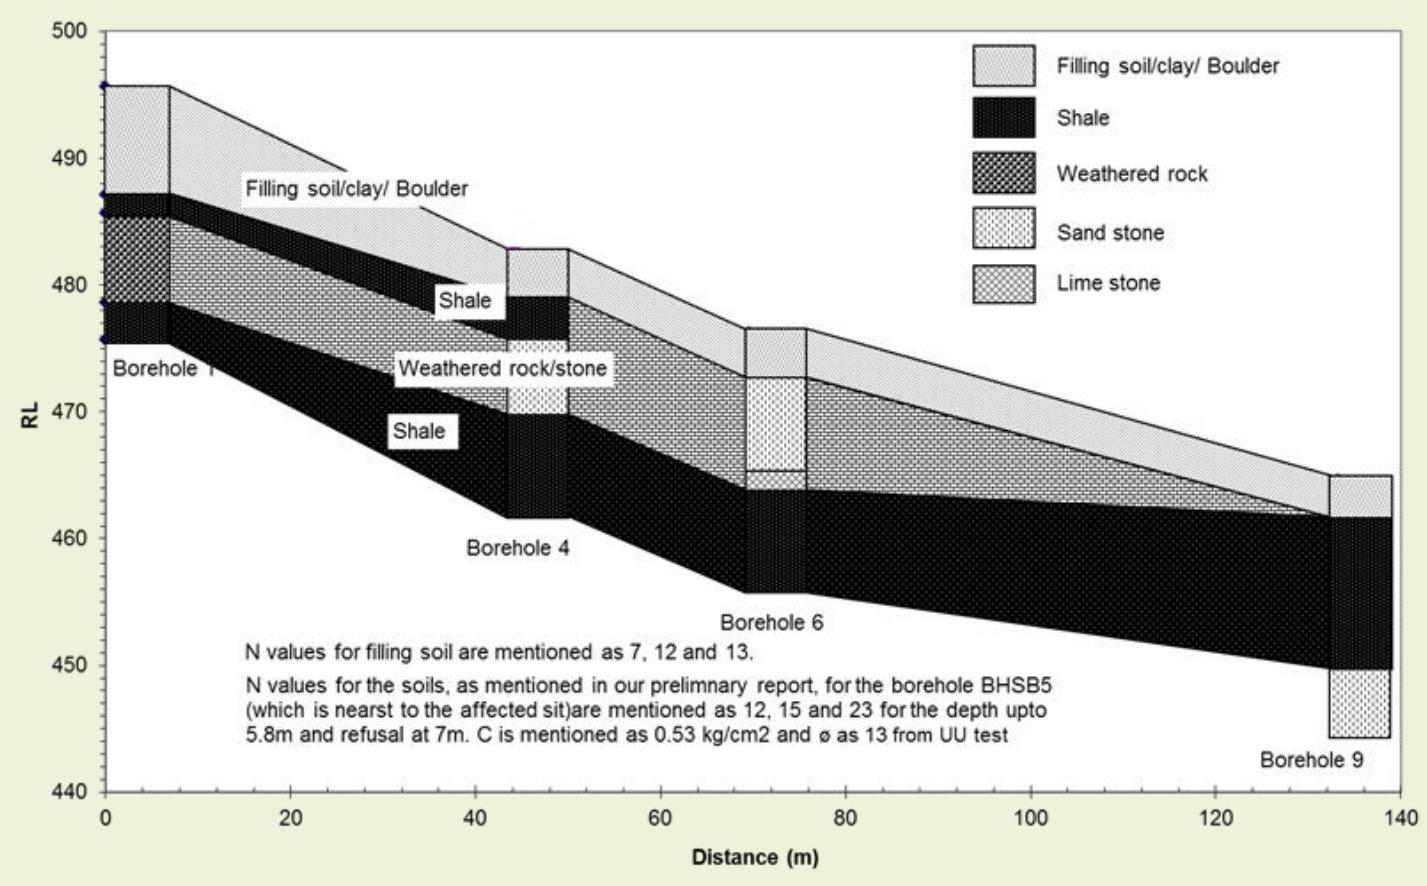
- A new understanding of the failure site
 - Presence of weathered rock/stone
 - Allows easy gradient-based migration of water beneath the slope surface

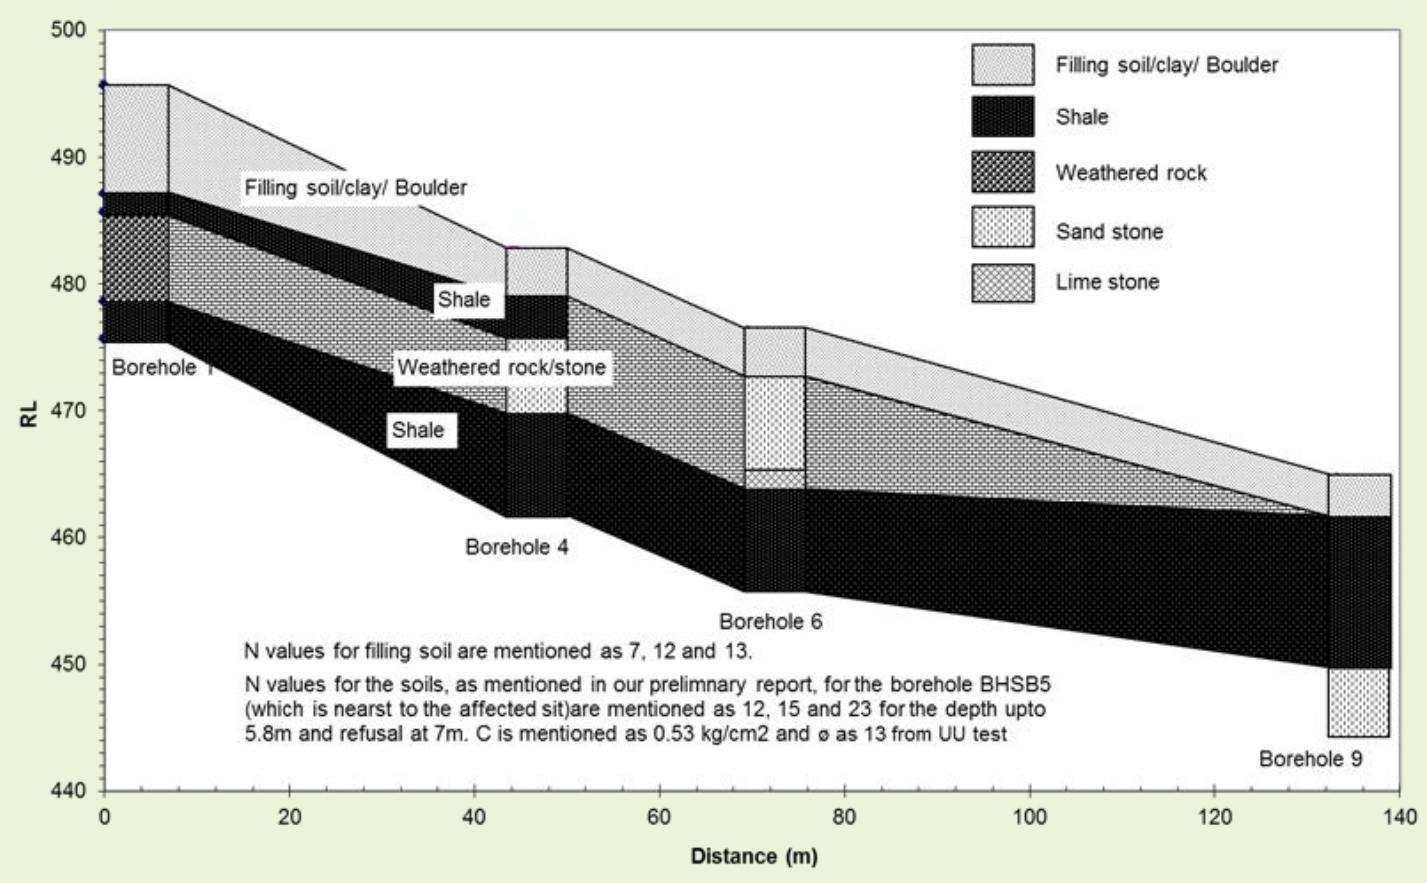
- A new understanding of the failure site
 - * Presence of thick deposit of shale
 - May act either as bedrock when dry, or offer sliding surface when wet

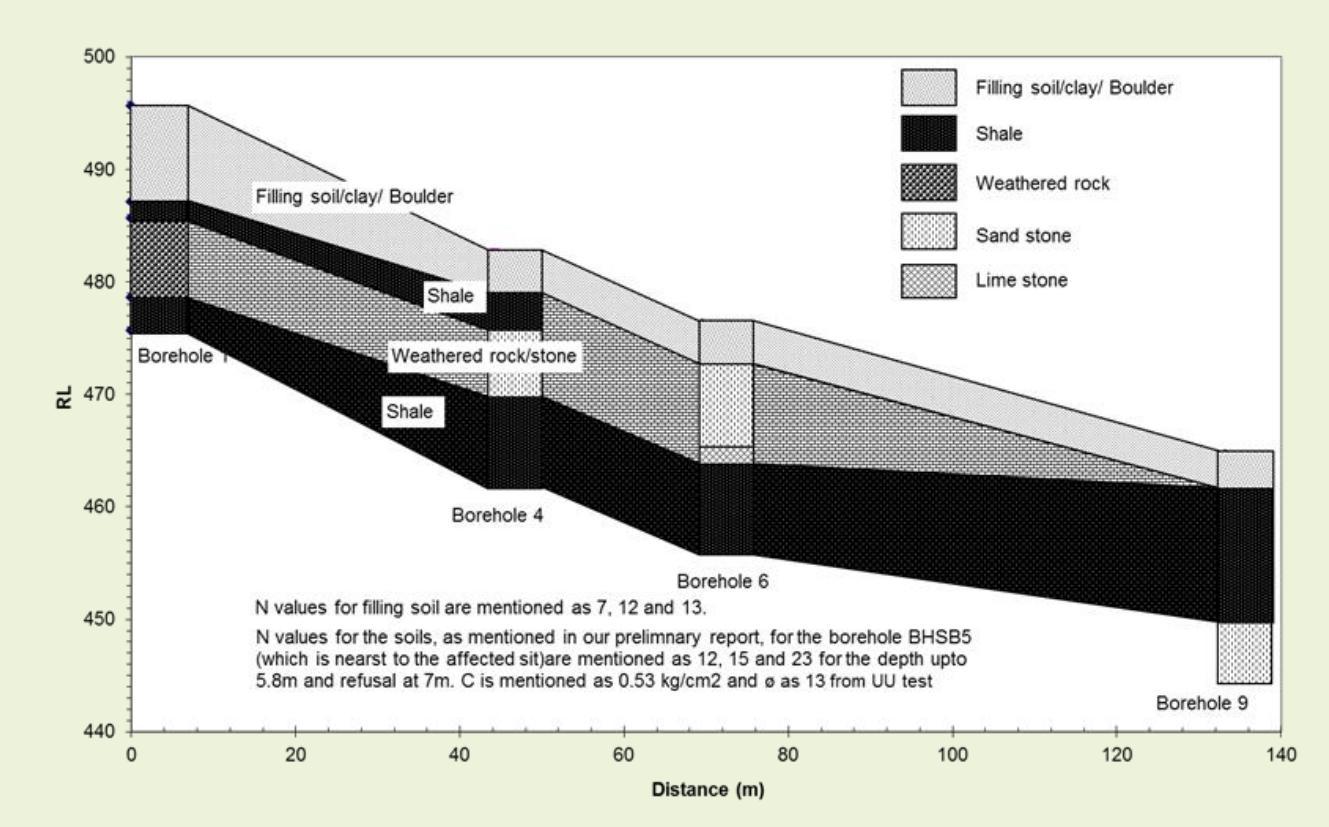
- A new understanding of the failure site
 - * A strong intuition developed that the failure is actually shallow slide due to the movement of the loose deposit itself
 - All the retaining walls and workers colony were simply resting on the loose deposit

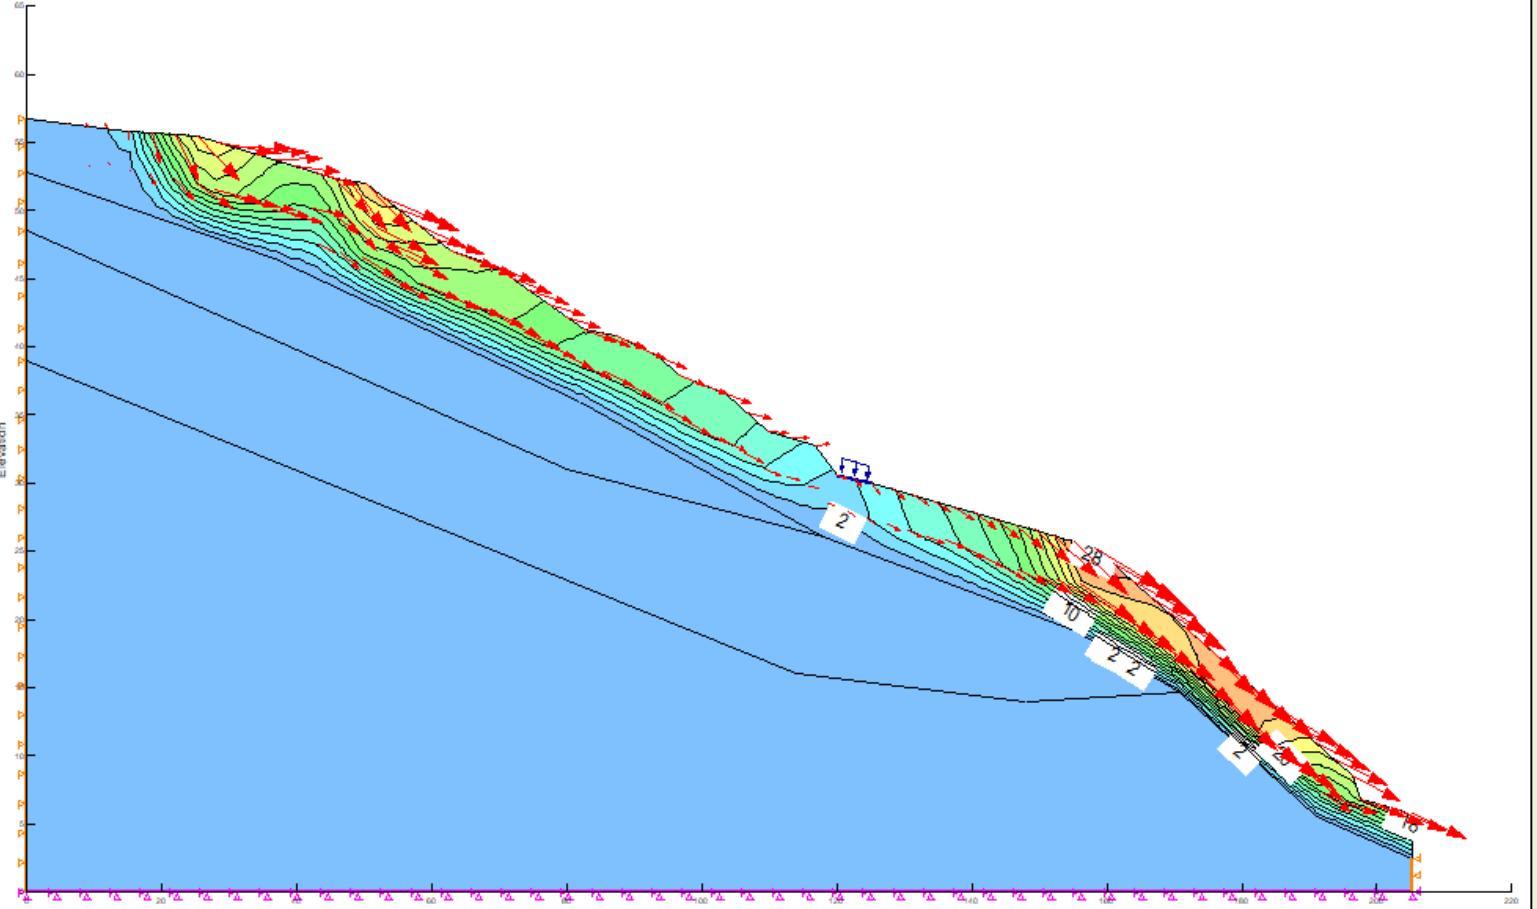
♦ *RW2* placed on loose deposit \rightarrow *Deformation zones start overlapping*

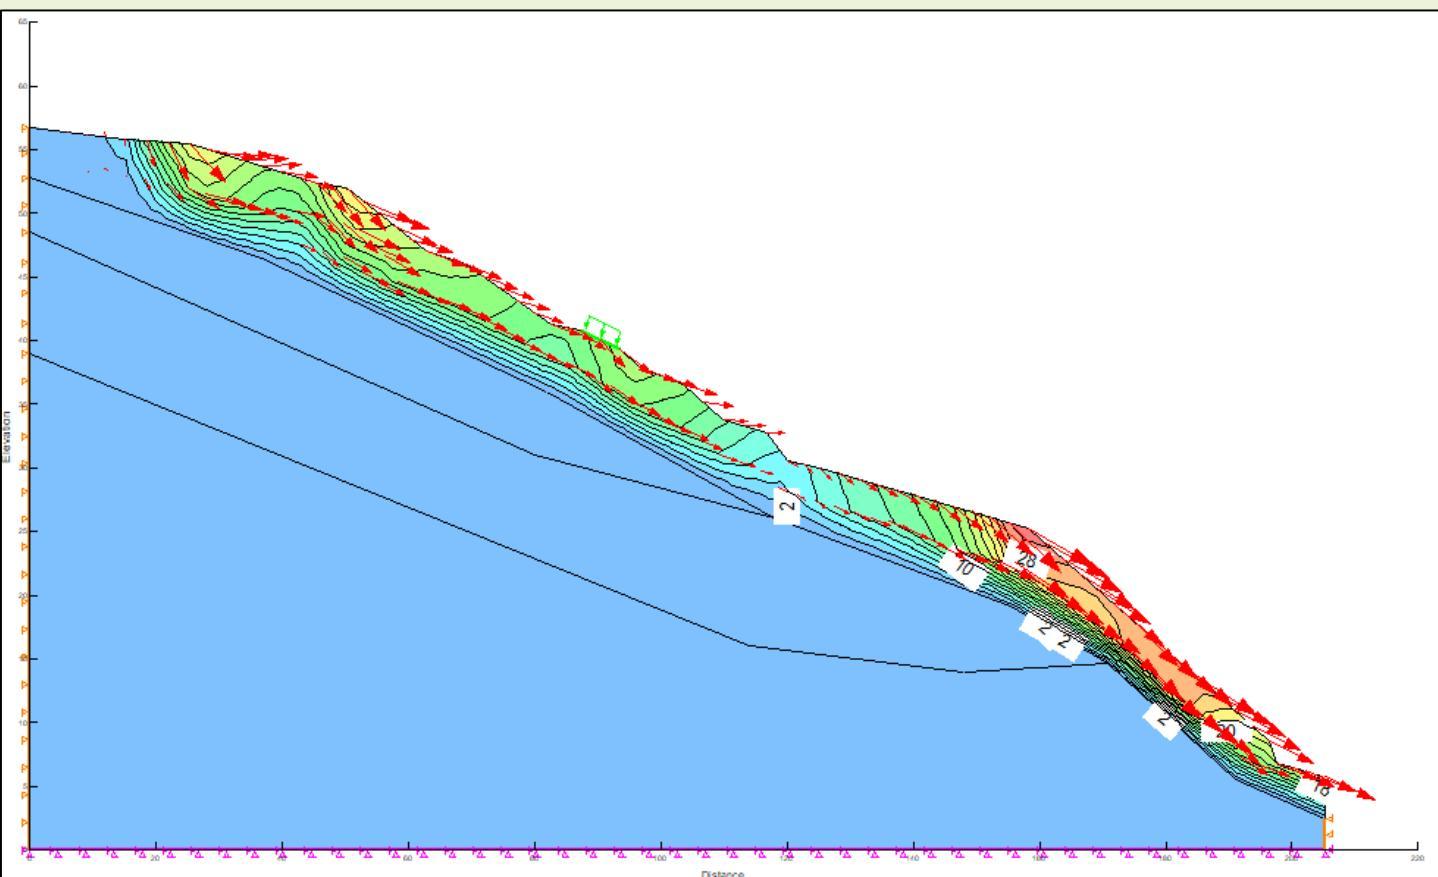
- Application of RW3
 - RW3 placed on loose deposit \rightarrow Deformation zones completely overlaps
 - MASS MOVEMENT OF SOIL towards complete failure

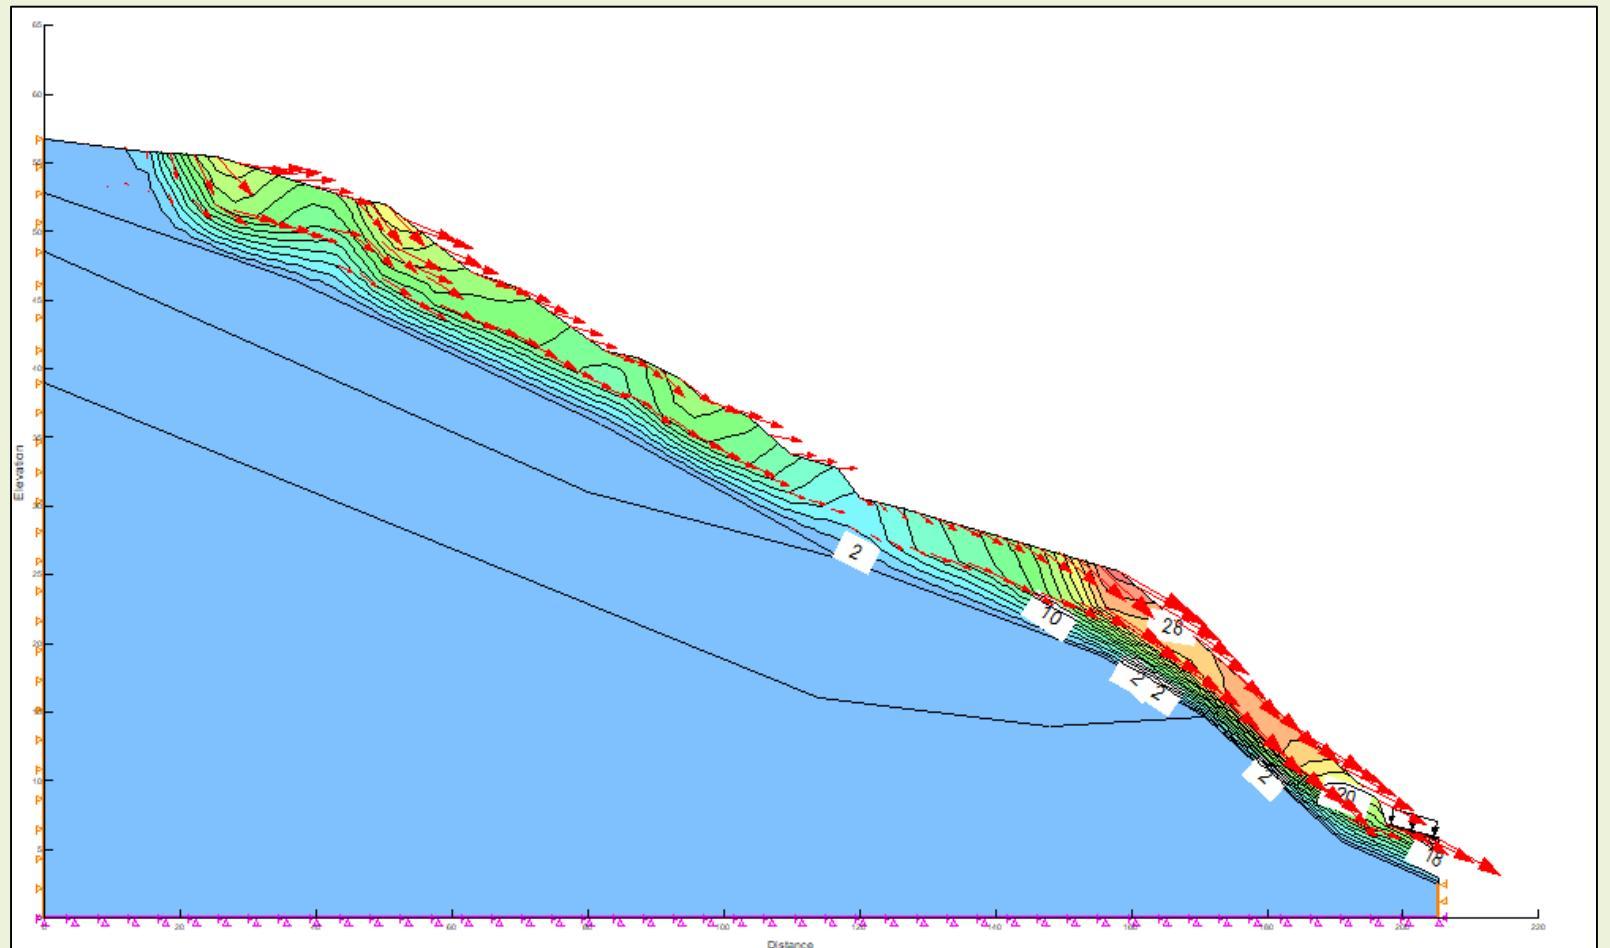
- Application of RW4
 - The bottommost barrier gets overtopped by excessively displacing soil

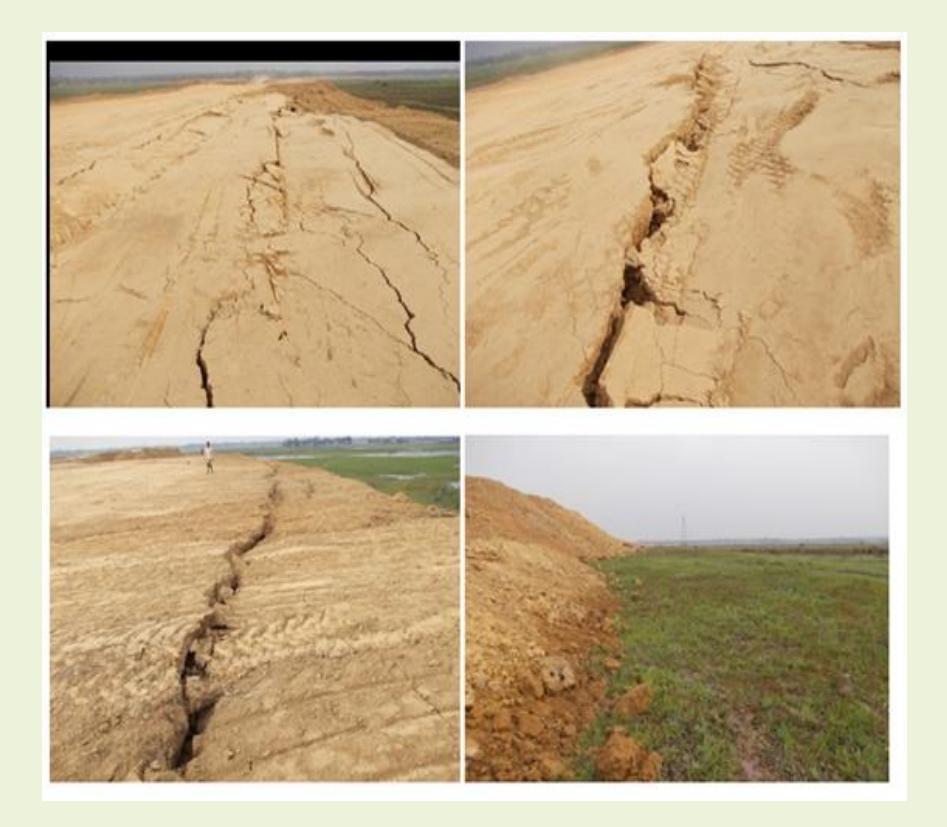
- Height of embankment = 6.2 m
- Embankment construction started in stages: Dec' 2010.
 - September 2011
 - First failure noticed at 3.0-3.5 m height:
 - ***** *March* 2012
 - Large settlement of 5-5.2 m
 - Heaving up of ground until 30 m distance from the embankment
- After that further construction stopped

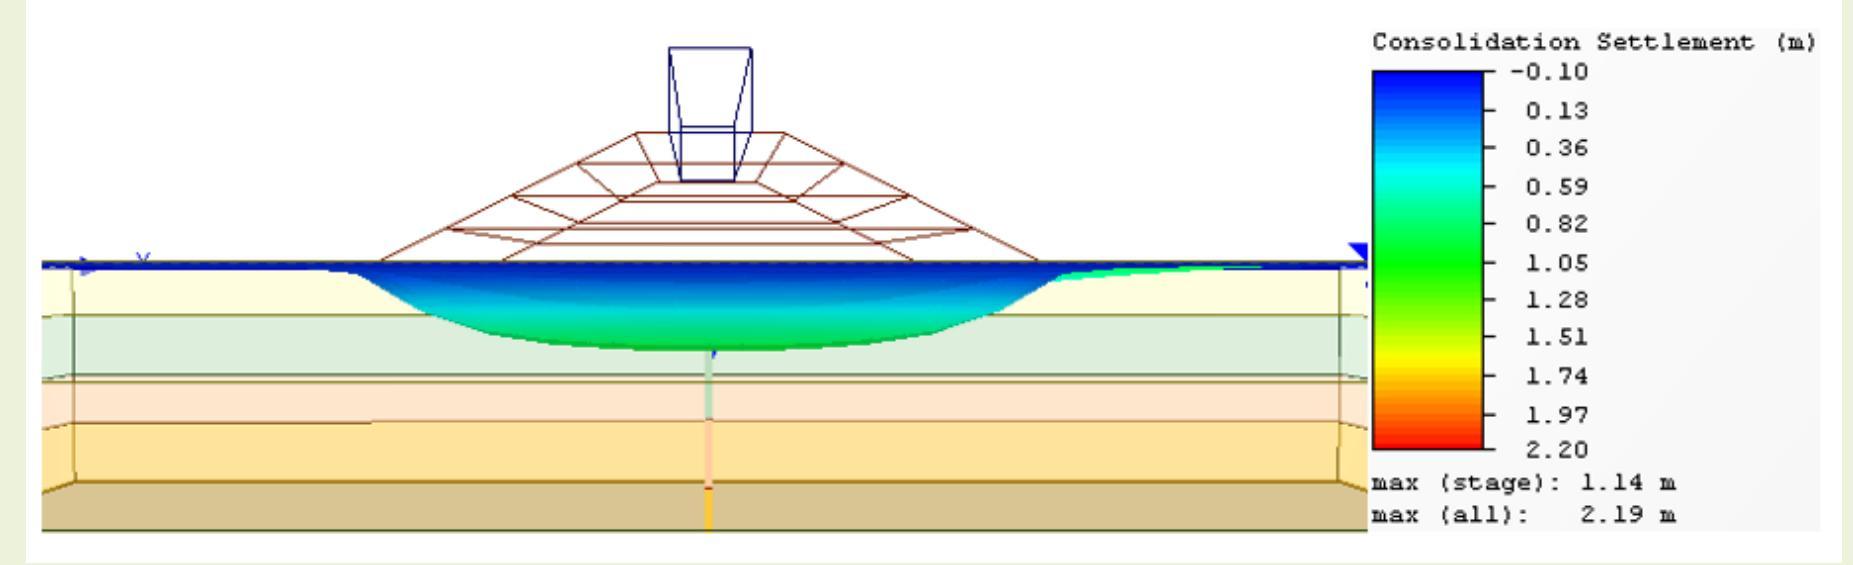
- Using SETTLE3D software (Rocscience 2014)
 - The primary consolidation settlement of 0.505 m, 0.755 m, and 0.951 m after 3.14 m, 4.64 m, and 6 m embankment heights were observed.

- Numerical study confirms large deformations observed in the field
- Warrants for ground improvement
