## Characterization of Earthquake induced road damages in and around Indian subcontinent

### EXTENDED ABSTRACT

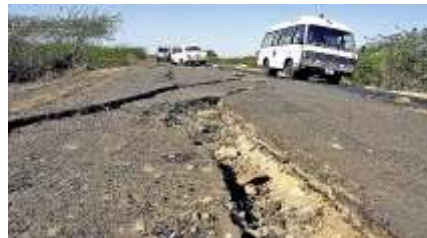
damages during this earthquake have been intensively discussed in the literature. Similar to above damages, road damages were also considerable during this earthquake. Fig 1 presents the kind of road damages in Bhuj area located about 20km northwest of the epicenter showing 15 to 20cm wide cracks during the earthquake. Although the width of crack is more than 100mm, but a RDS of 2 is assigned to this damage since the road condition can be restored with minor treatment. Further, road damage during 2001 Bhuj earthquake at Chopadva located around 200km from the epicenter is shown in Fig 2 showing an uplift of 80cm. This location is assigned RDS of 3 in accordance with Anbazhagan et al., (2012).

**Fig 1.** Road damage in Bhuj during 2001 Bhuj earthquake

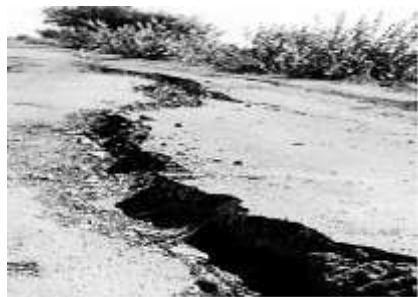
**Fig. 2.** Road damage at Chopadva during 2001 Bhuj earthquake

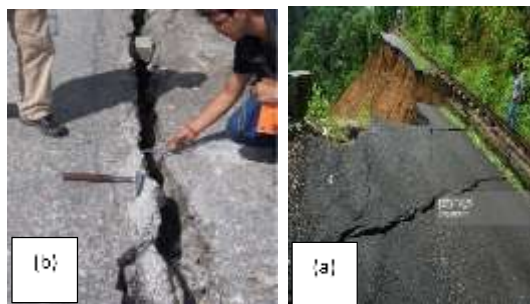
During the year 2011, Sikkim was shaken by another earthquake having magnitude of 6.8 reported at a focal depth of 20km as per USGS. Intensive shaking during this earthquake triggered a large number of landslides and caused significant damage to infrastructure. As per the available data, 2011 Sikkim earthquake triggered 354 new landslides in addition to reactivation of 48 old landslides. As a result of falling of rubbles and their impact, roads were also undergone severe damages. One such damage was observed on Lachung located just 68km from the epicenter. As per Sharma et al., (2012) cracks having width of over 20cm were observed in Lachung as shown in Fig 3(a). For the present analysis, RDS of 2 was assigned to this damage. In addition, Fig 3(b) presents a collapsed portion of NH 55 between Siliguri and Darjeeling during 2011 Sikkim earthquake. This damage is assigned RDS 5 for the present analysis indicating worst kind of damage.

**Fig. 3.** (a) Ground rupture in Lachung as per Sharma et al., (2012); (b) collapsed portion of NH 55 between Siliguri and Darjeeling as per EERI (2012)
