National Workshop on Importance of Disaster Risk Reduction and Resilience

Mizoram University, 10 April 2023

Recent Advances in Geotechnical Engineering Learning through Case Studies

Landslide at Calcom Cement Plant, Umrangso, Assam Forensic Geotechnology

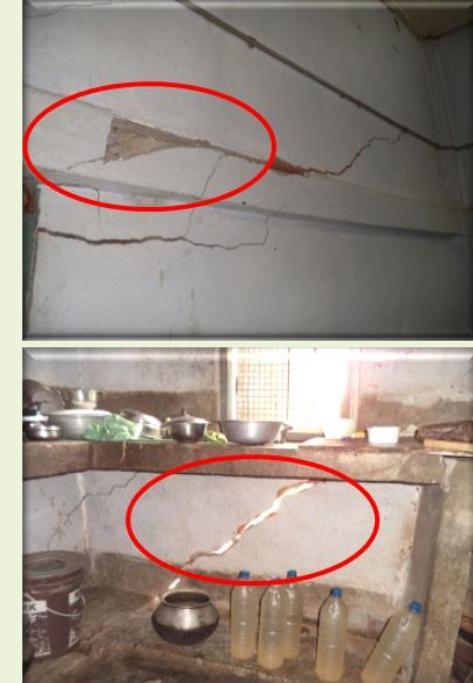
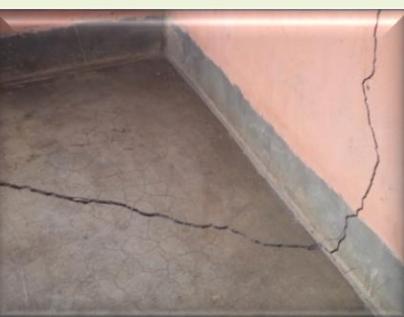
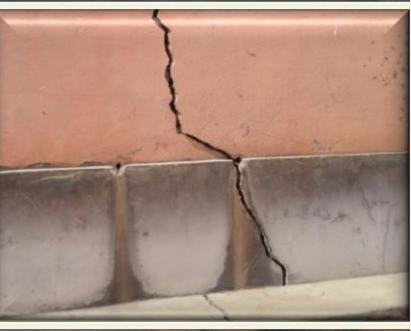
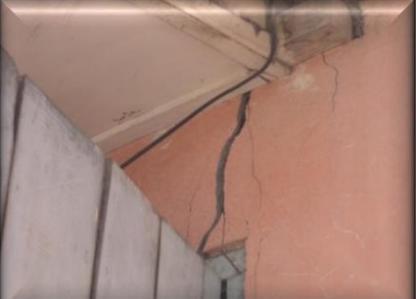
- 2nd November 2015: Meeting with the client
 - * Pictures of damages of the 24-Colony Residential Housing blocks
 - 2 rows of 12 quarters face-to-face: All extensively damaged
 - Wall and Floor cracking / See through cracks
 - Detachment of plasters
 - Abnormal sounds from cracking
 - Detachment in floors
 - Shifting of soil in plinth raft

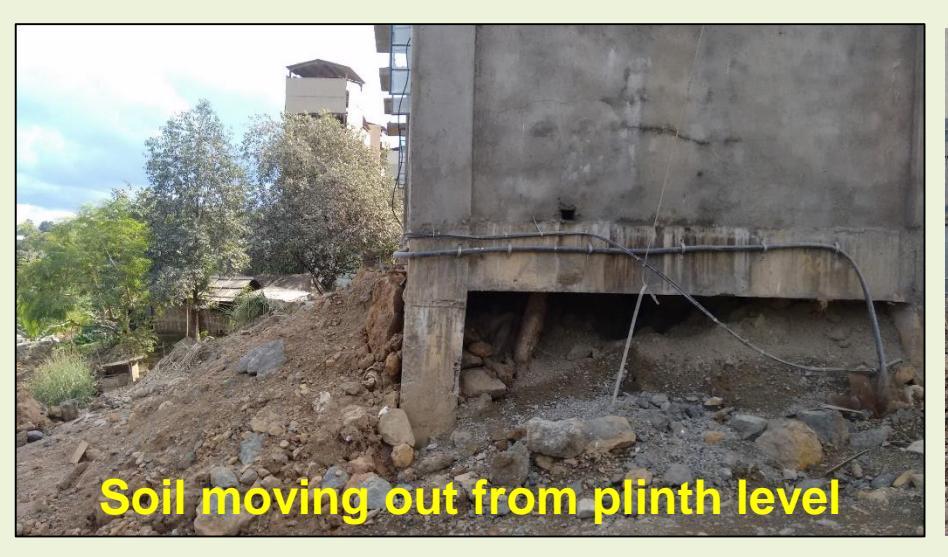
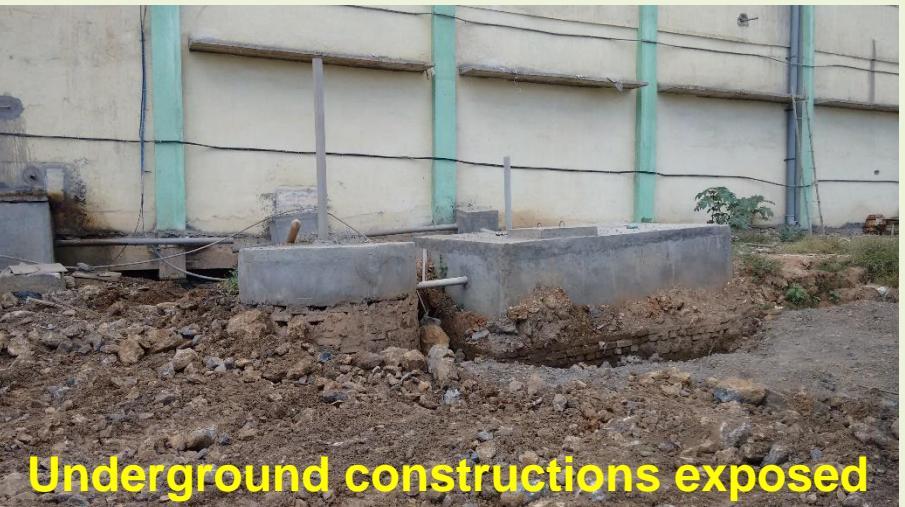
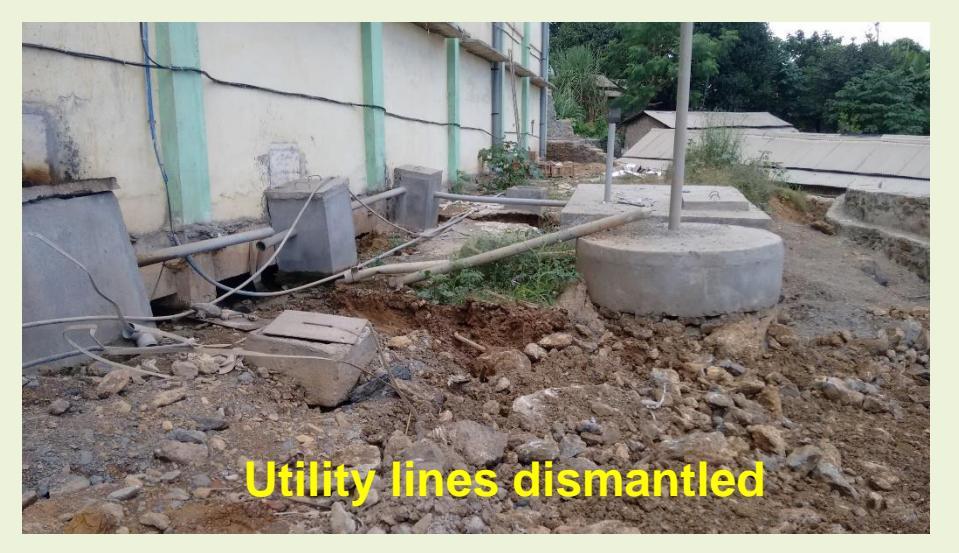
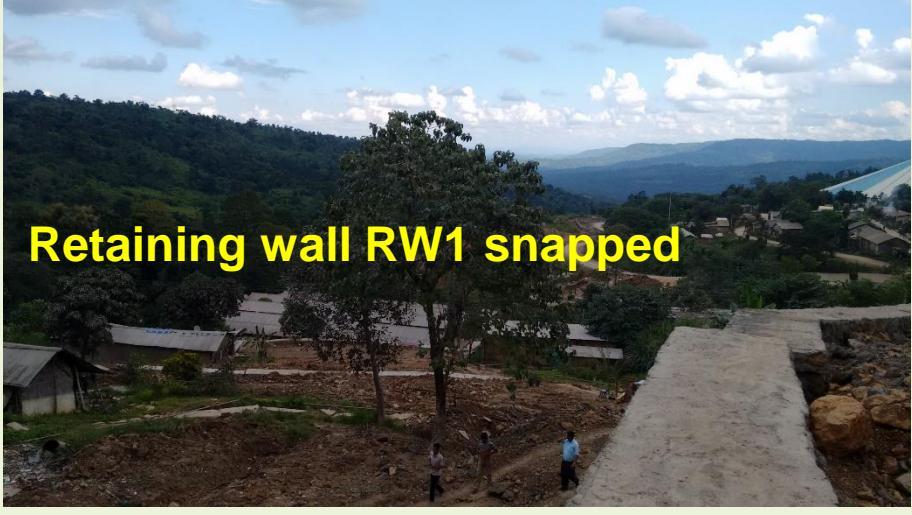
Site Visit for Reconnaissance Survey: 3rd Nov 2015

- Immense mass movement of soil
- Broken boundary wall
- Ejection of seeping water
- Overtopping of retaining wall
- Breakage of downhill protection wall

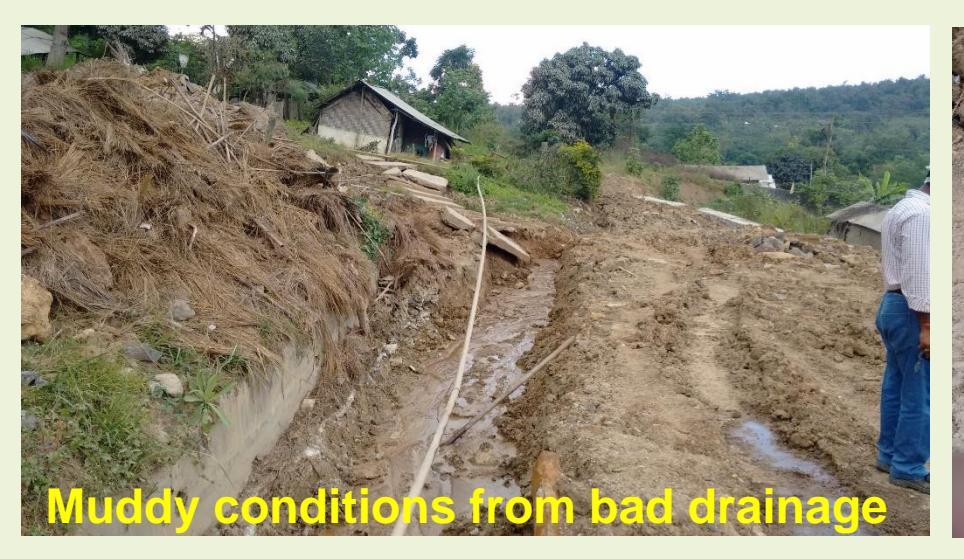
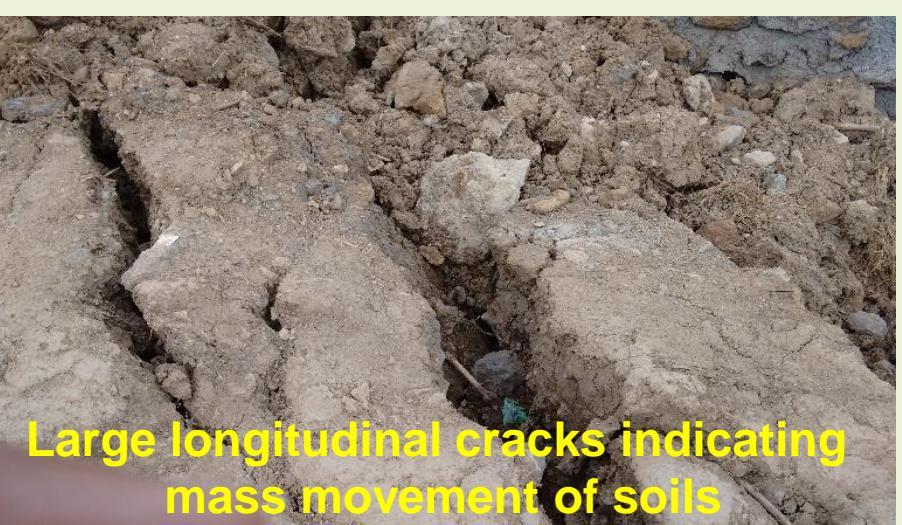
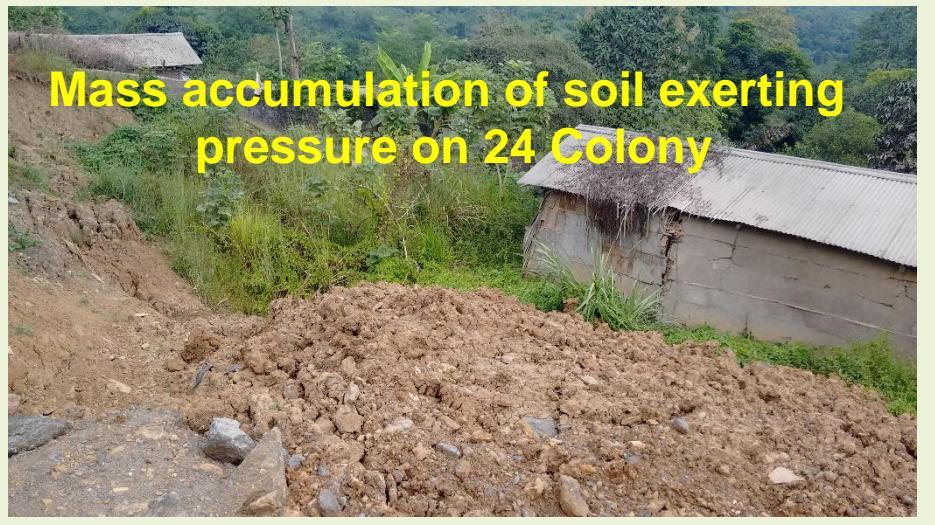
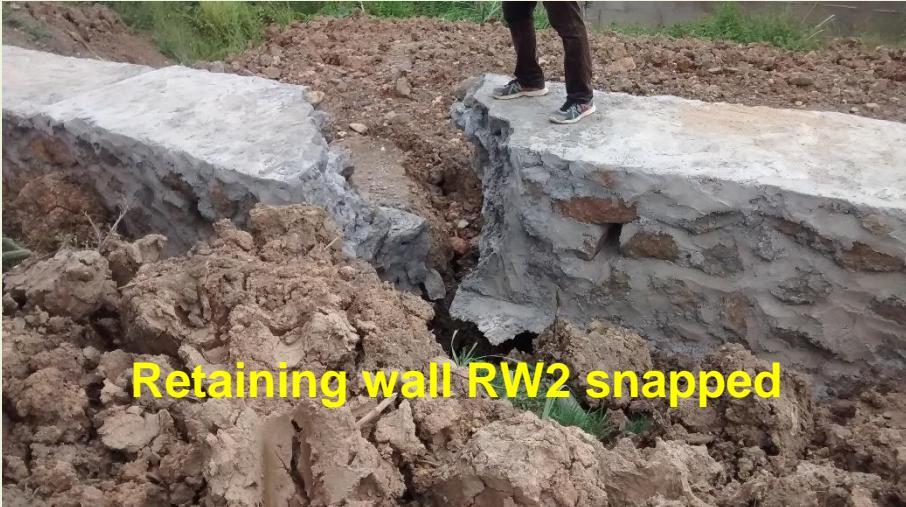
Site Visit for Reconnaissance Survey: 3rd Nov 2015

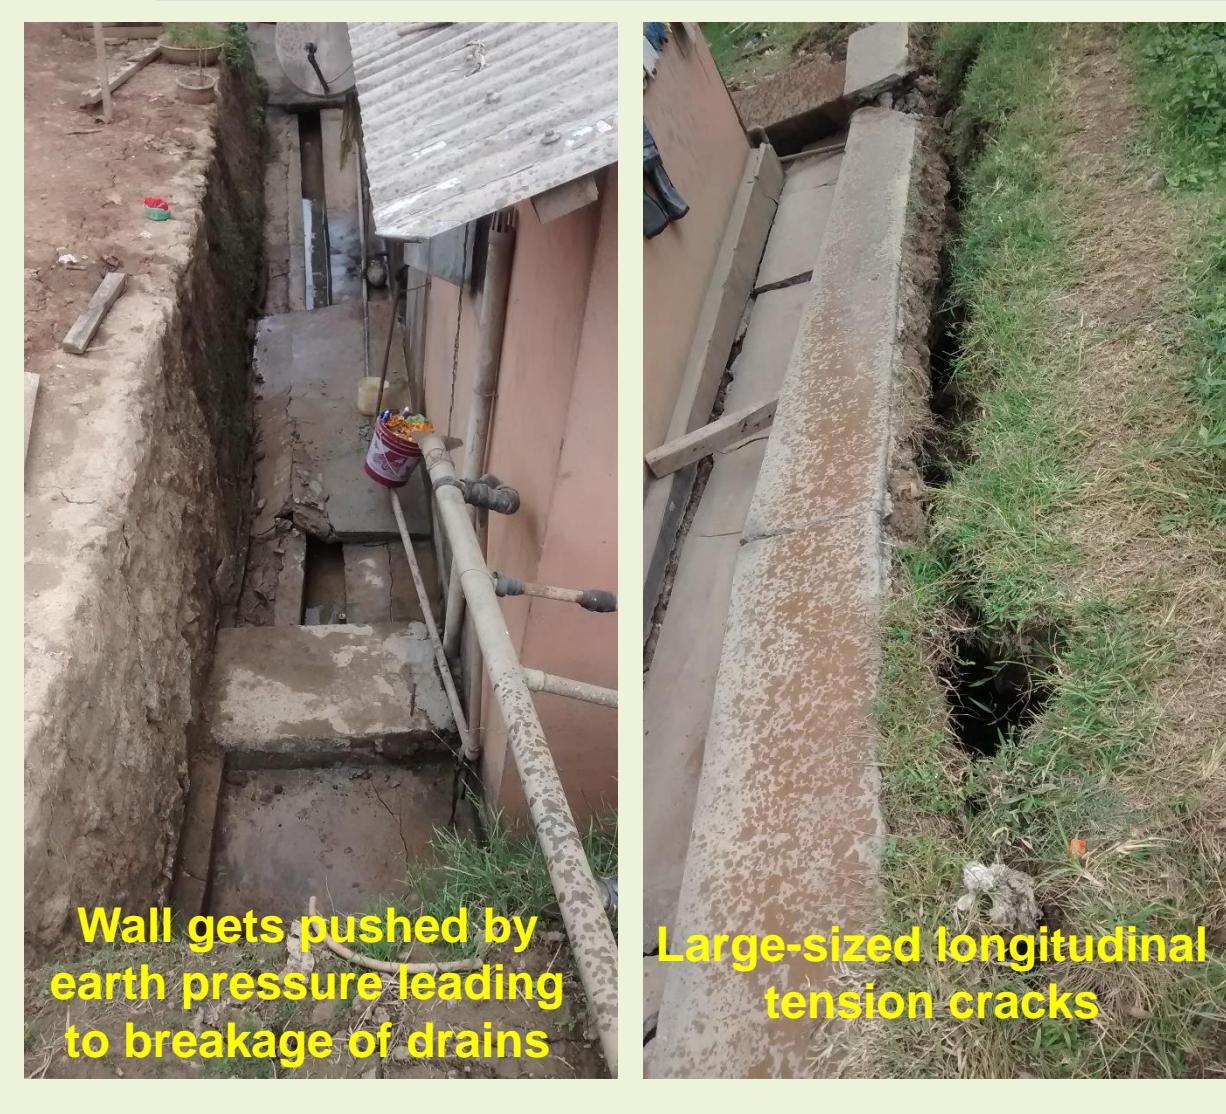
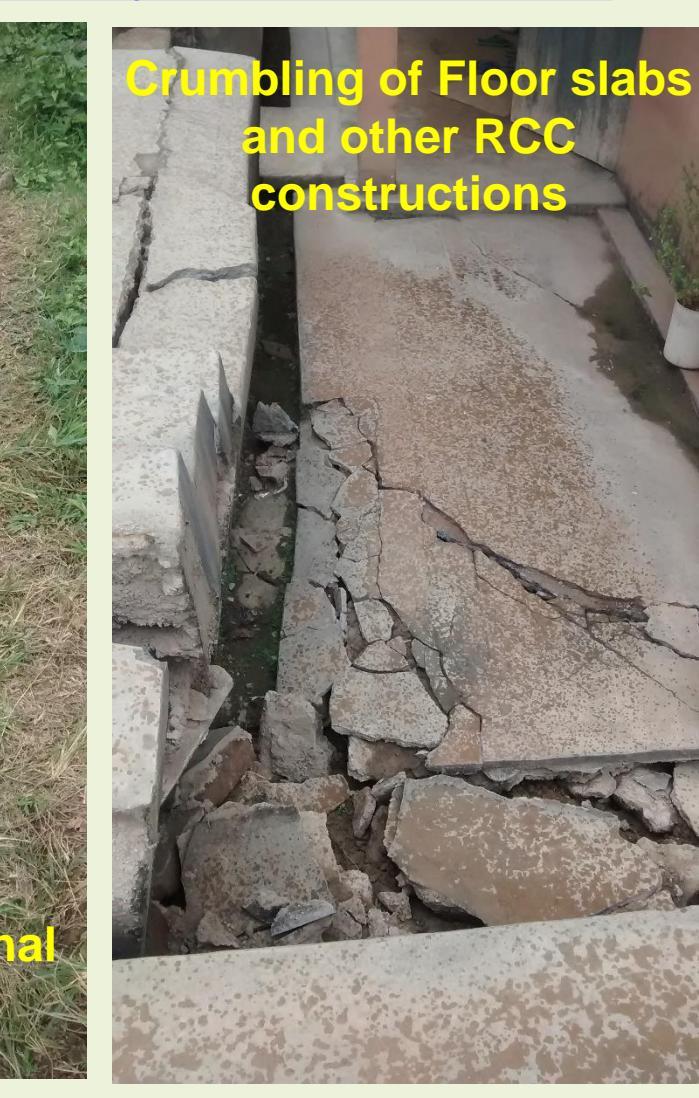
Site Visit for Reconnaissance Survey: 3rd Nov 2015

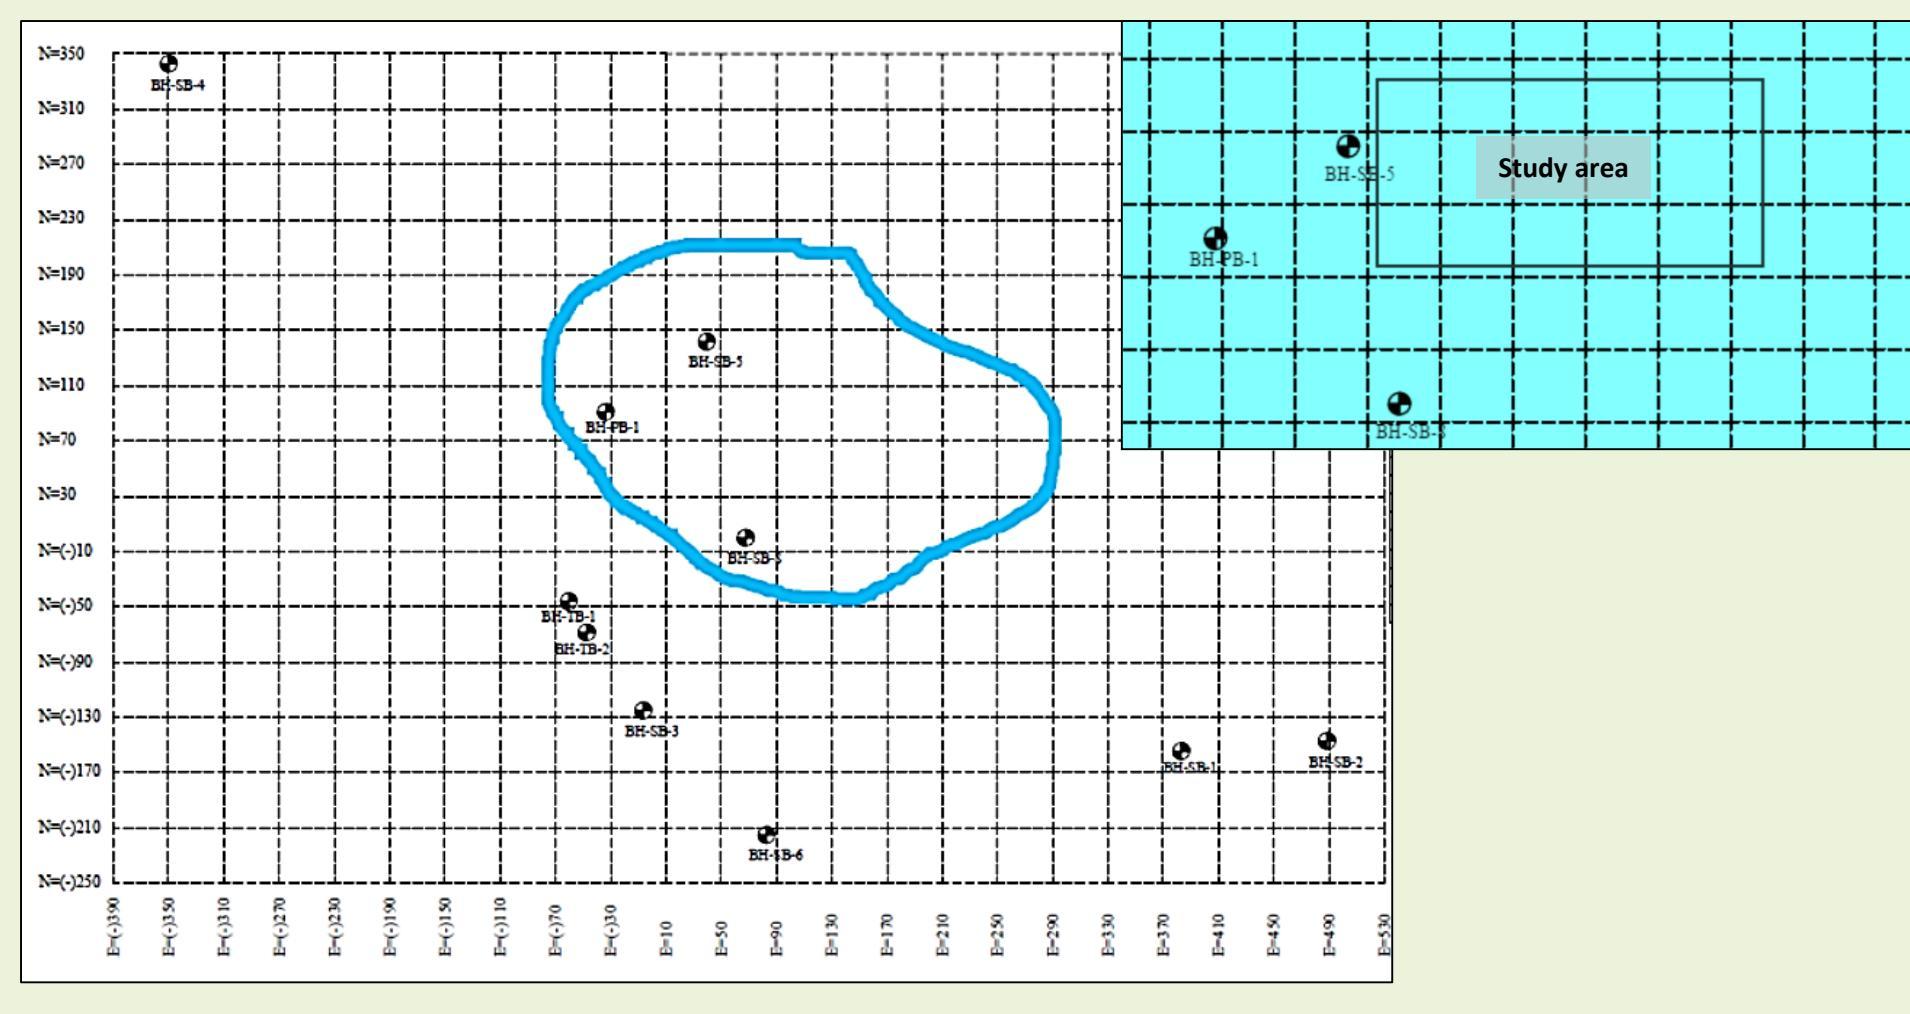
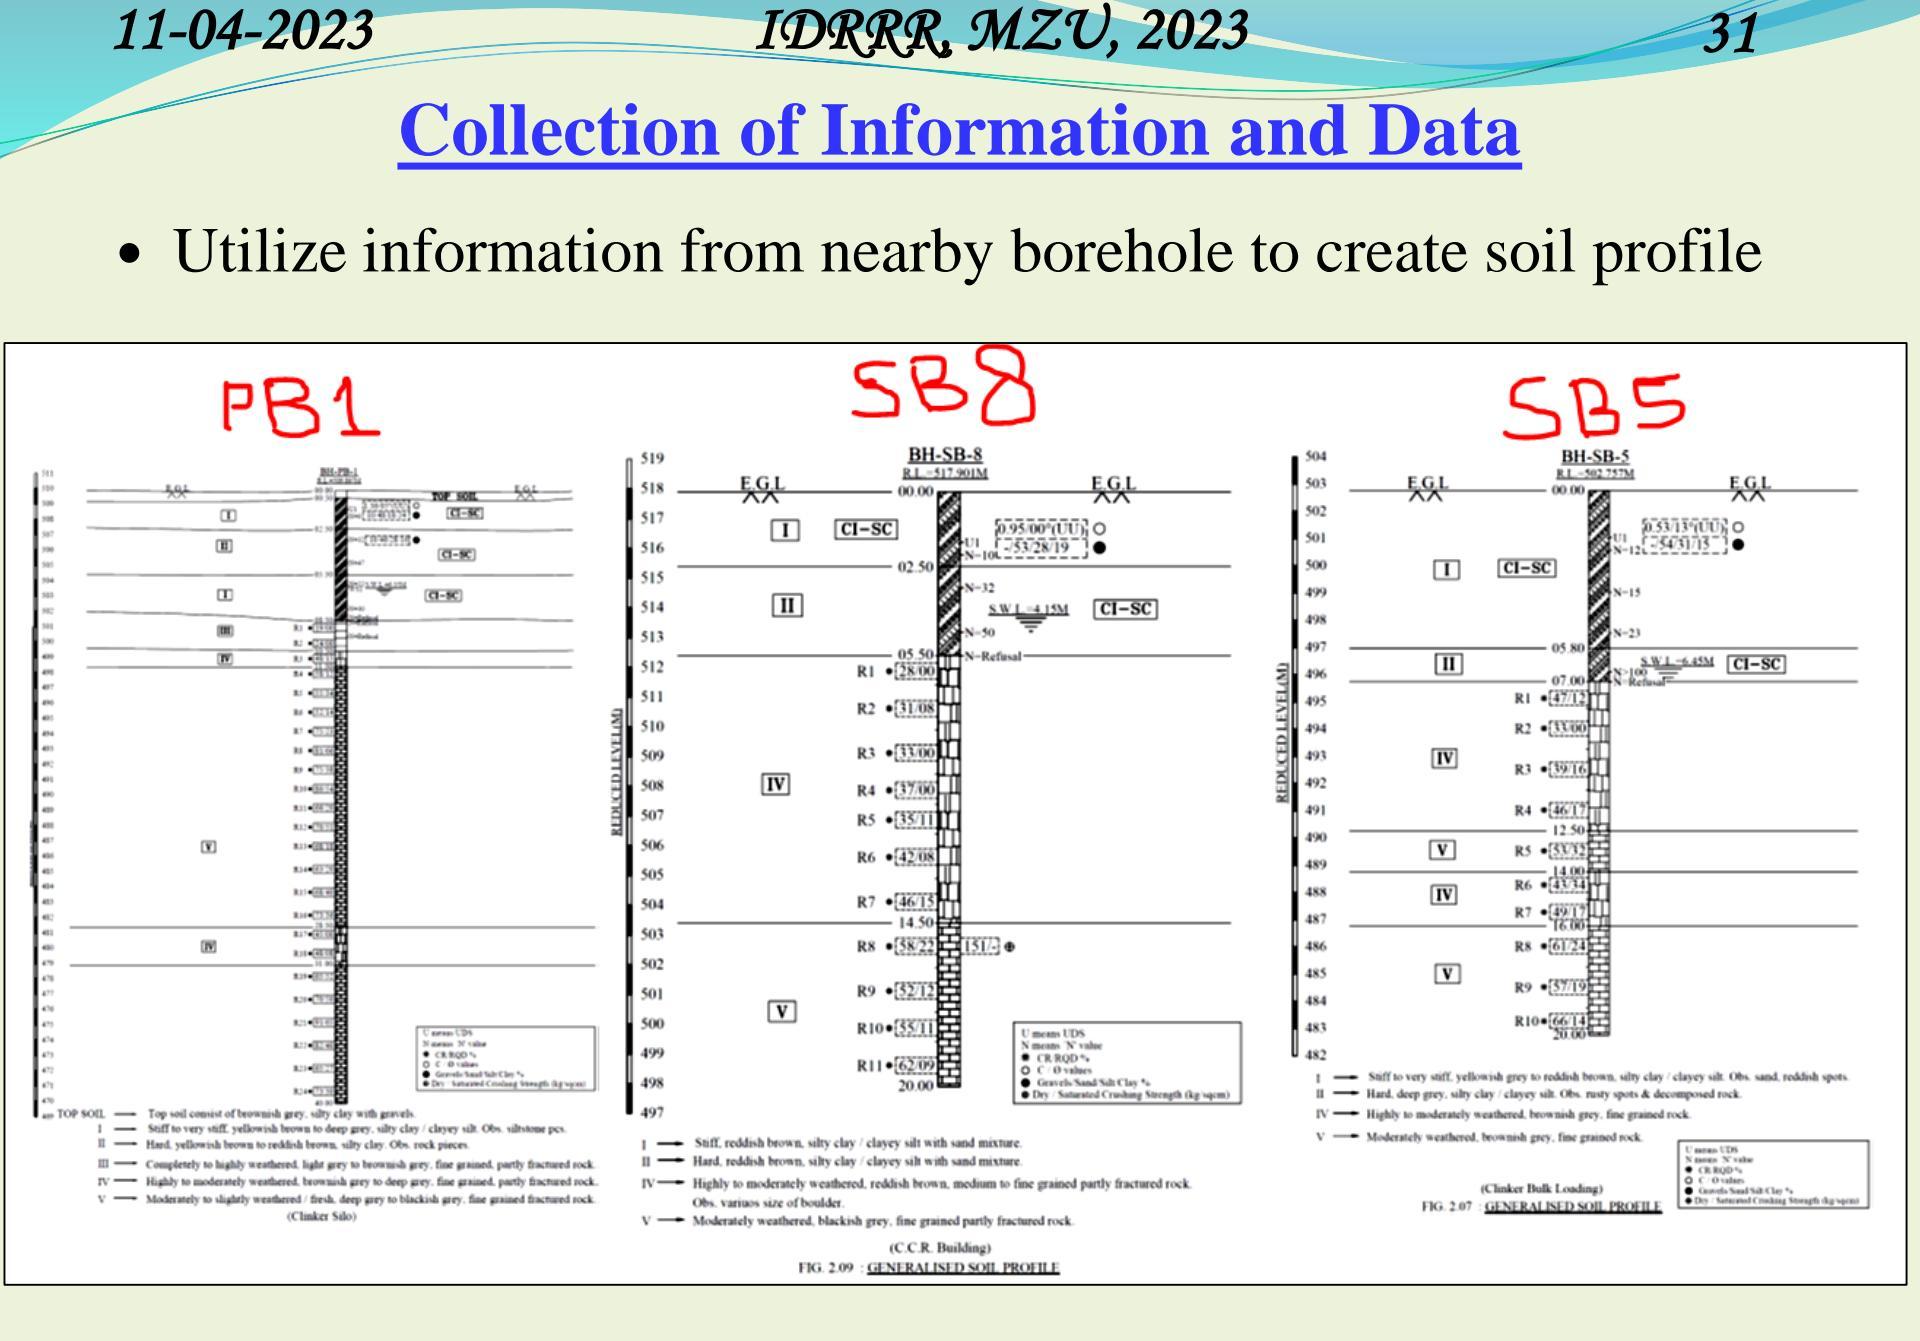
• Borehole locations at the site

* No boreholes present exactly at the failure site

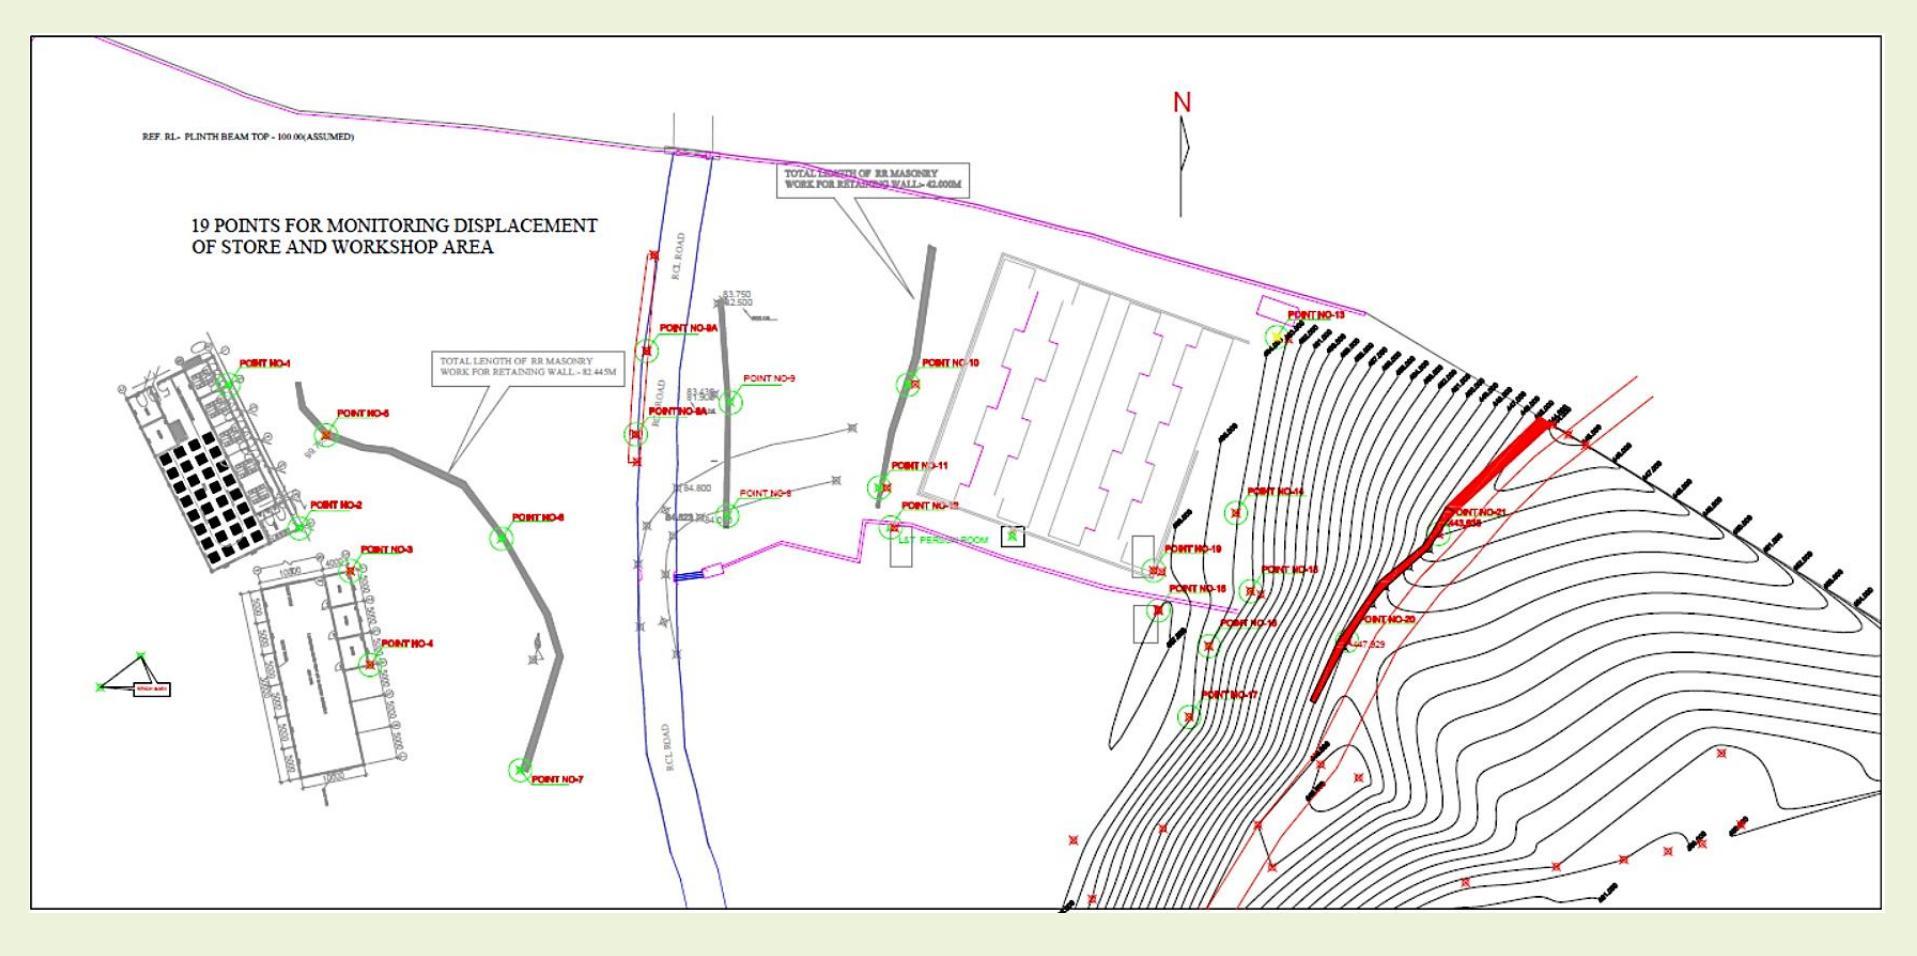
Displacement monitoring stations – 19 locations
Till December 2015

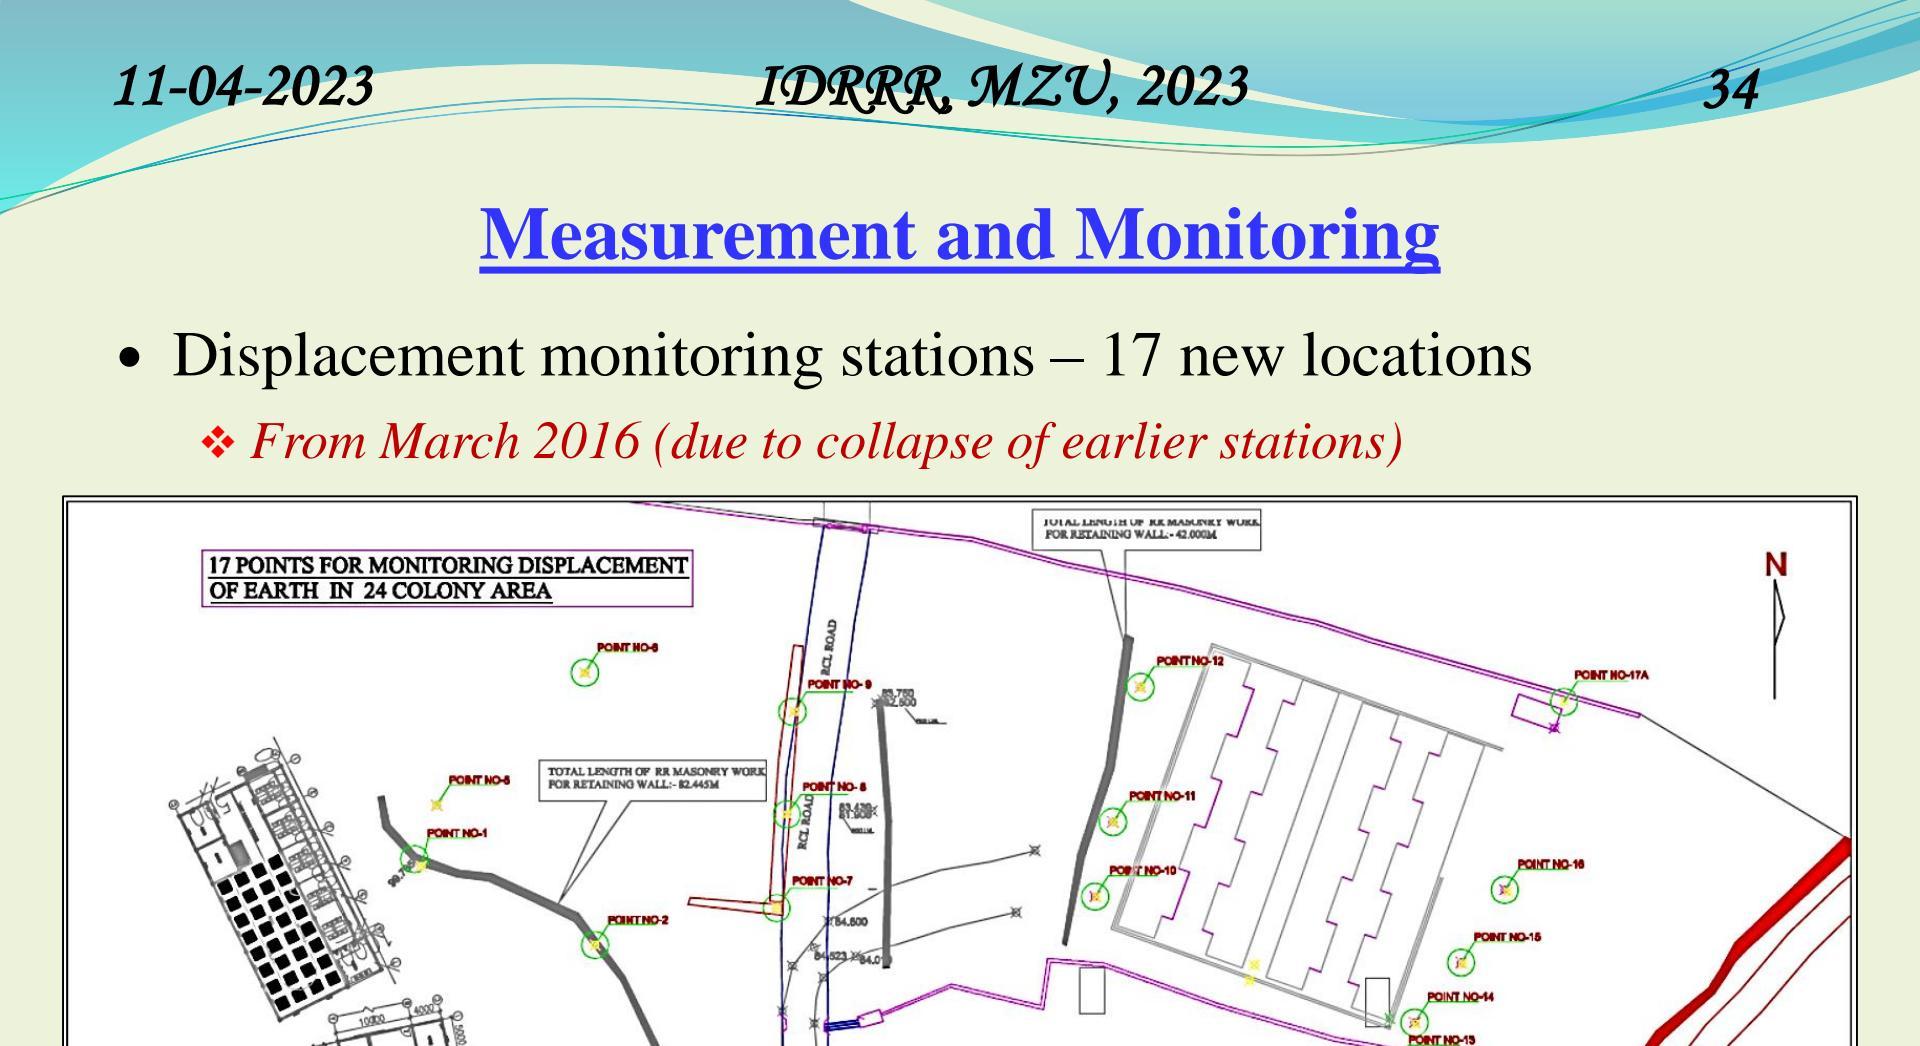
• Typical lateral and vertical displacement monitoring data

* Some monitoring points were destroyed due to extreme displacement

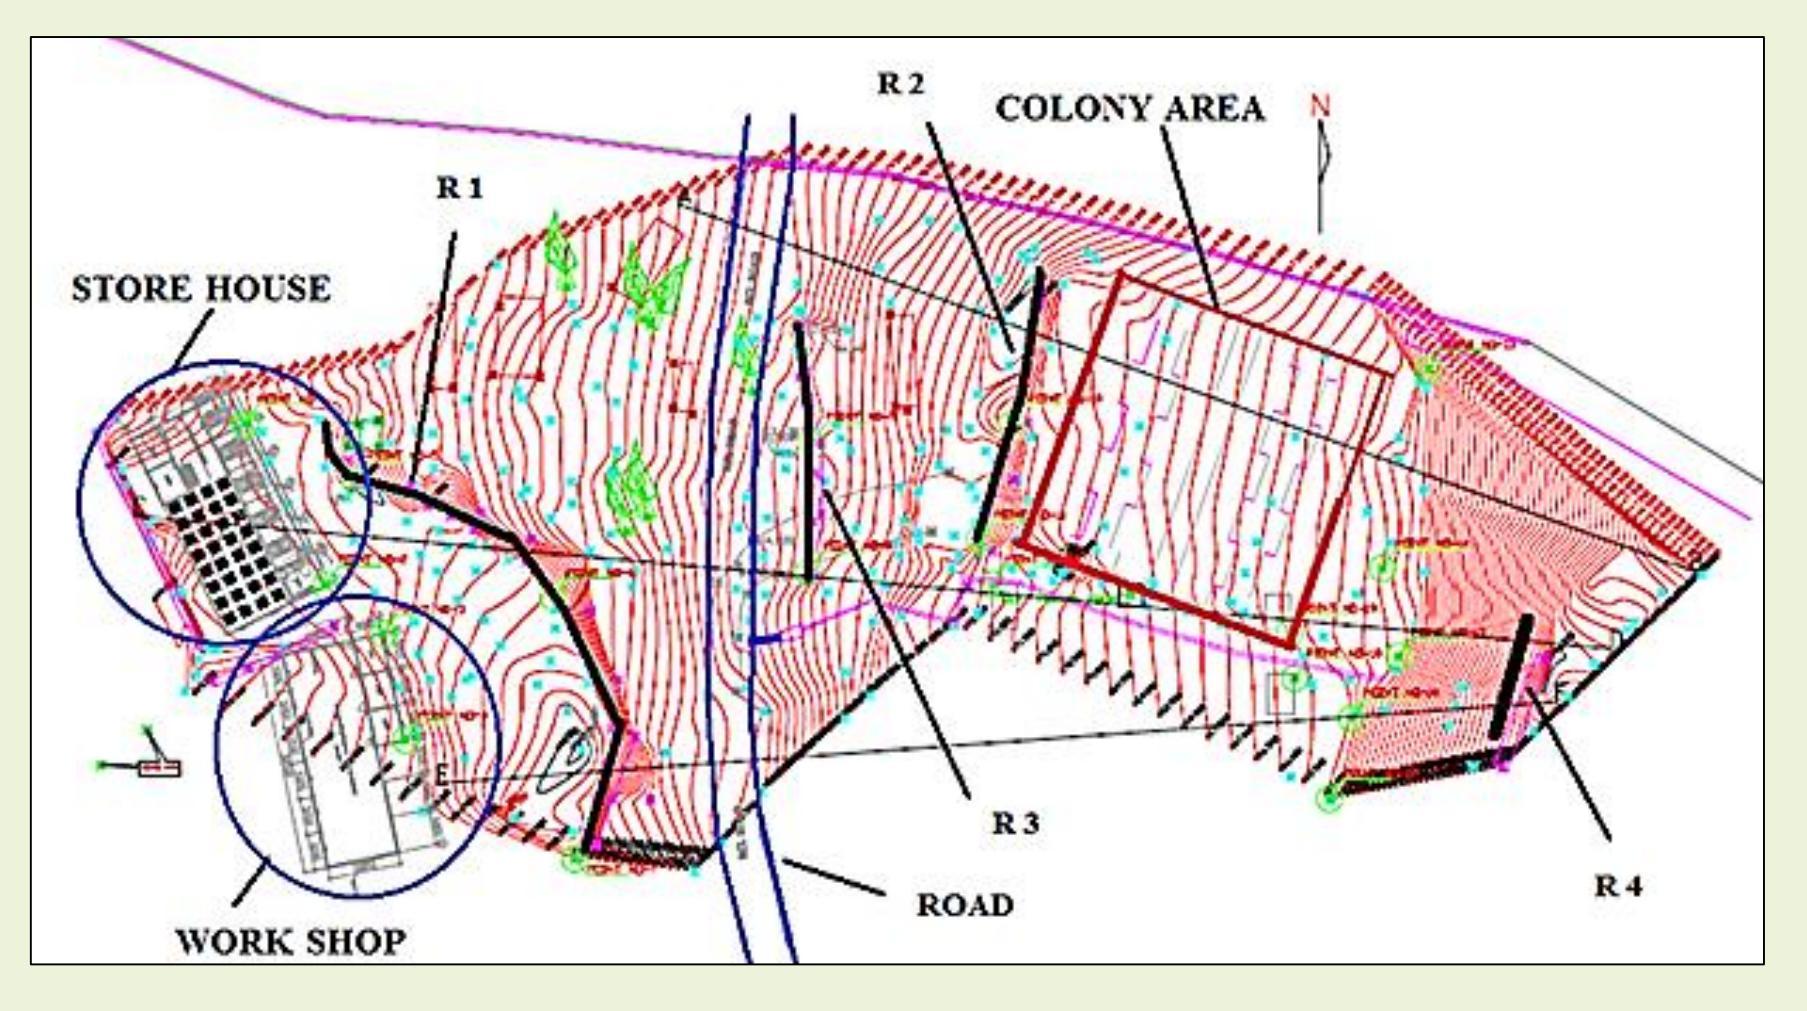
• Contour and Profile of failure site

Sequence of construction of protection retaining walls

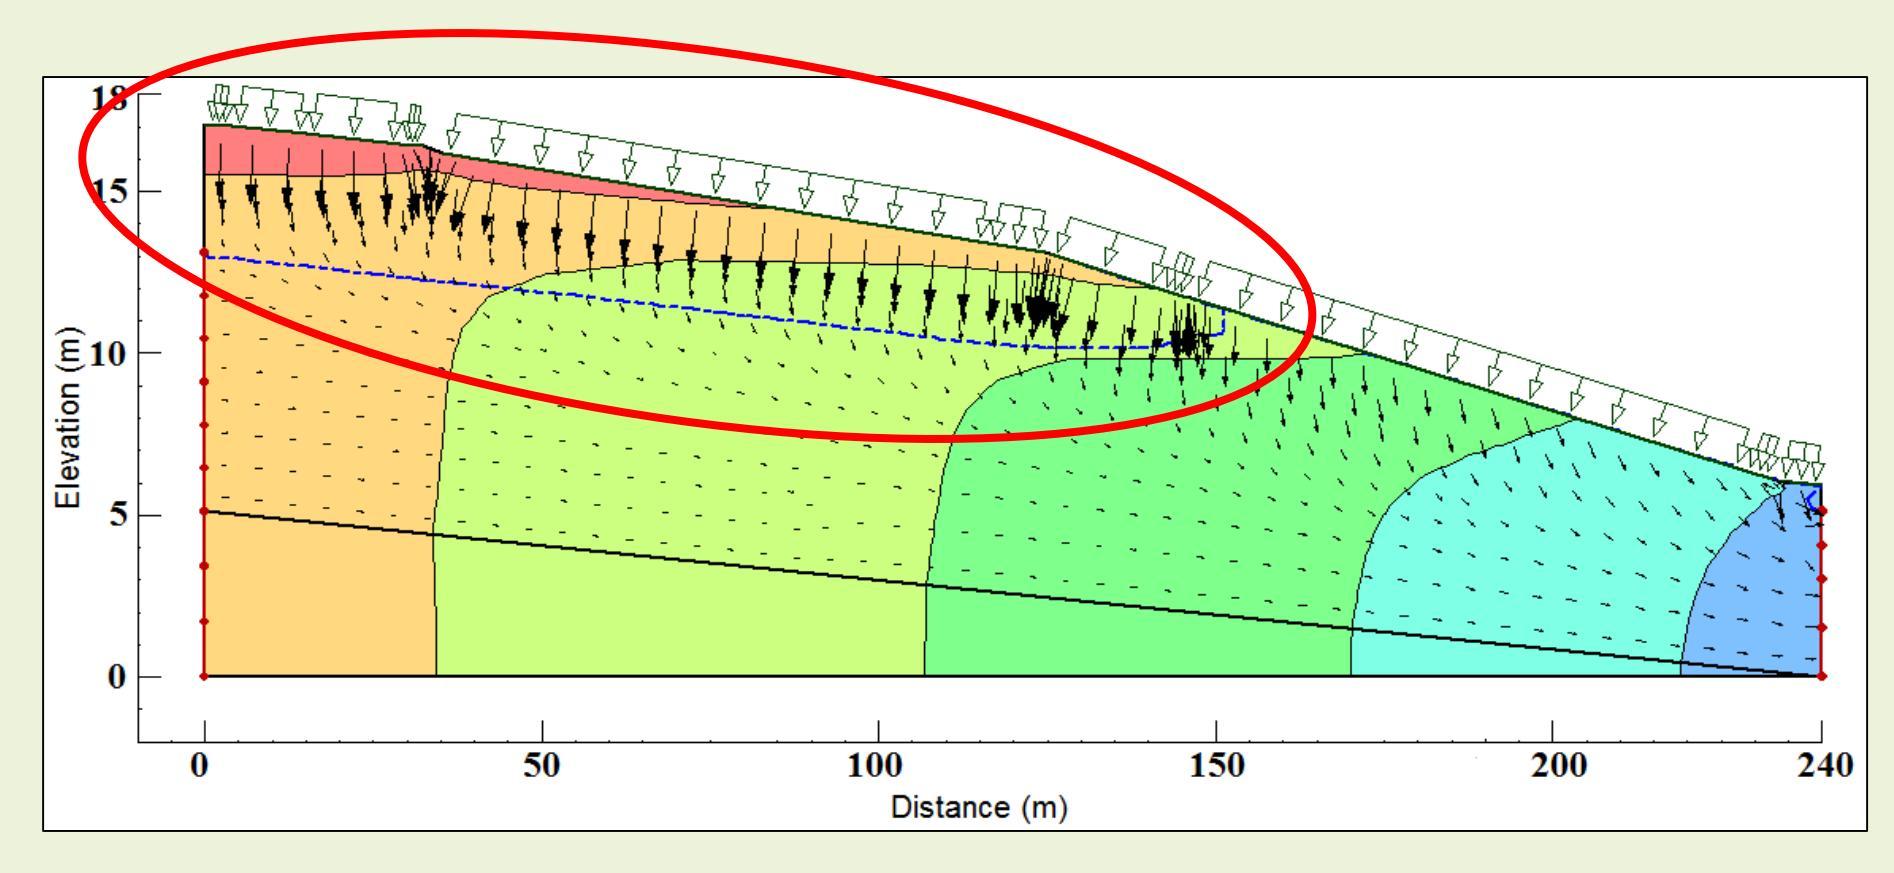
- Interesting inferences !!!
 - ✤ Infiltration leads to the rise of the WT
 - WT, upon rising, intersects the slope face near the 24 colony

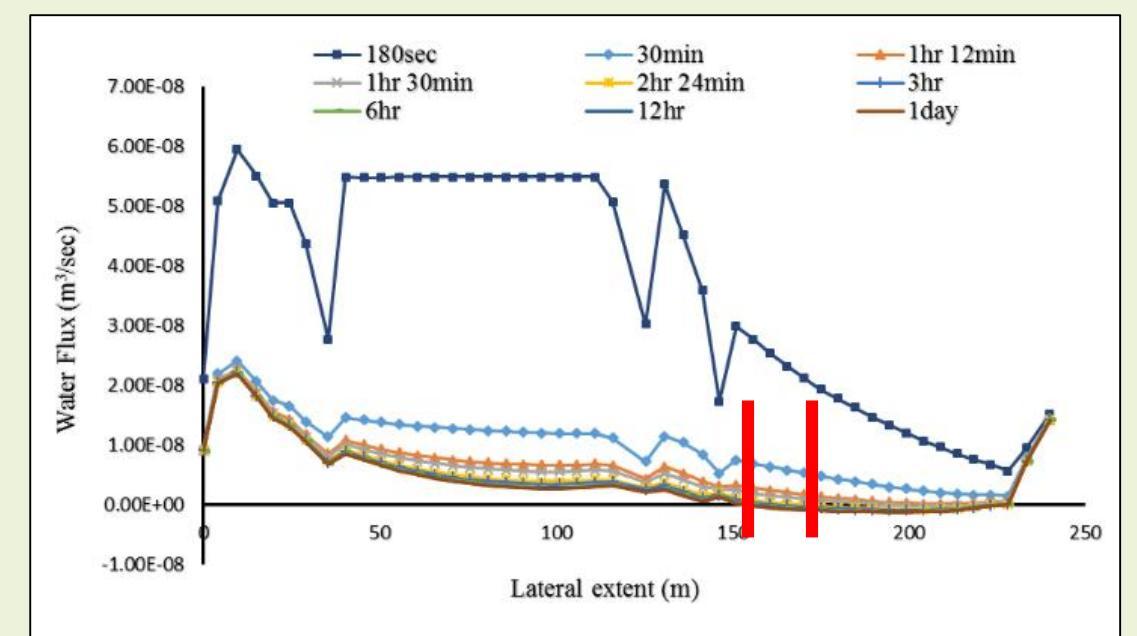
- Interesting inferences !!!
 - * Intersection of WT at the slope face near the 24 colony (160-180 m from left)
 - Denoted by achievement of zero or negative water flux at the slope face
 - Water comes out of the slope face at the prescribed location
 - Time duration of the rise of WT to intersect: Approximately 3-6 h of rain
 - Coincidentally, the same was reported from the field that the first slide behind the colony was noted after an initial 3-4 hr of rainfall around October 2015

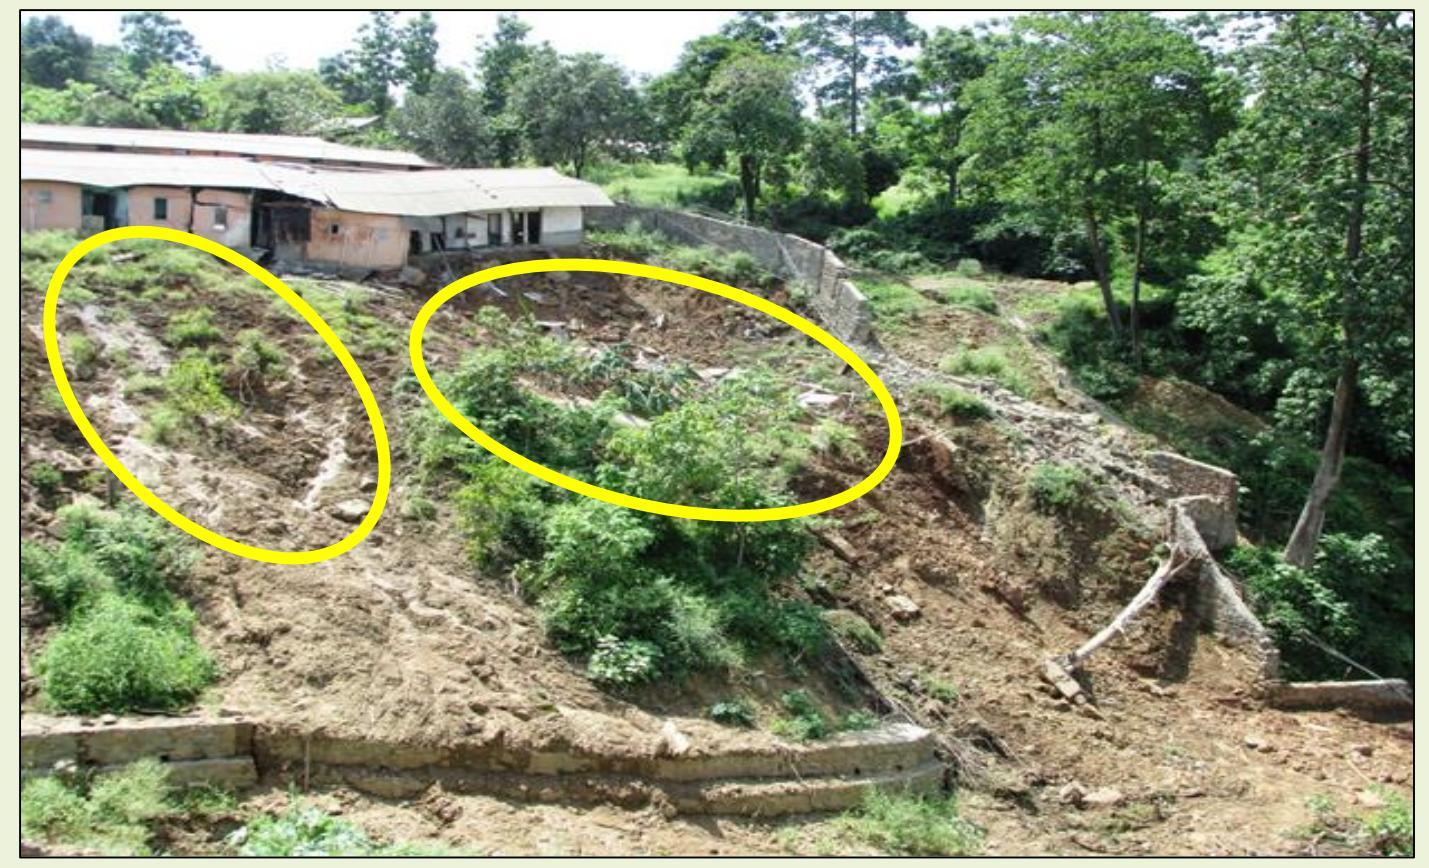
- Interesting inferences !!!
 - *Intersection of WT at the slope face near the 24 colony (160-180 m from left)*
 - Field observation of water emanating out of the slope face behind 24 colony

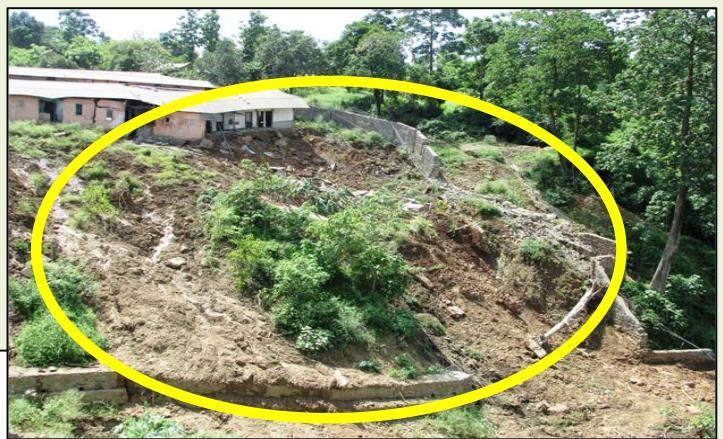
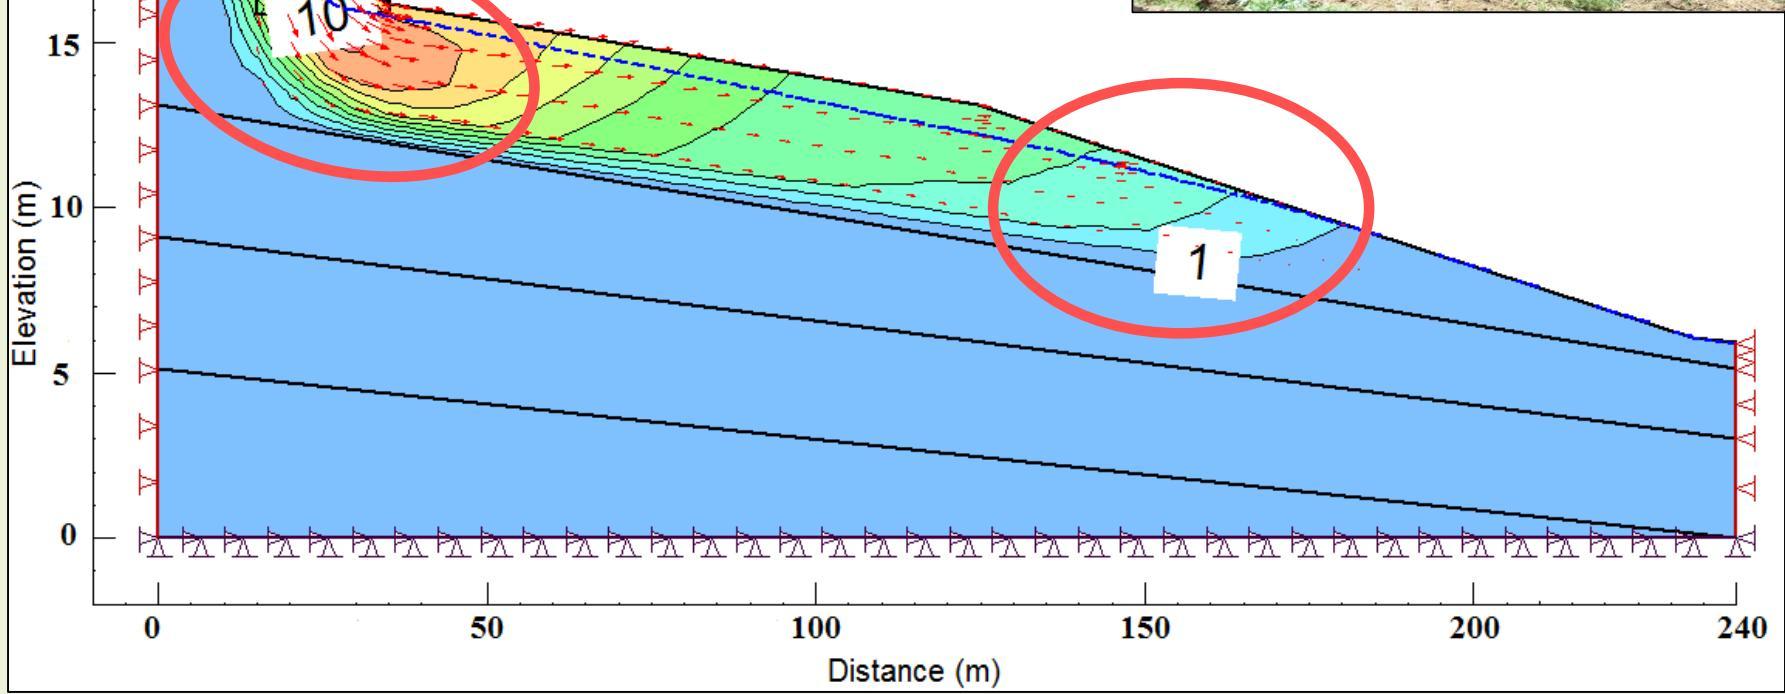
Why so less displacement behind the 24 colony, while the field displacement was maximum at that location !?

• Max displacement around building???
