National Workshop on Importance of Disaster Risk Reduction and Resilience

Mizoram University, 10 April 2023

Recent Advances in Geotechnical Engineering Learning through Case Studies

Landslide at Calcom Cement Plant, Umrangso, Assam Forensic Geotechnology

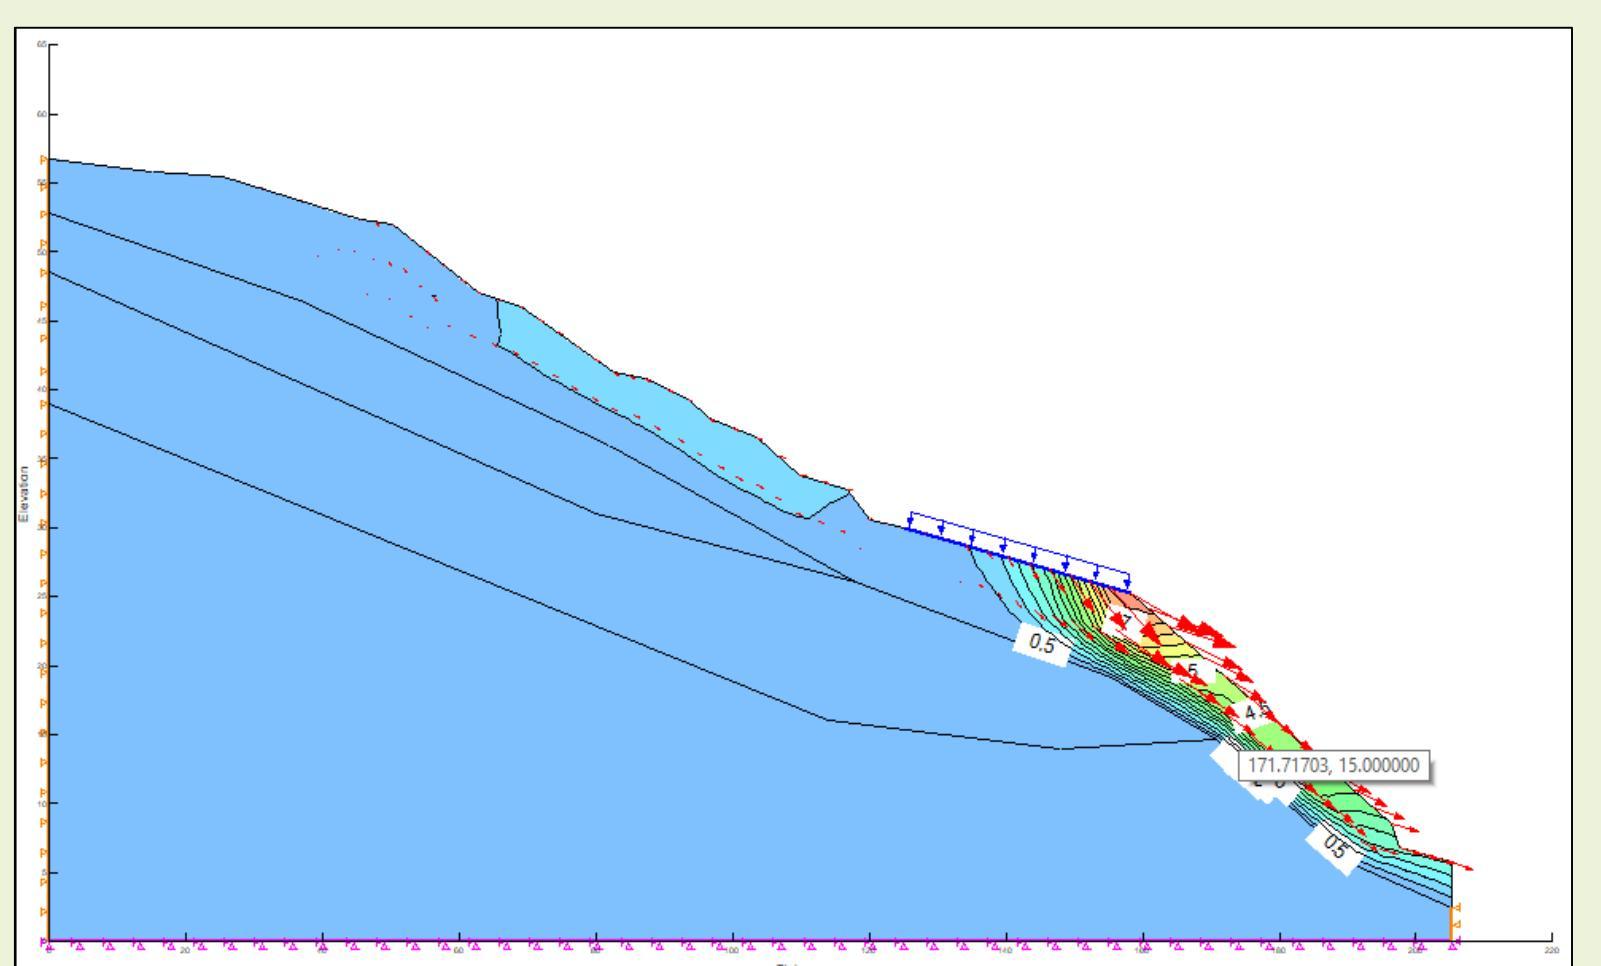
Displacement Results from Updated Analysis

- Application of colony load
 - Invokes sufficient displacement in saturated stage

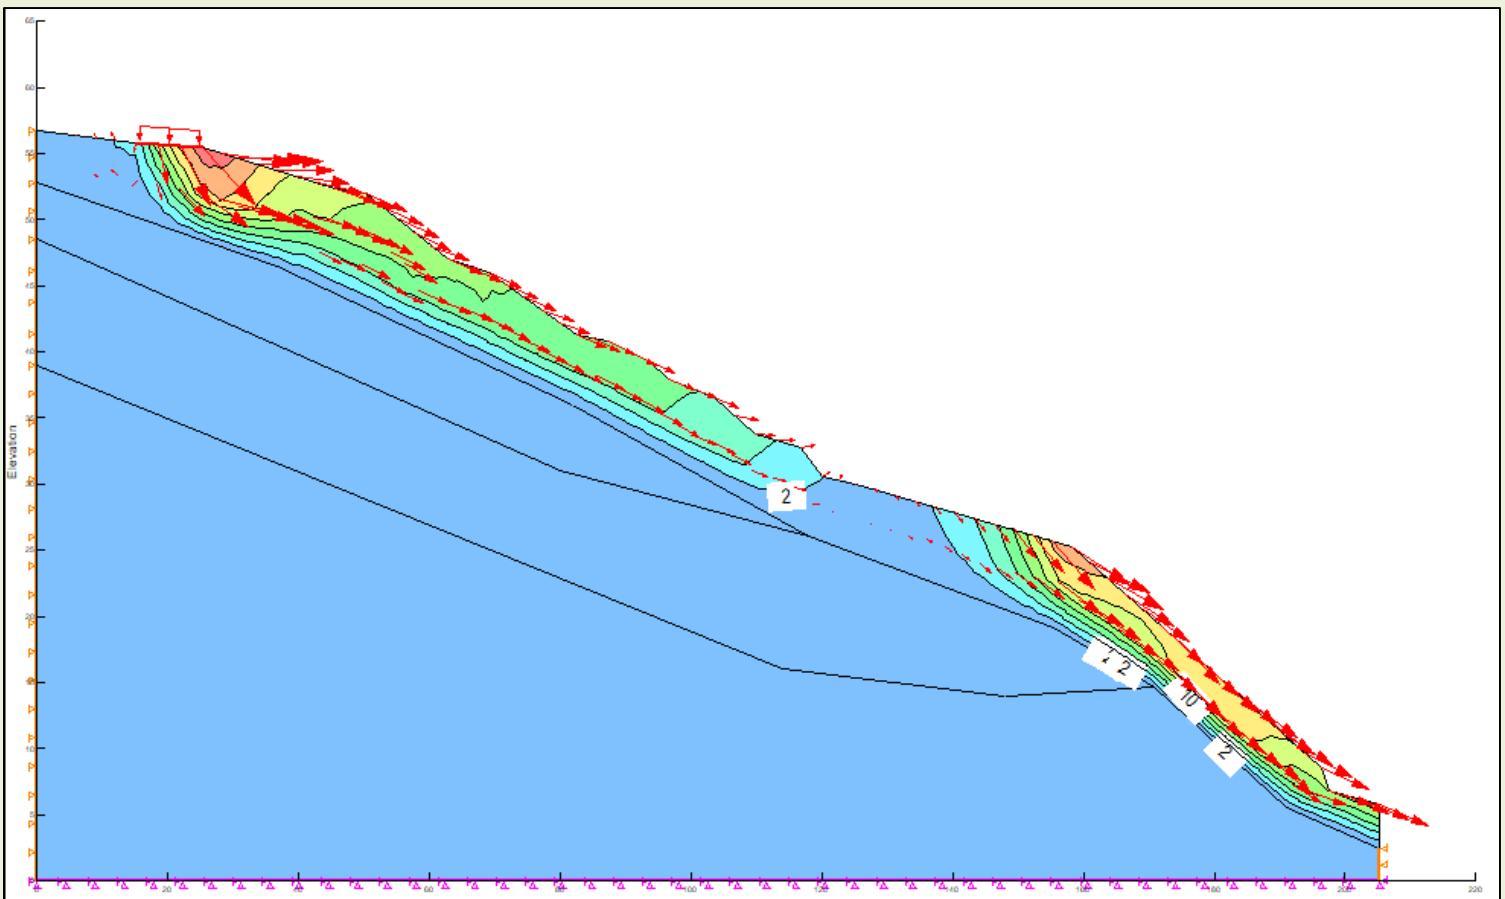
Displacement Results from Updated Analysis

- Application of building load
 - * Another slip deformation zone is initiated

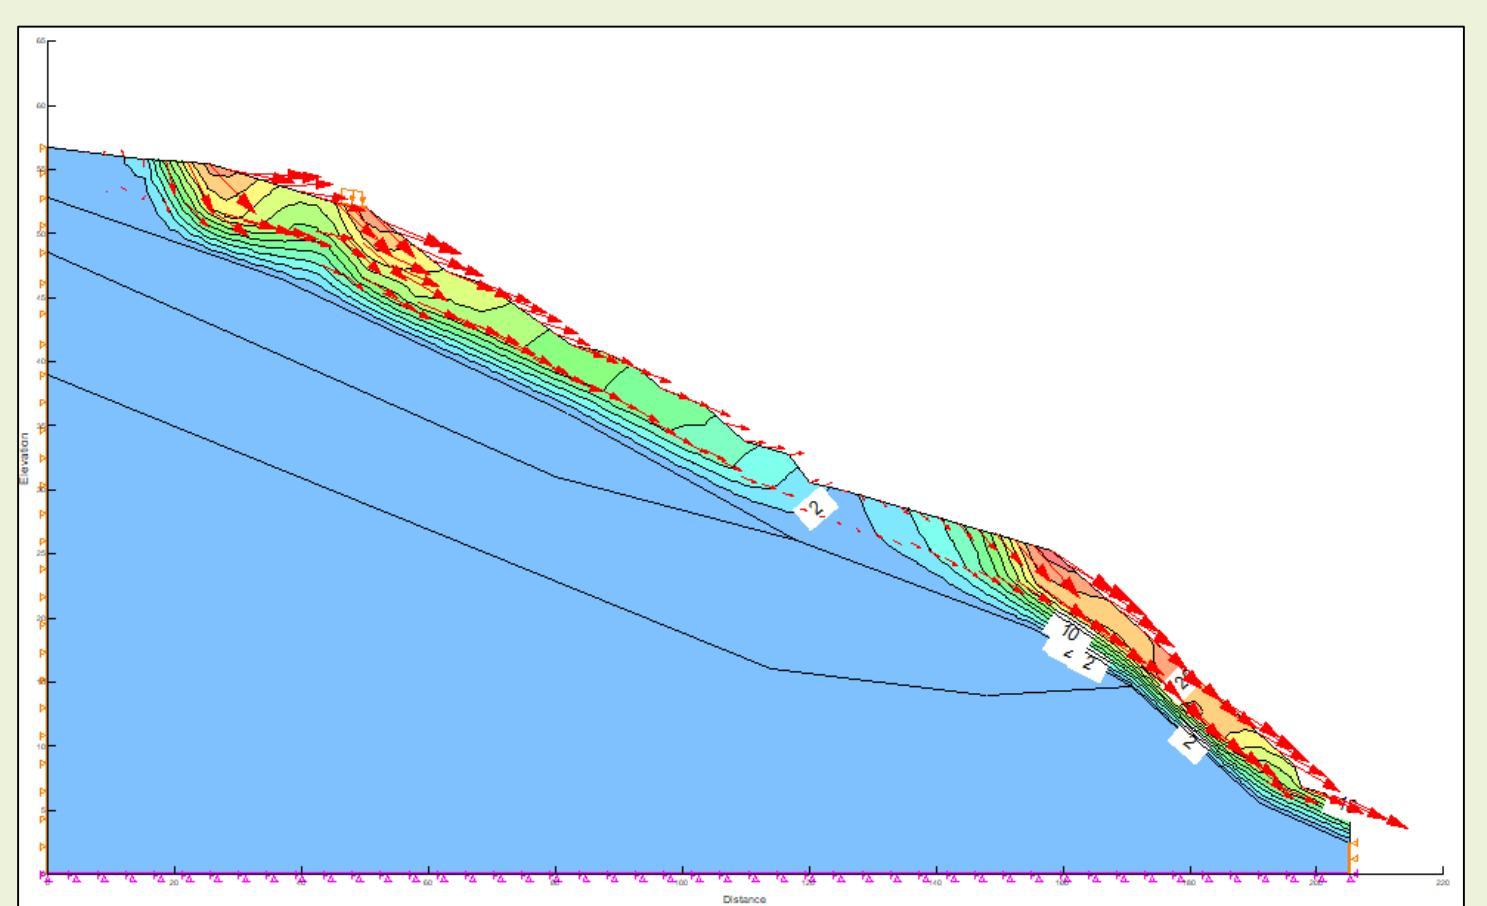
Displacement Results from Updated Analysis

• Application of RW1

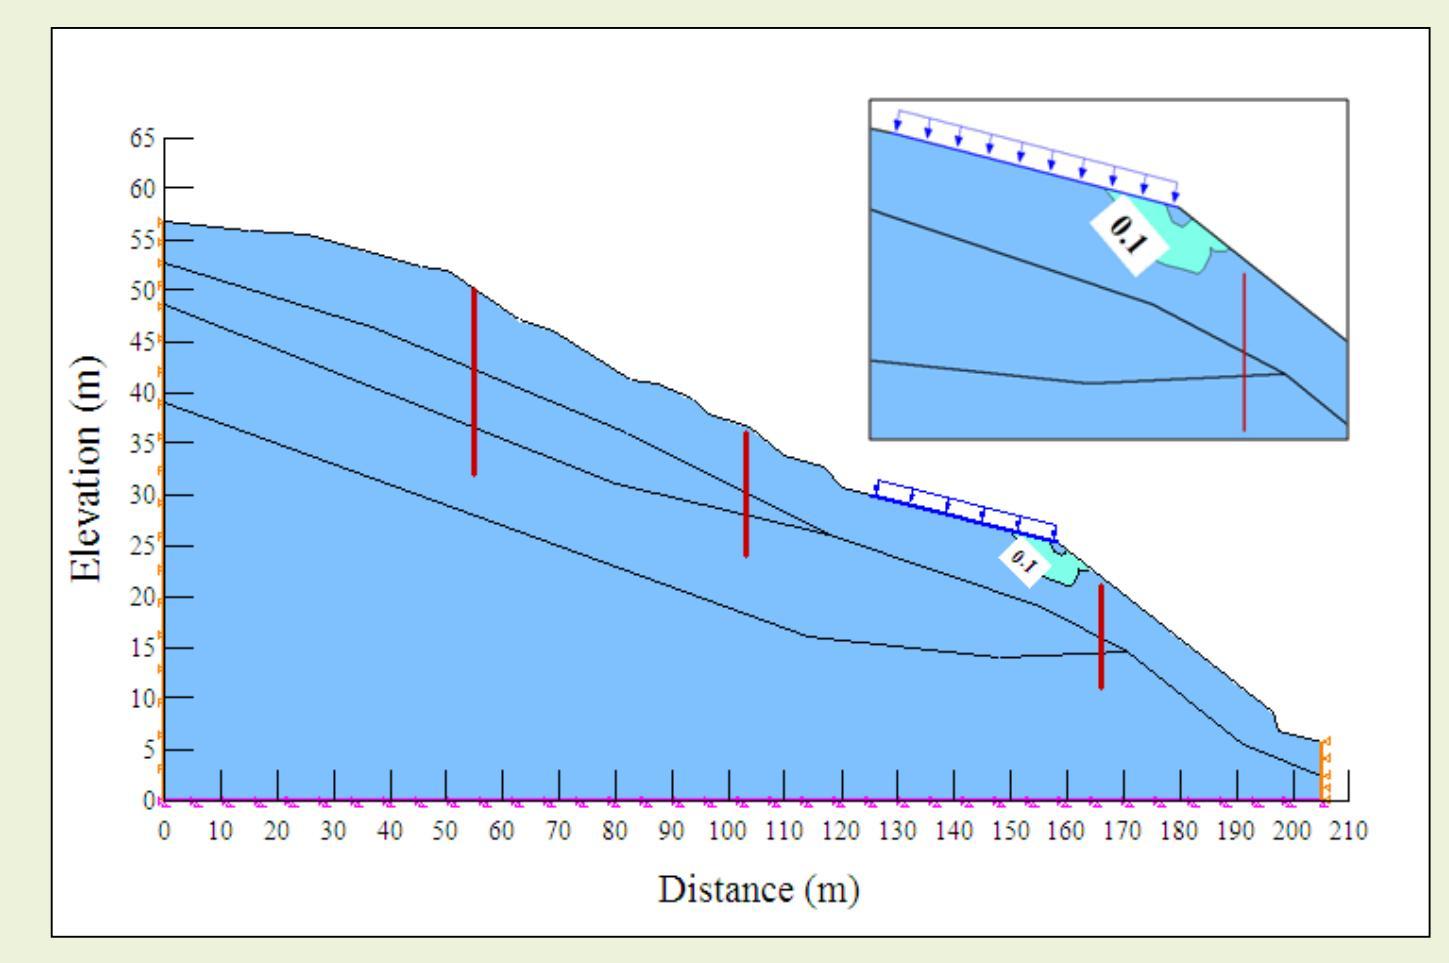
- Cut-off Sheet Pile Wall with adequate drainage
 - * Large displacement behind the colony were well arrested

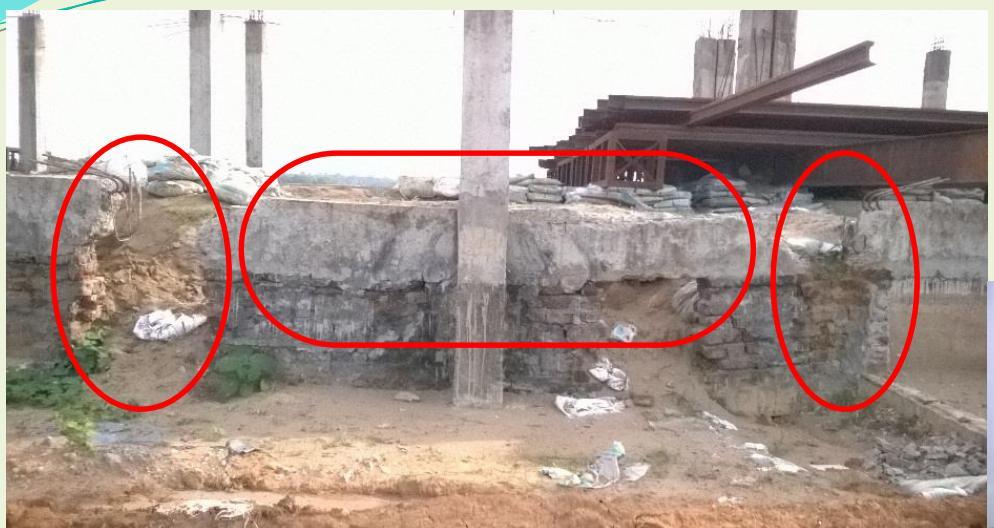
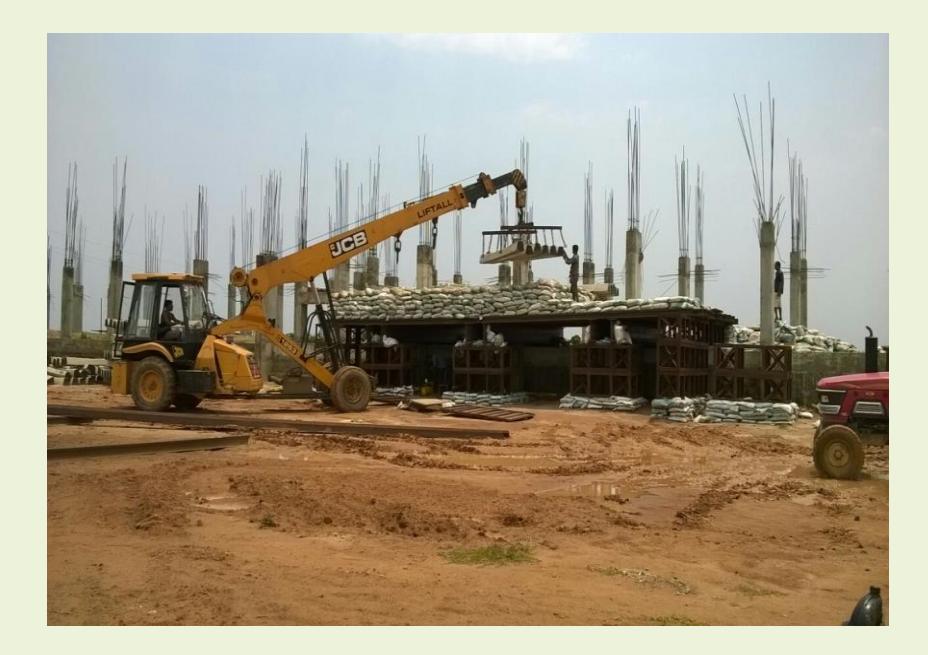
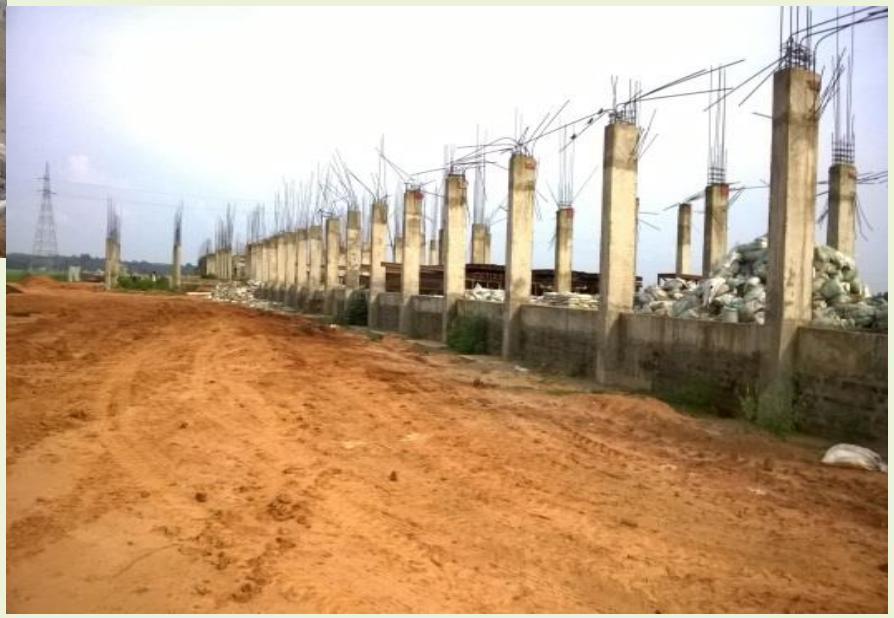
- Formation in station yard:
 - ✤ Construction started in Dec '2010.
 - Excessive settlement in the range of 1-2 m was noticed in Oct' 2011 when constructed embankment height reached 3 m.
 - ✤ The work continued & reached to a height of 5 m.
 - Huge Settlement, Cracks and Heaving of adjacent ground beyond toe (up to 25m on both sides of embankment).
- Station building:
 - *Earth filling started in Nov* 2011.
 - ✤ Pile foundation started in Dec '2011.
 - ✤ Pile foundation completed by Nov'2012.
 - * Differential settlement observed in Pile cap No. 13, 14 and 35 in May 2012
 - Cracks noticed in plinth beam and grade beams connected to above mentioned pile caps.
 - * Brickwork for wall done in Jan' 2014 and differential settlement increased further.

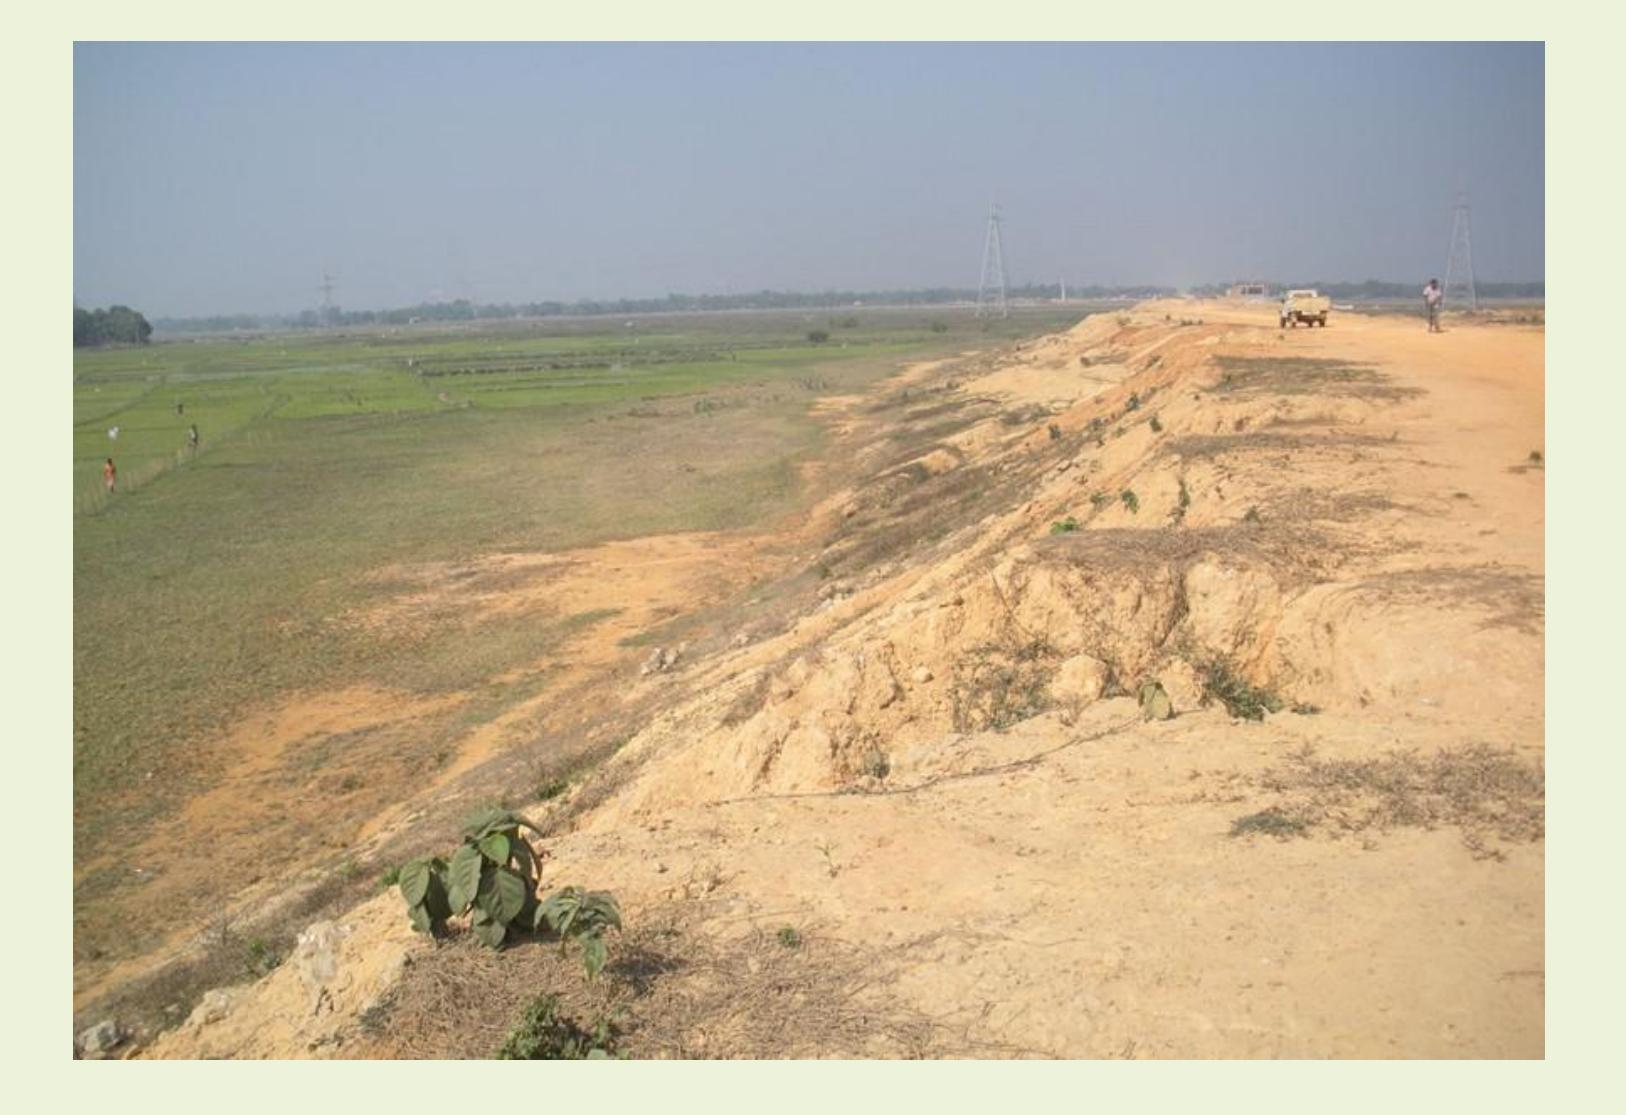
- Height of embankment = 6.2 m
- Embankment construction started in stages: Dec' 2010.
 - September 2011
 - First failure noticed at 3.0-3.5 m height:
 - ***** *March* 2012
 - Large settlement of 5-5.2 m
 - Heaving up of ground until 30 m distance from the embankment
- After that further construction stopped

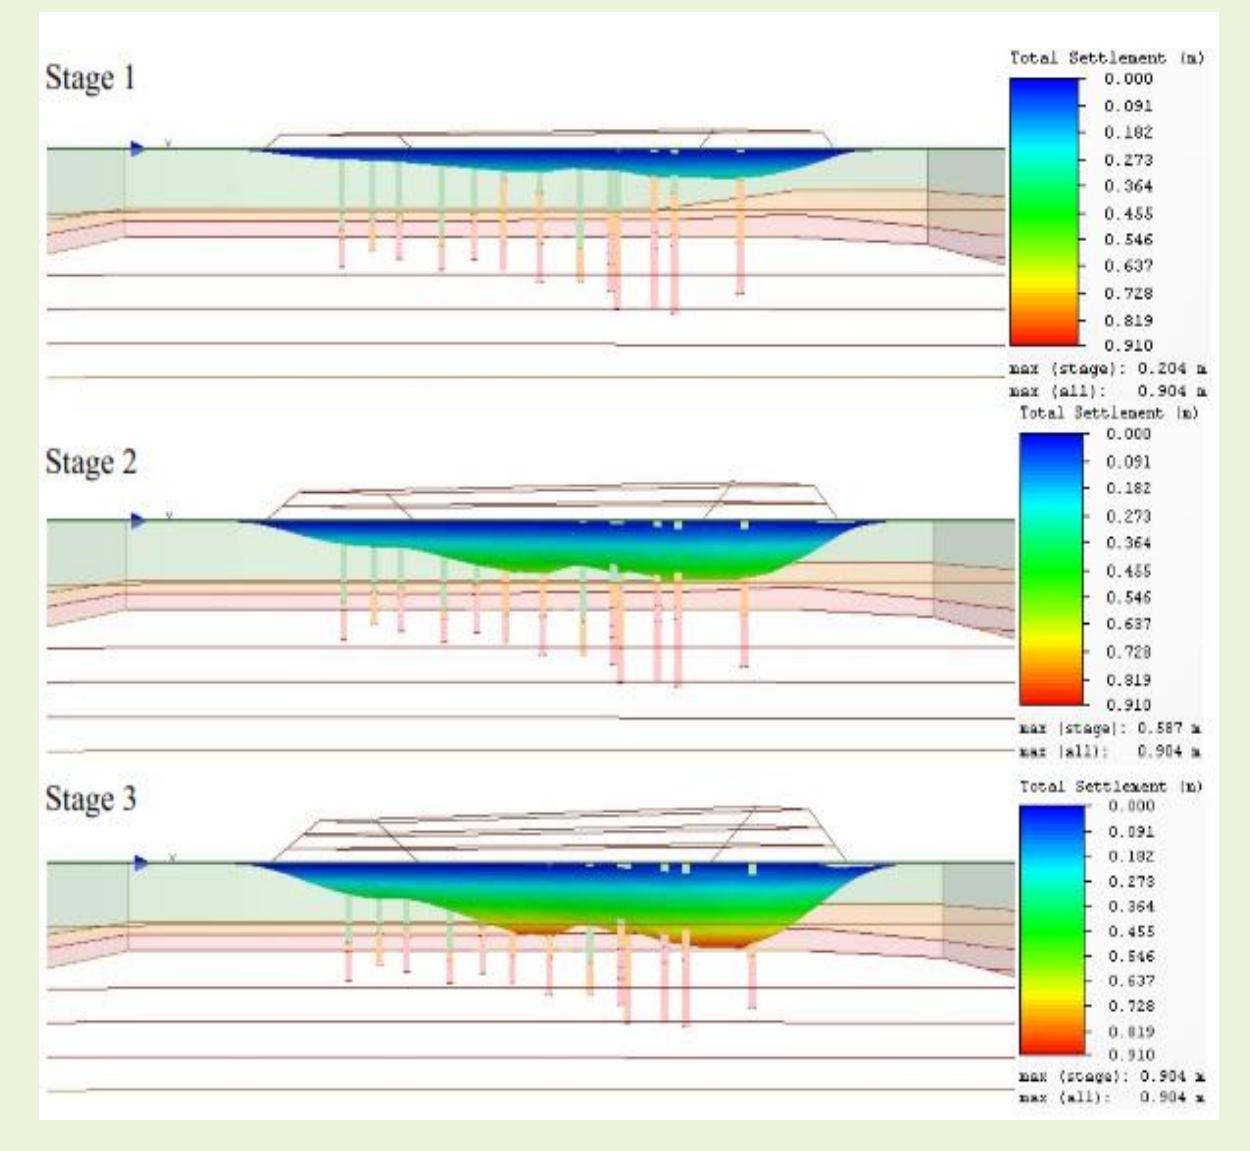
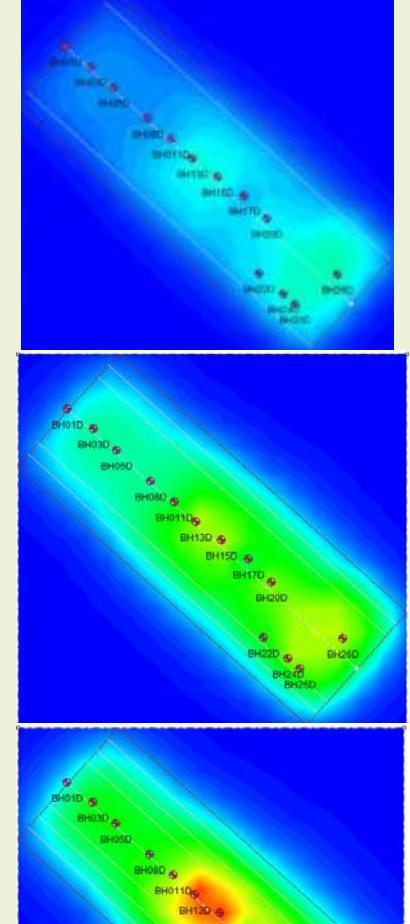
Large Differential Settlements along the Embankment

- Numerical study confirms large deformations observed in the field
- Warrants for ground improvement

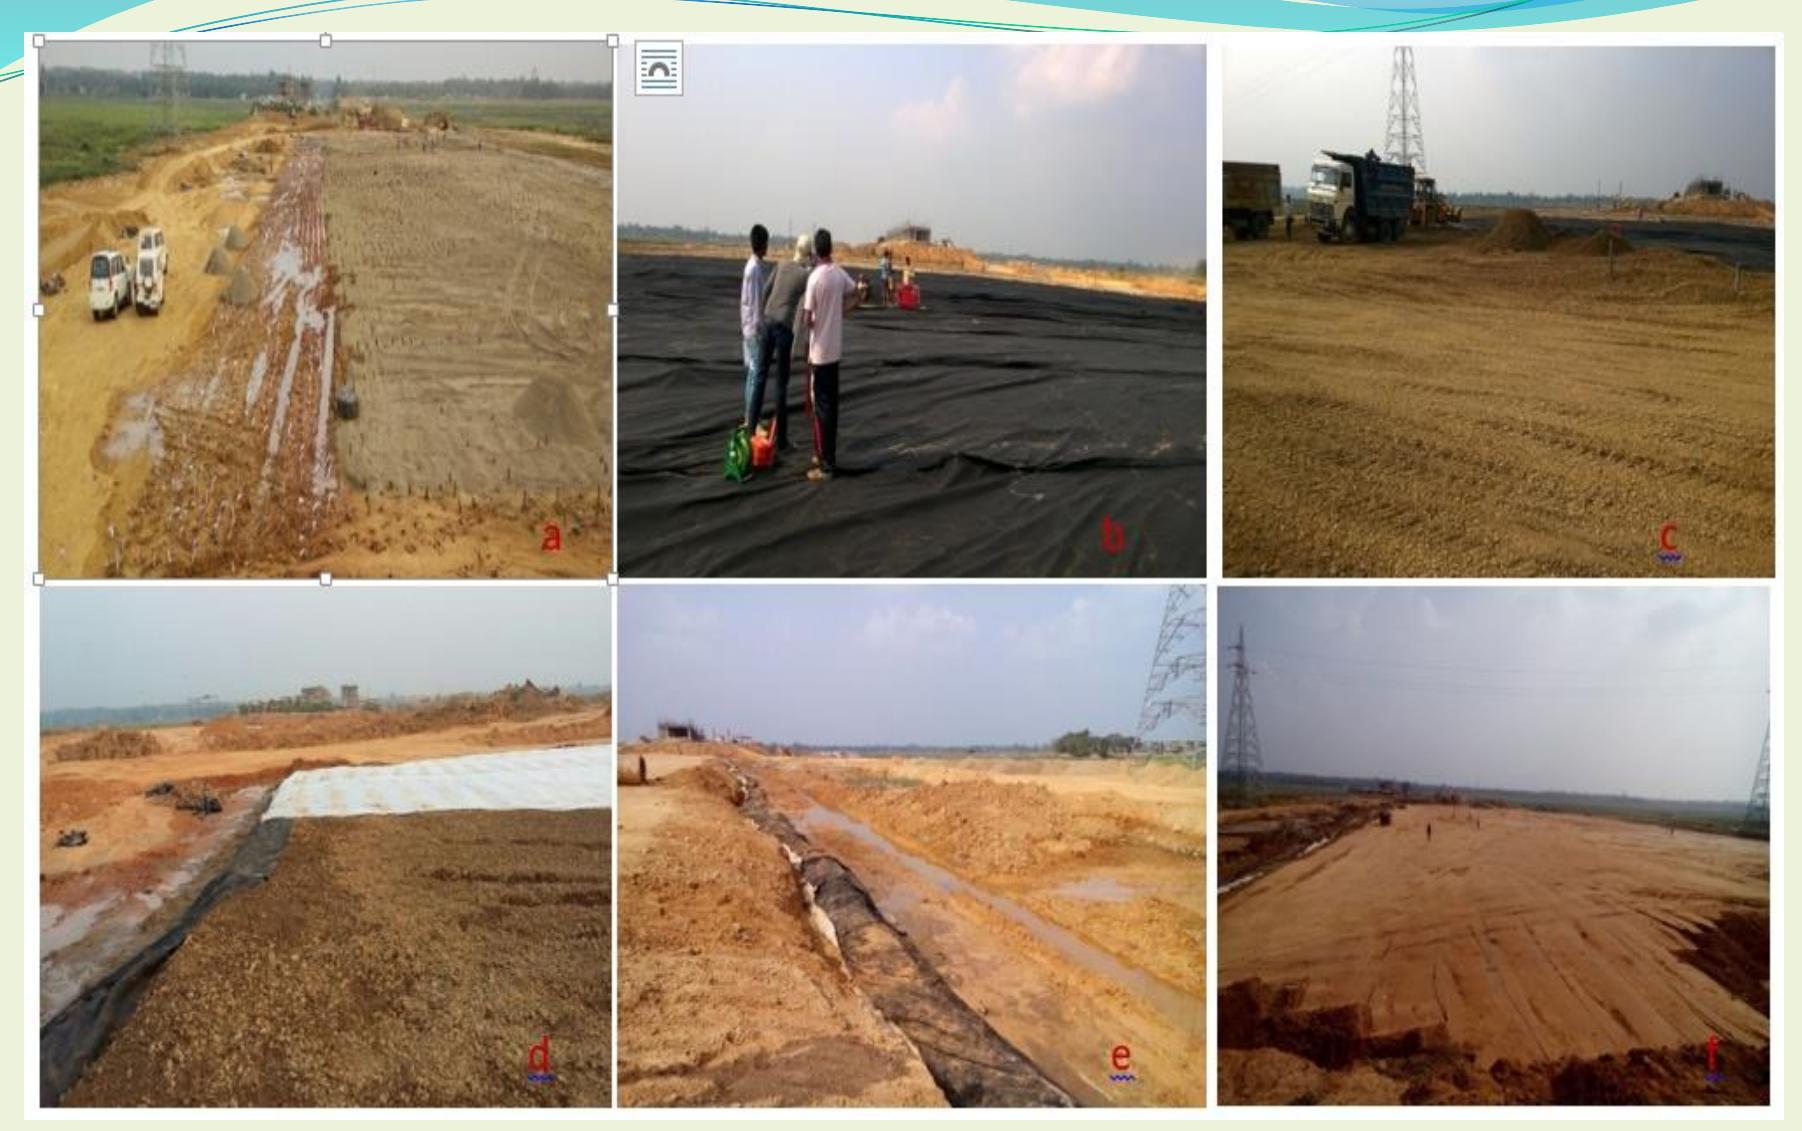
a) Laying of Coarse sand, b) Laying of Non-Woven Geo-textile, c) Laying of Granular Blanket.

d) Laying of Woven Geo-textile, e & f) Stage construction of embankment.

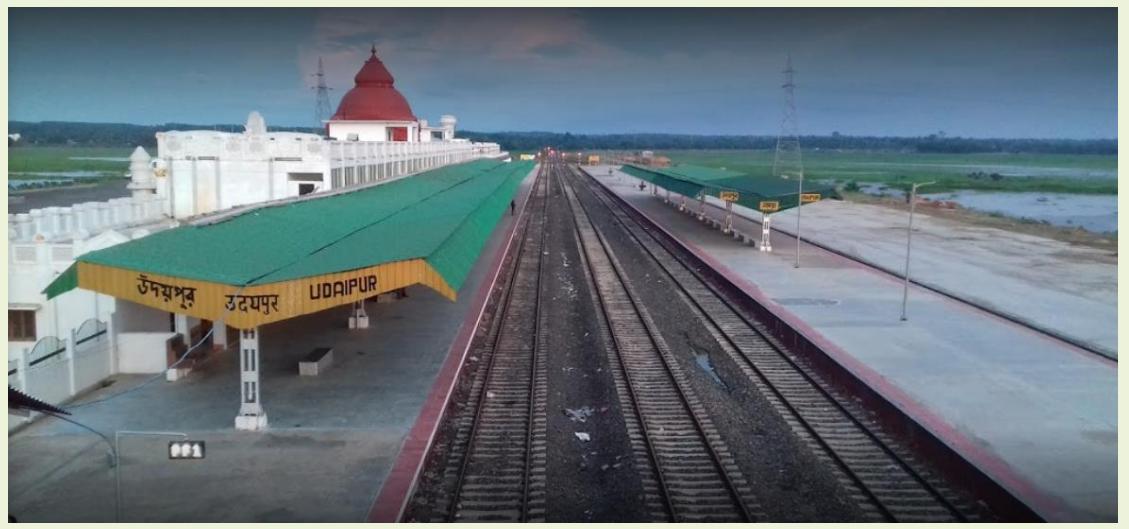
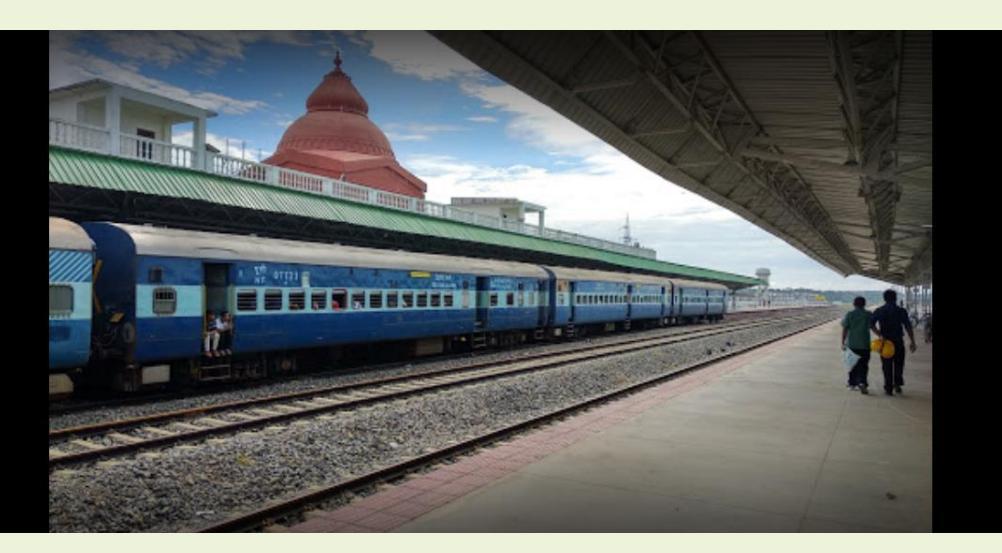
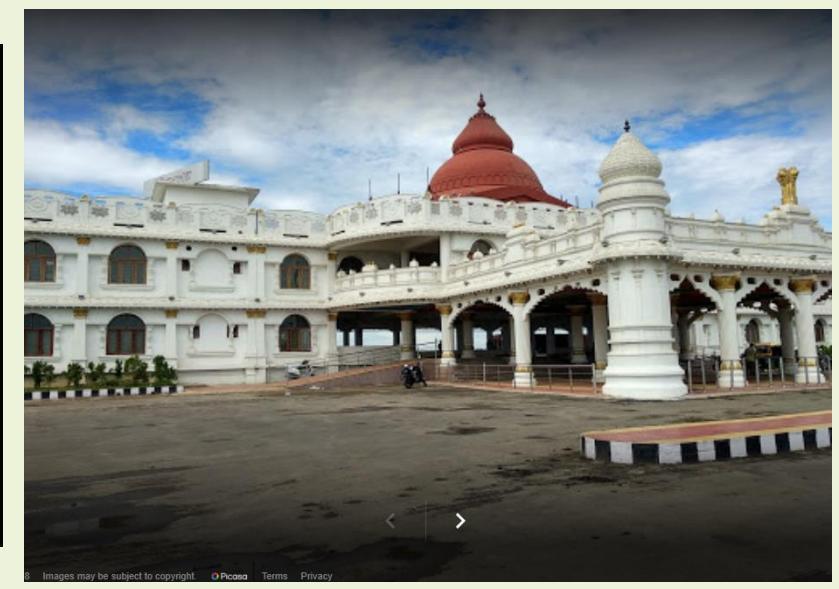
Heritage Railway Station, Udaipur, Agartala

• Application of preloading and PVD for developing of railway yard in a ditch marshland
