# CE504 Slope Stability and Retaining Structures

## Failure of a Marginally Stable Hillslope: A Forensic Investigation

**Dr. Arindam Dey**

## Landslide at Calcom Cement Plant, Umrangso, Assam **Forensic Geotechnology**

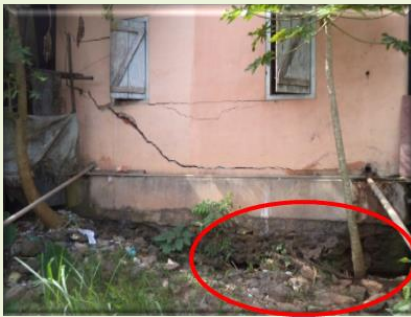
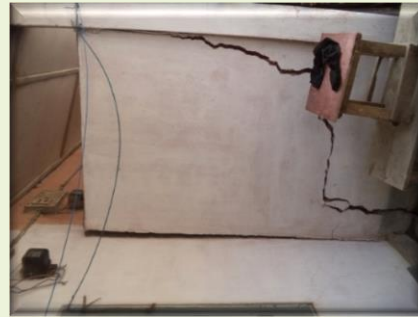
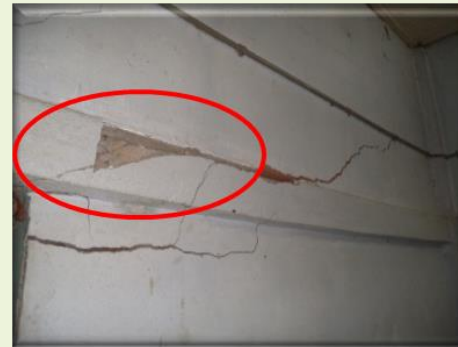
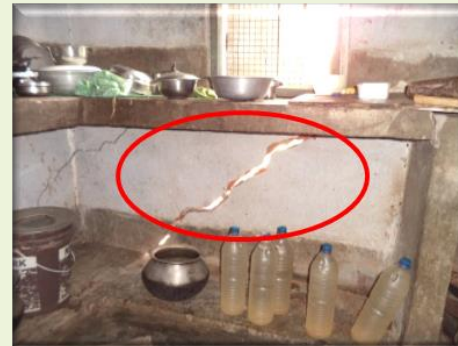
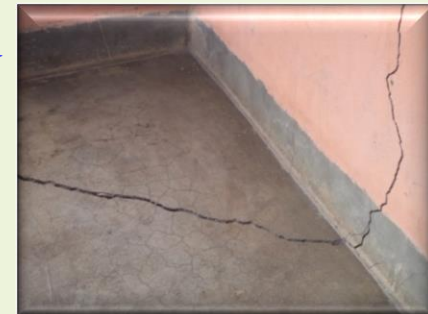
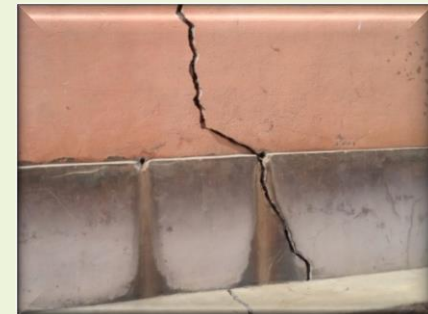
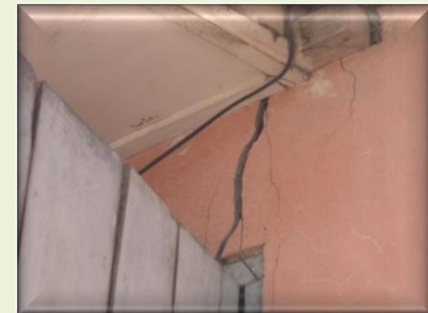
- 2<sup>nd</sup> November 2015: Meeting with the client
  - ❖ *Pictures of damages of the 24-Colony Residential Housing blocks*
    - 2 rows of 12 quarters face-to-face: All extensively damaged
      - Wall and Floor cracking / See through cracks
      - Detachment of plasters
      - Abnormal sounds from cracking
      - Detachment in floors
      - Shifting of soil in plinth area

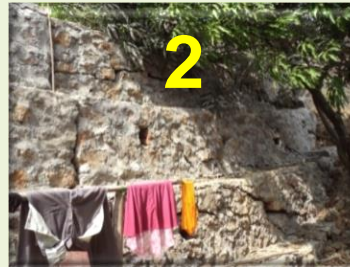
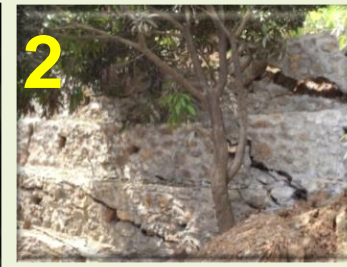
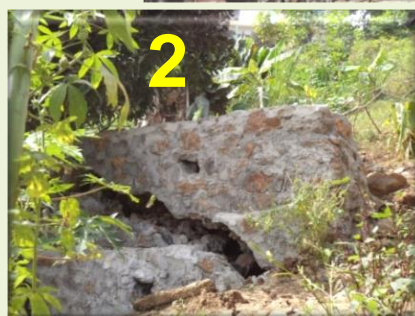
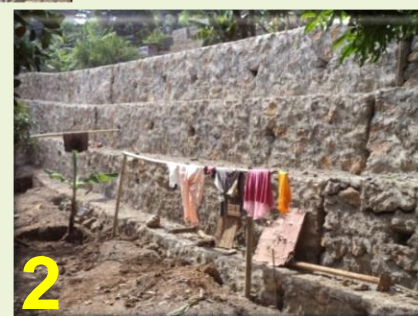
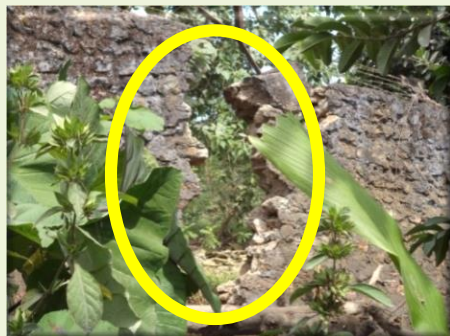
- Development of gaps and cracks in the retaining walls
  - Retaining wall 1: Between cement factory (workshop) and 24-Colony
  - Retaining Wall 3: Beside RCL road in front of 24 colony
  - Retaining wall 2: Frontal protection of 24-Colony (3 m)
  - Gaps in old boundary wall
  - Dislodgment of pavement and drains

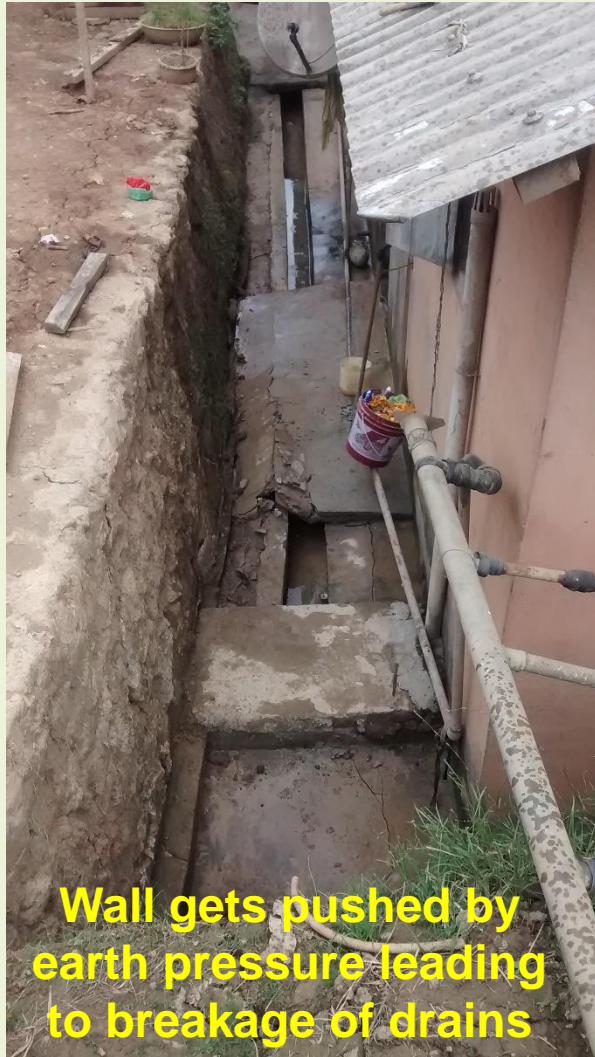
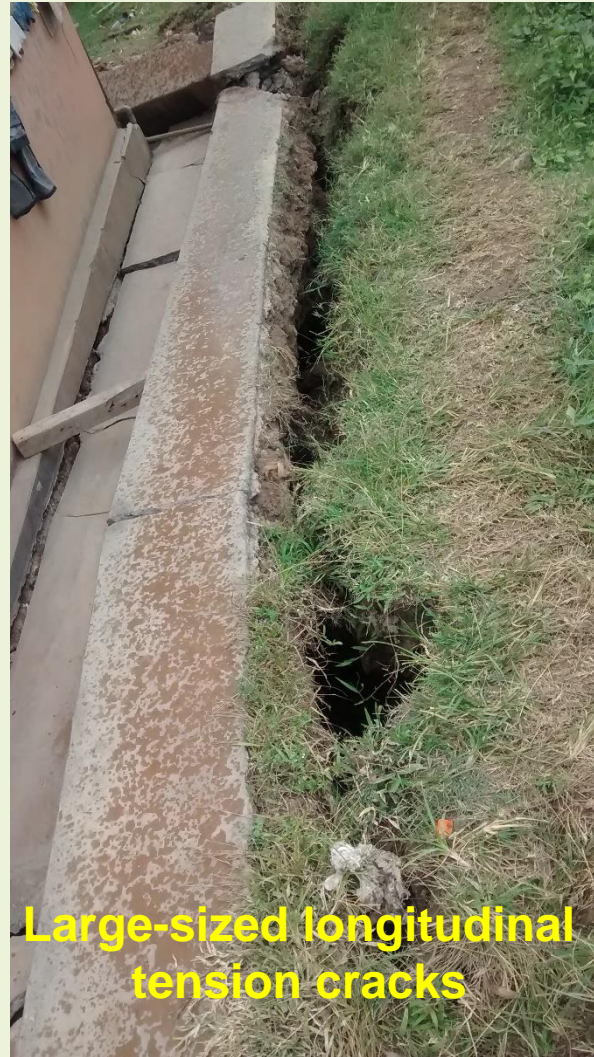
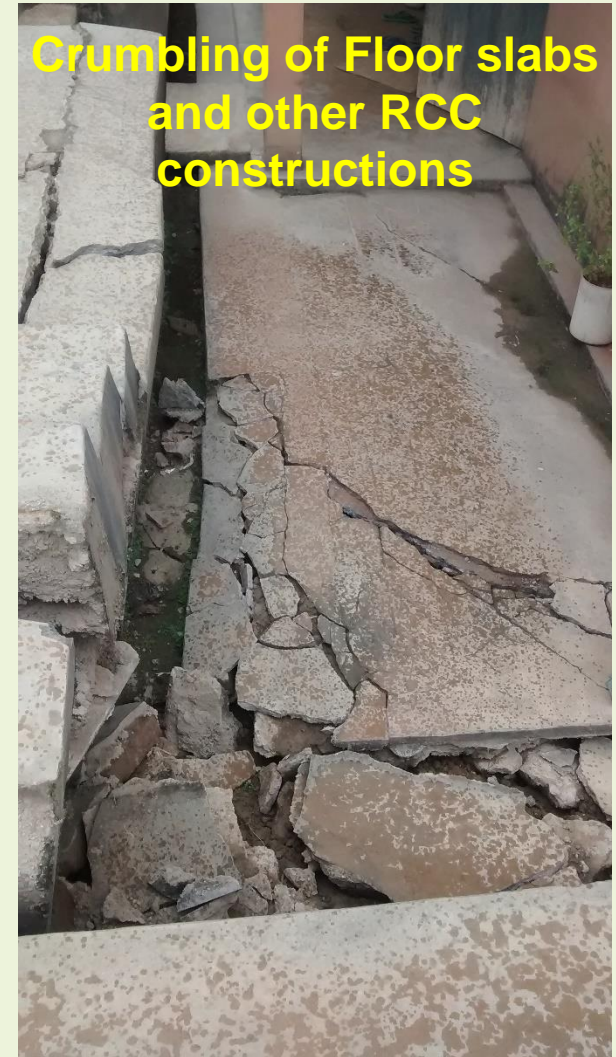
- Immense mass movement of soil
- Broken boundary wall
- Ejection of seeping water
- Overtopping of retaining wall
- Breakage of downhill protection wall

**Extensive damage in the  
24-Colony leading to  
relocation of workers**

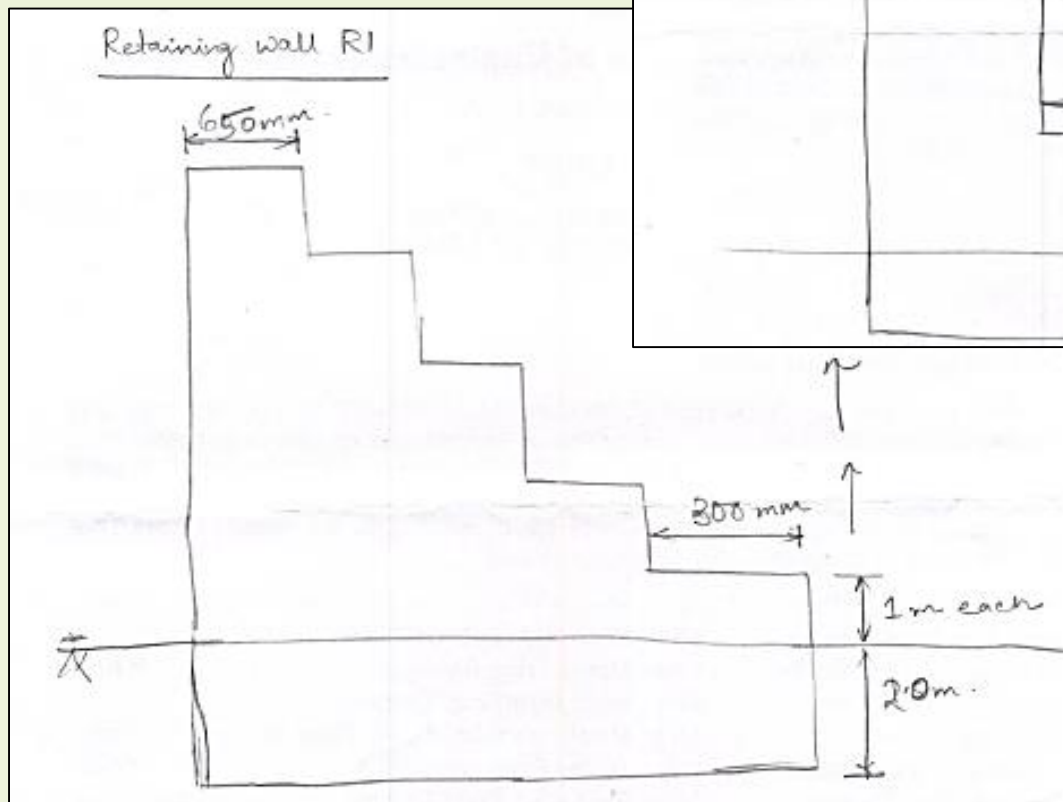
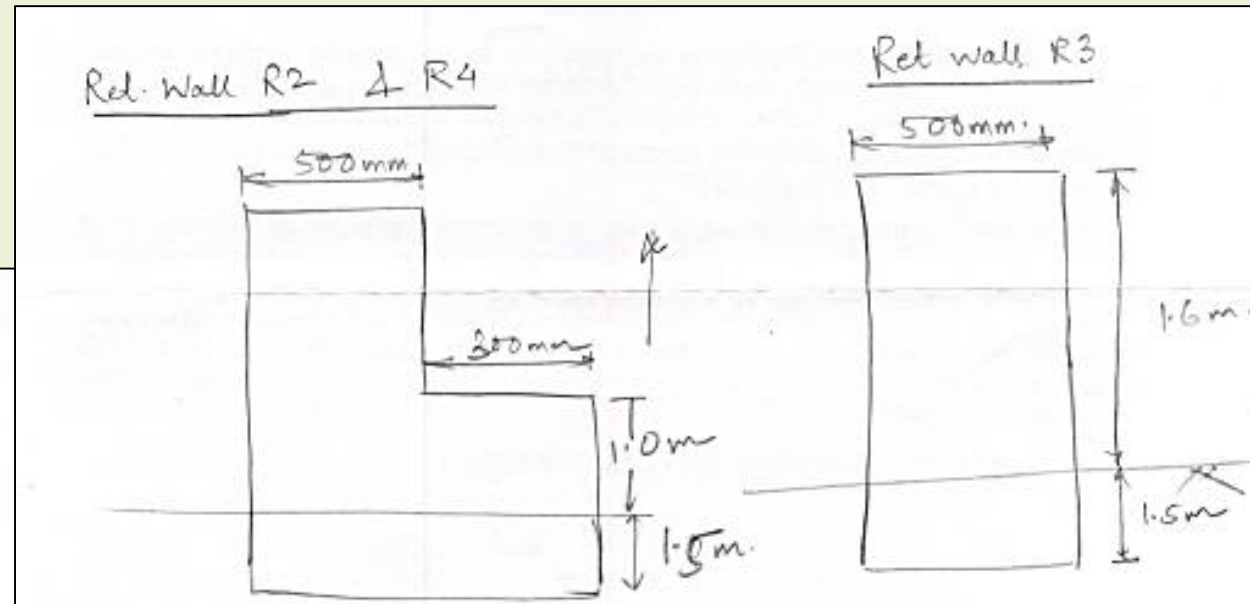
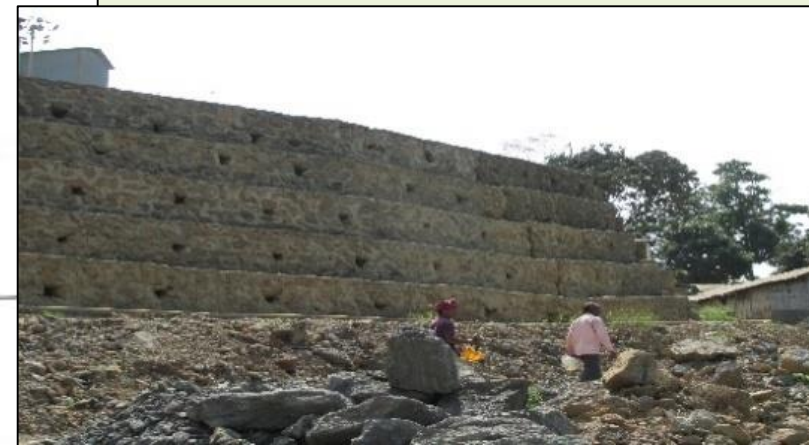
## Schematic Section of Retaining Walls

- Modelling the retaining wall

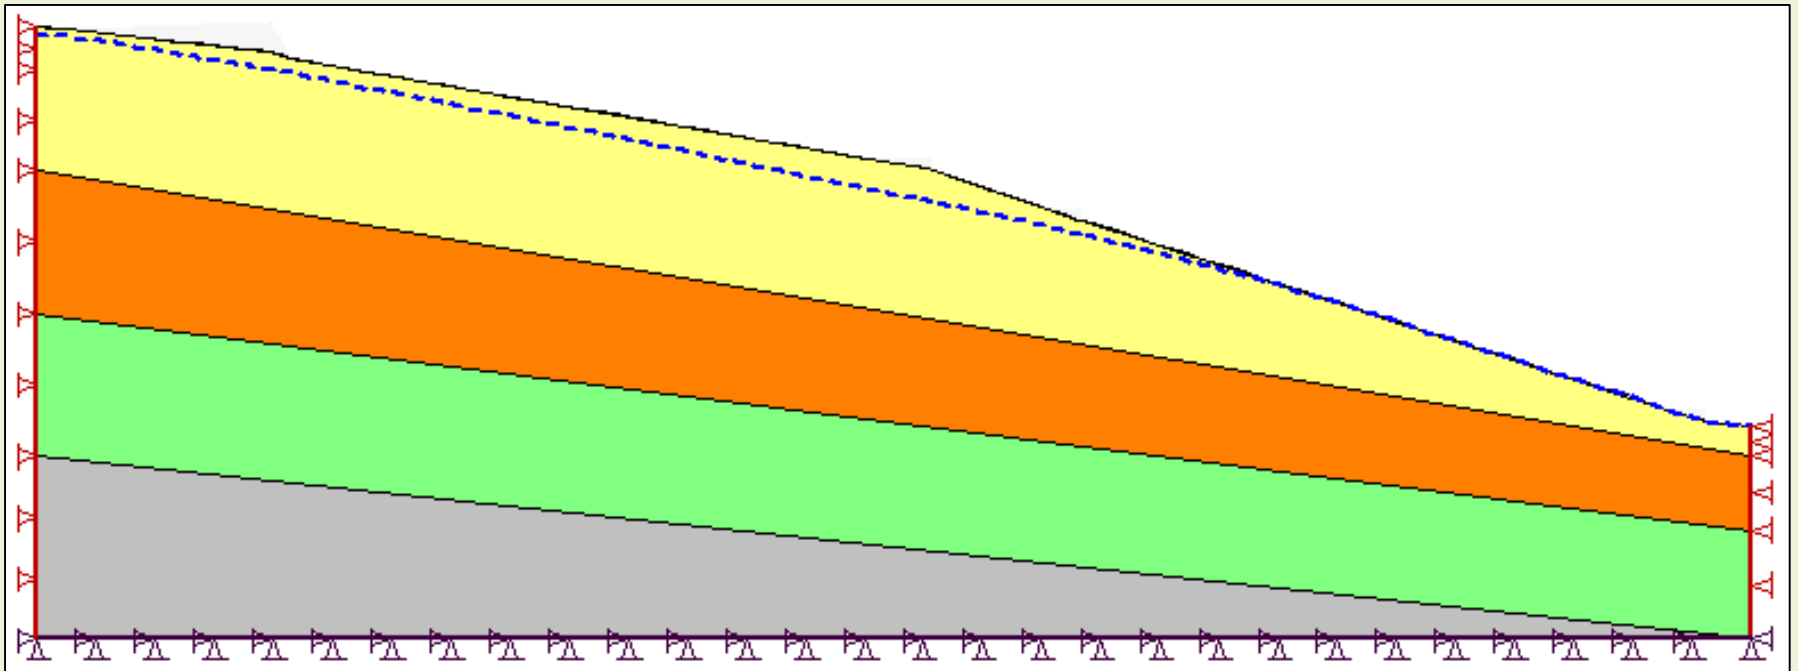
- Forensic analysis of hillslope failure
  - ❖ *Sequential anthropogenic intervention at the site (Stages of construction)*
    - **Stage 1:** In-situ analysis to assess the stability of the virgin slope before human intervention

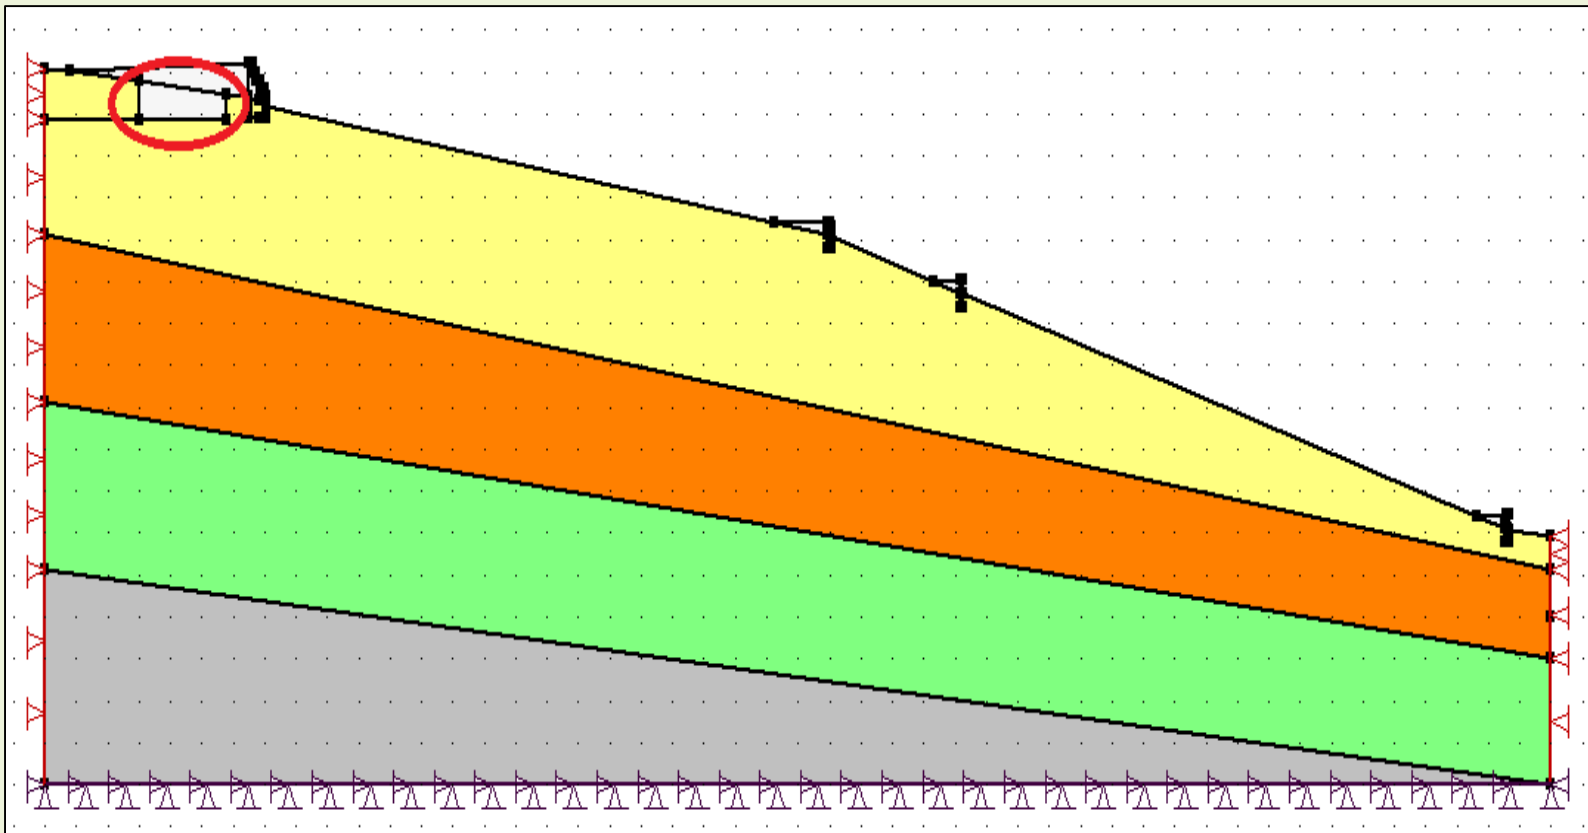
- Forensic analysis of hillslope failure
  - ❖ *Sequential anthropogenic intervention at the site (Stages of construction)*
    - **Stage 2:** Excavation of foundation of building

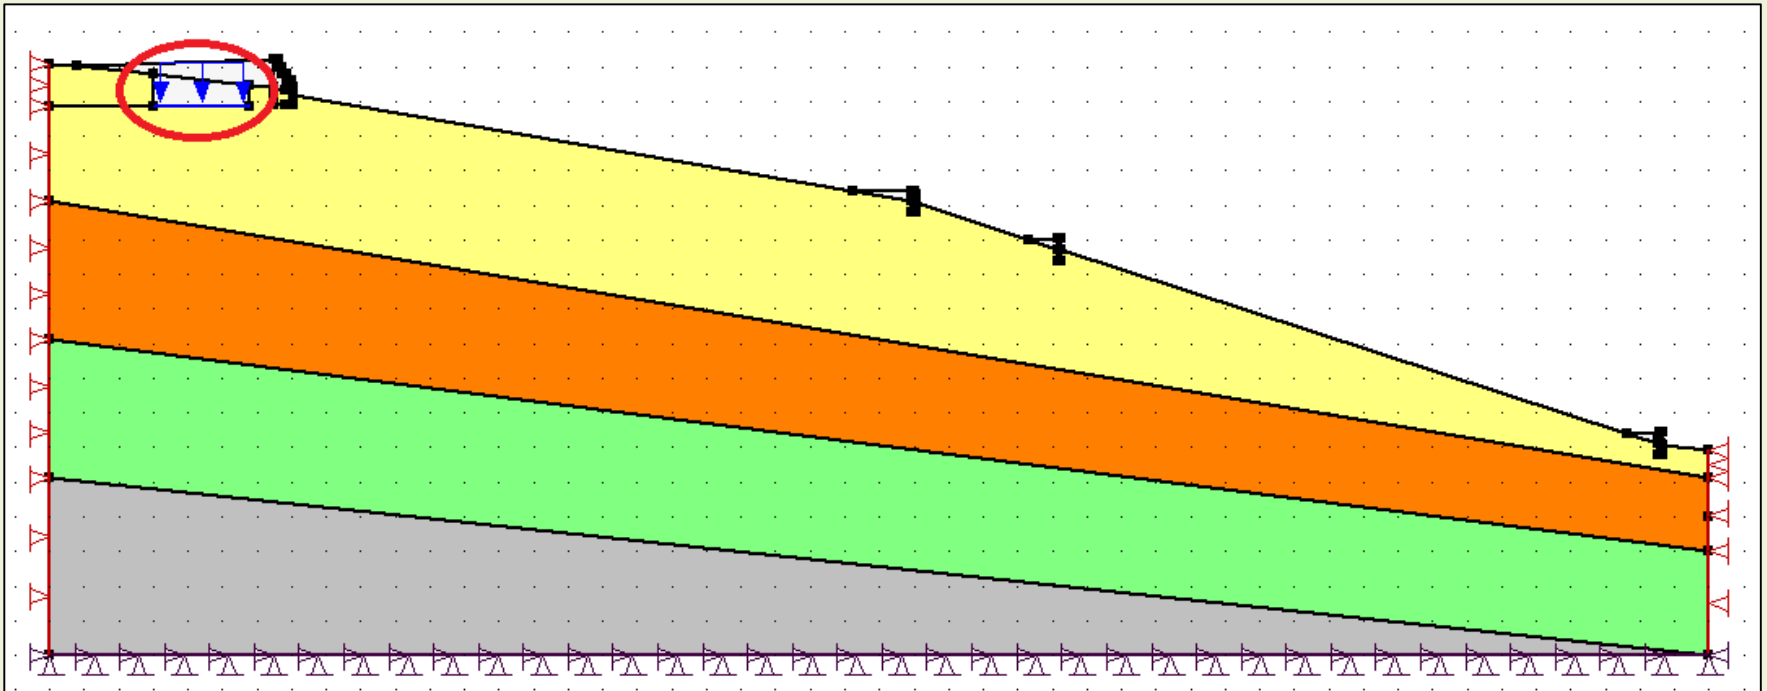
- Forensic analysis of hillslope failure
  - ❖ *Sequential anthropogenic intervention at the site (Stages of construction)*
    - **Stage 3:** Imposition of building load at the site due to the construction of the building (Calculated from structural data)

**Tertiary model indicates that imposition of building load (Stage 3) induced the marginal stability in the natural hillslope**

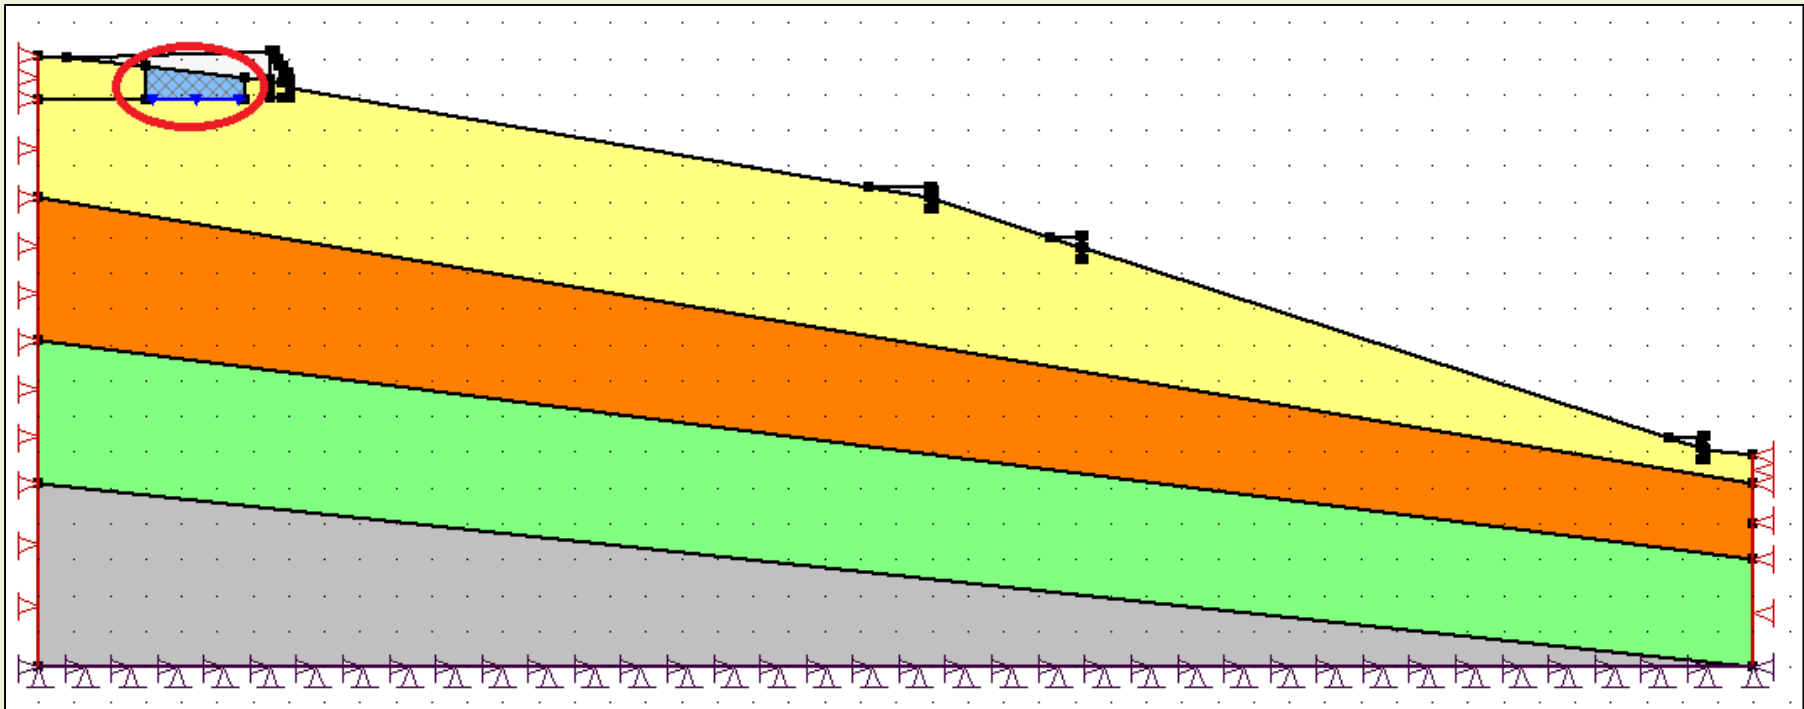
- Forensic analysis of hillslope failure
  - ❖ *Sequential anthropogenic intervention at the site (Stages of construction)*
    - **Stage 4:** Filling back and embedment of the shallow footings (Stages 3 and 4 are done simultaneously in the field)

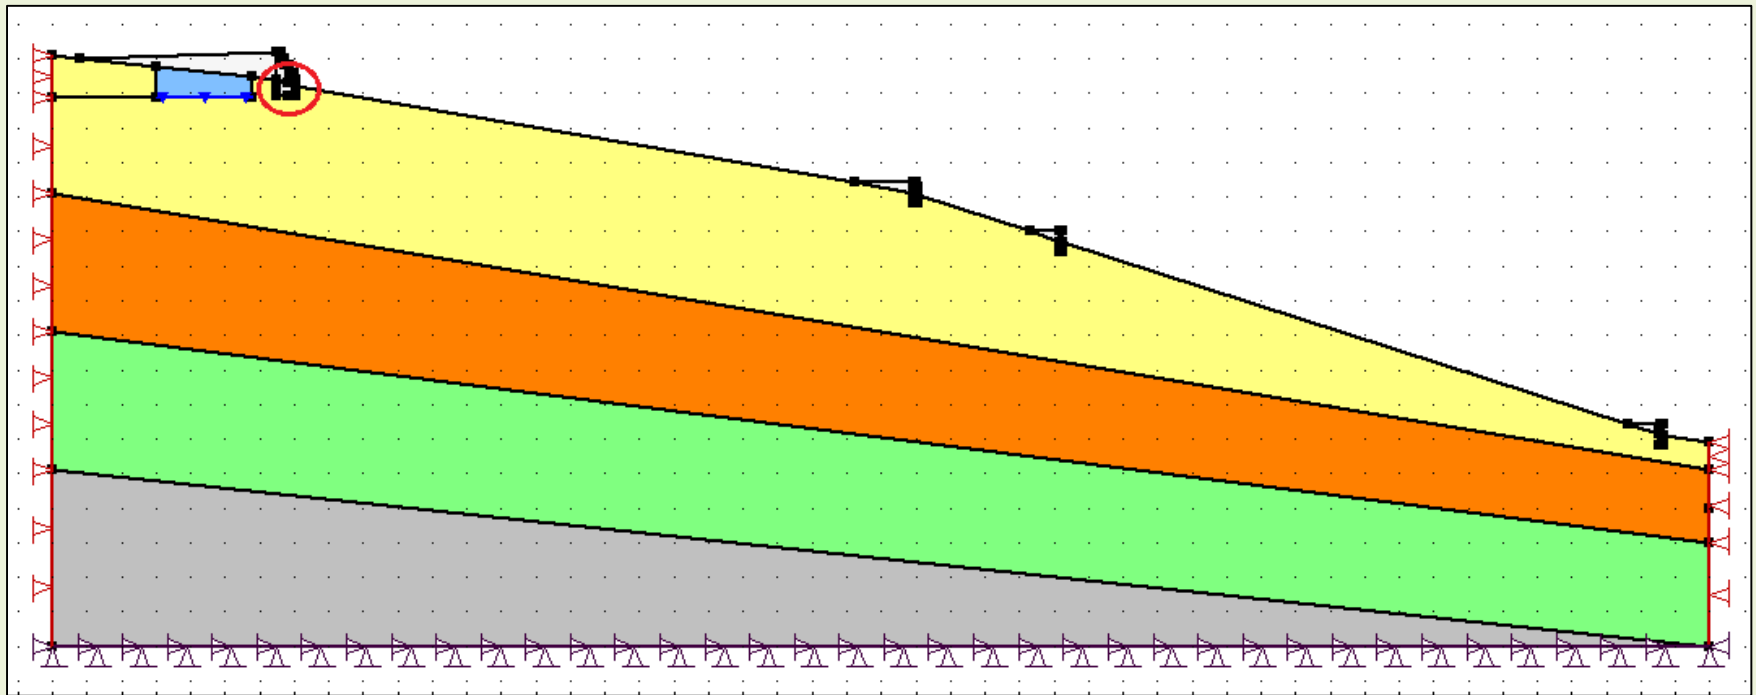
- Forensic analysis of hillslope failure
  - ❖ *Sequential anthropogenic intervention at the site (Stages of construction)*
    - **Stage 5:** Excavation of the foundation of the retaining wall R1

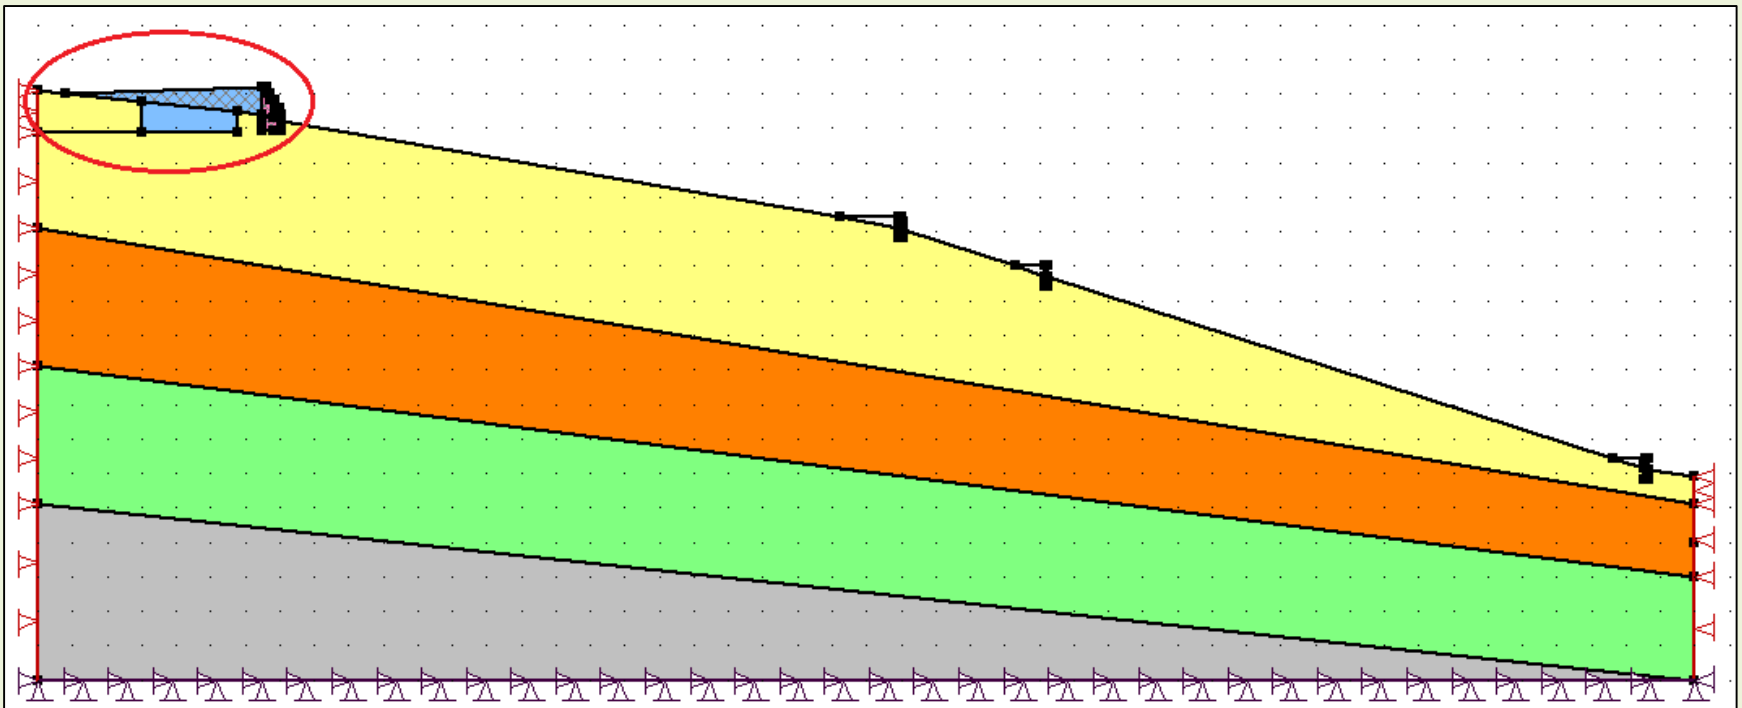
- Forensic analysis of hillslope failure
  - ❖ *Sequential anthropogenic intervention at the site (Stages of construction)*
    - **Stage 6:** Construction of R1 and simultaneous back-filing

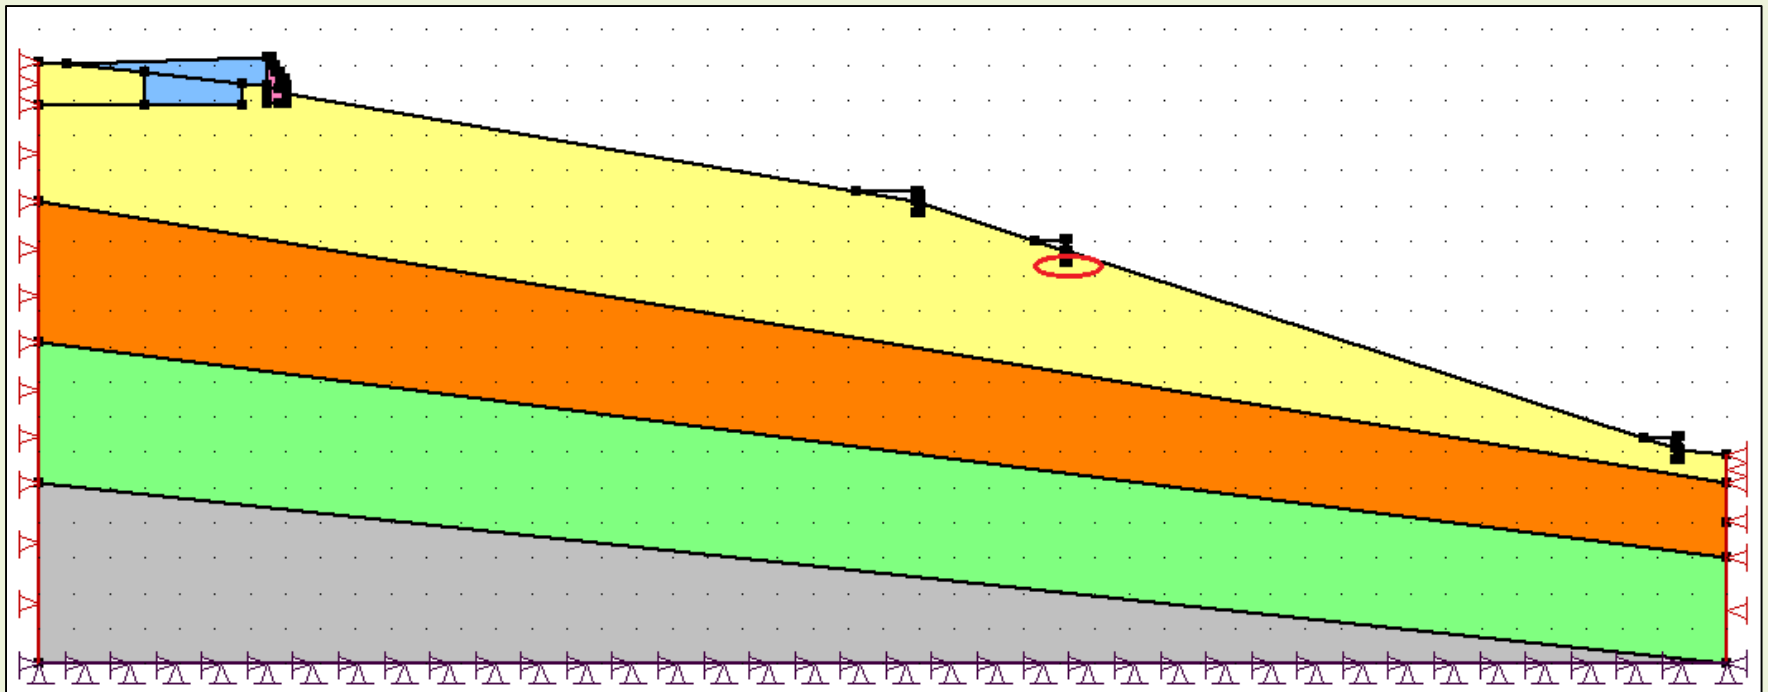
- Forensic analysis of hillslope failure
  - ❖ *Sequential anthropogenic intervention at the site (Stages of construction)*
    - **Stage 7:** Excavation of the foundation of the retaining wall R2

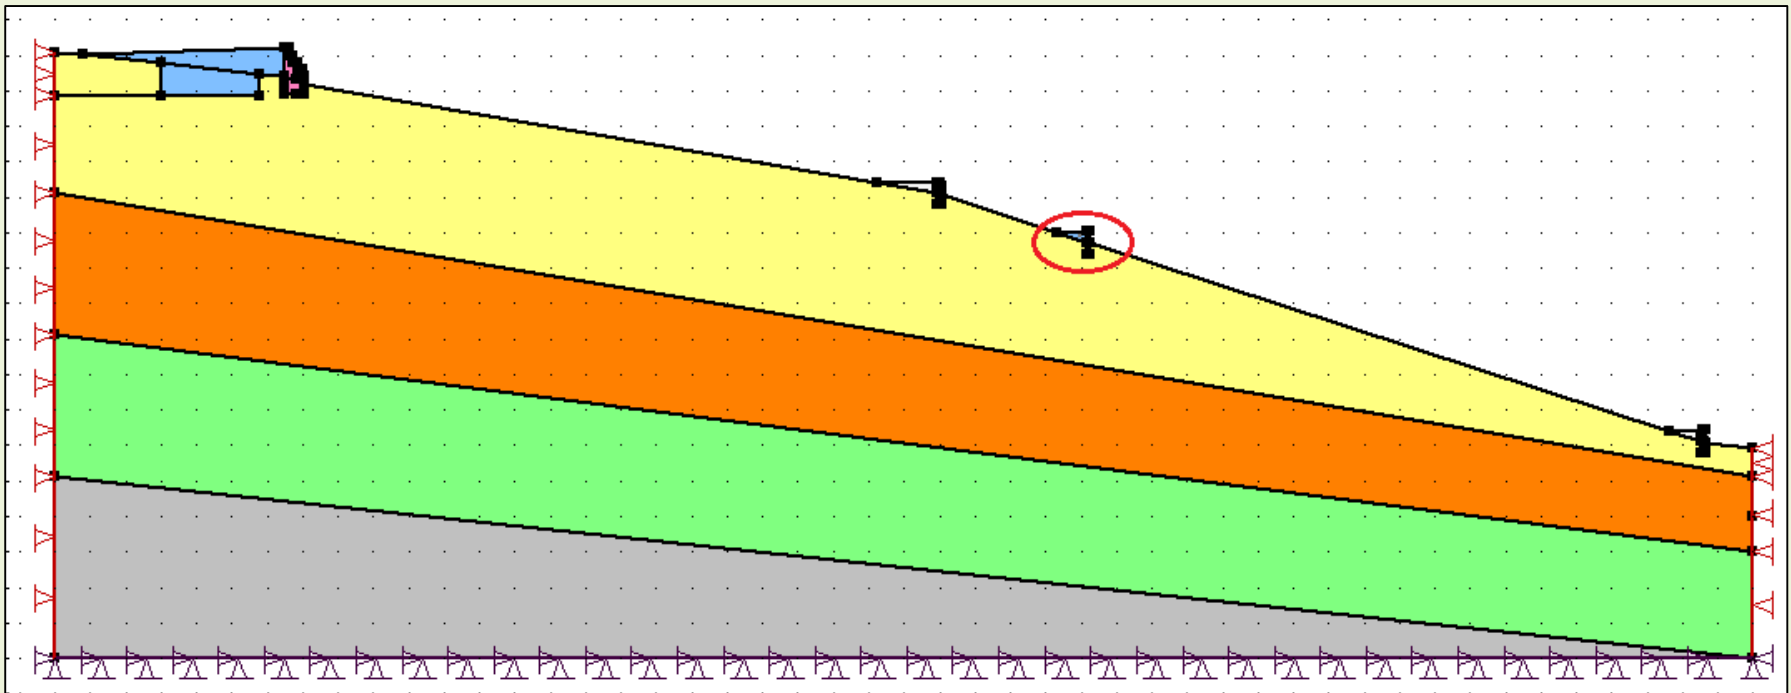
- Forensic analysis of hillslope failure
  - ❖ *Sequential anthropogenic intervention at the site (Stages of construction)*
    - **Stage 8:** Construction of R2 and simultaneous back-filing

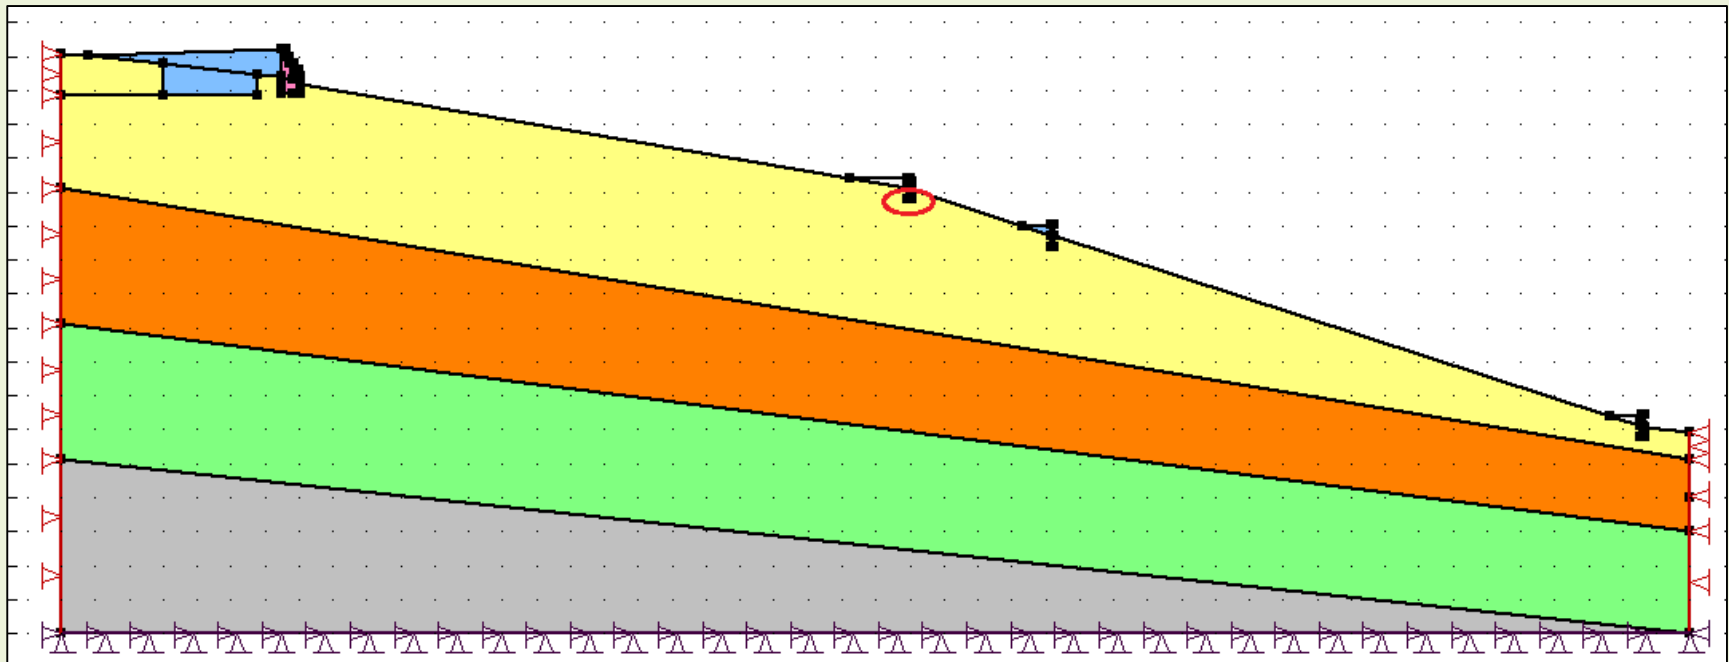
- Forensic analysis of hillslope failure
  - ❖ *Sequential anthropogenic intervention at the site (Stages of construction)*
    - **Stage 9:** Excavation of the foundation of the retaining wall R3

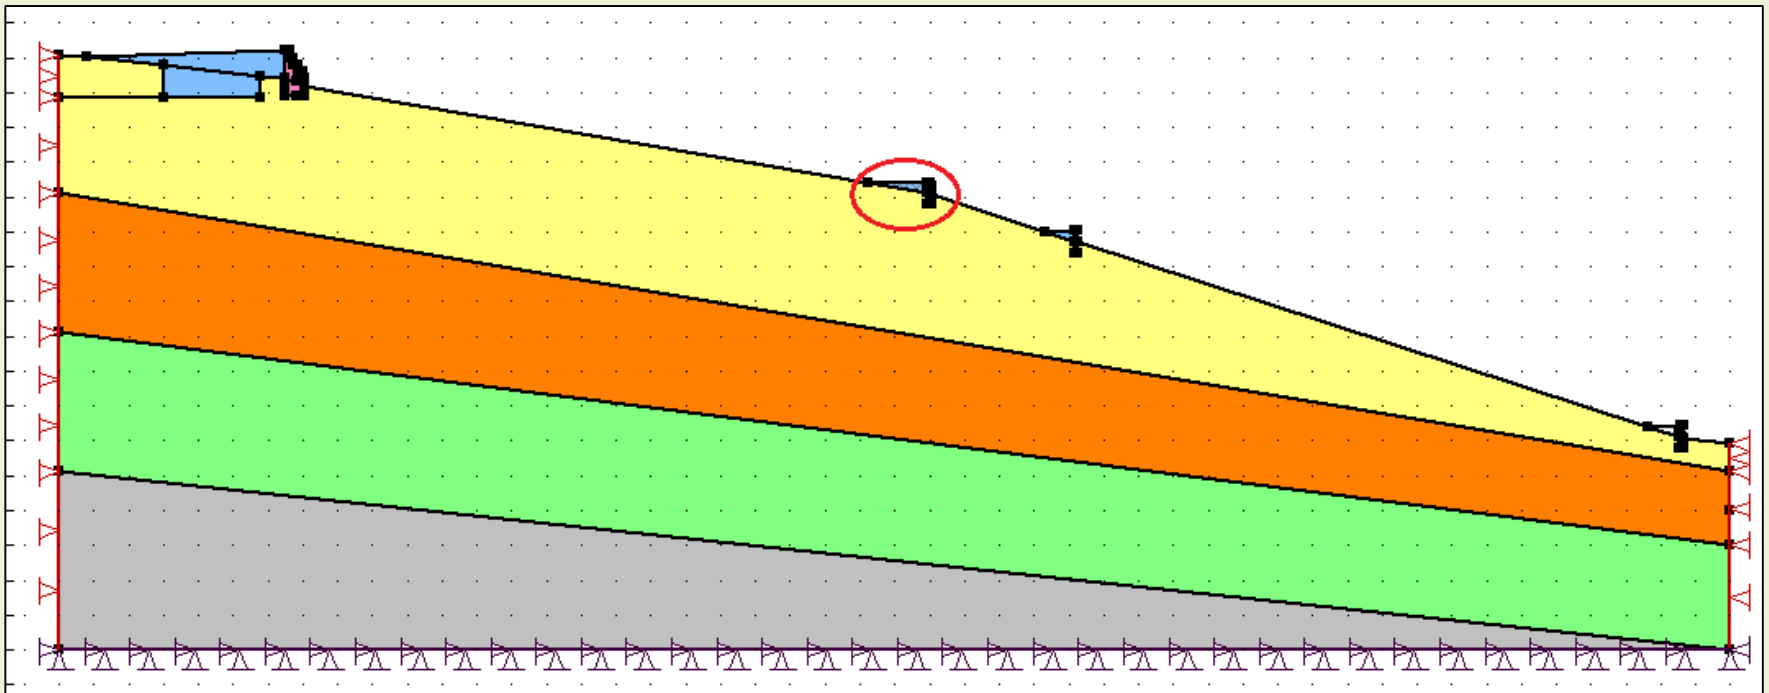
- Forensic analysis of hillslope failure
  - ❖ *Sequential anthropogenic intervention at the site (Stages of construction)*
    - **Stage 10:** Construction of R3 and simultaneous back-filing

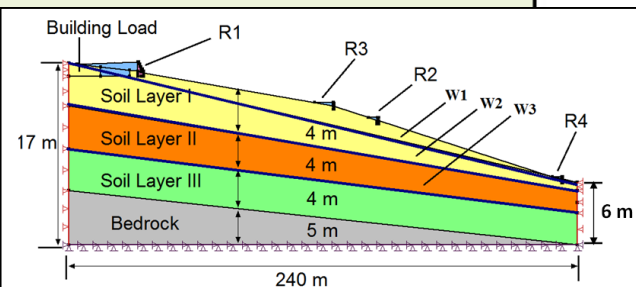
- In dry condition, the imposition of building load (Stage 3) might have initiated some creep instability, which was arrested by constructed RWs
- WT assumed at any depth (W1, W2 or W3) showed similar instability after Stage 3
  - However, under such scenarios, no water seepage is expected in the hillslope
  - The possible location of initial WT yet remains unsolved from this aspect

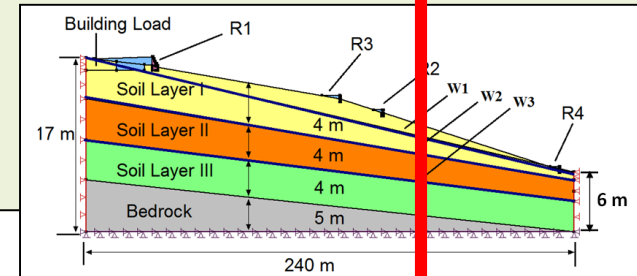
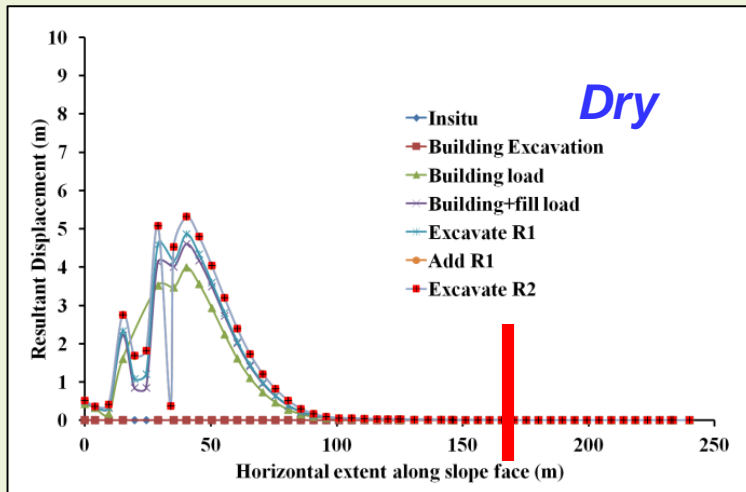
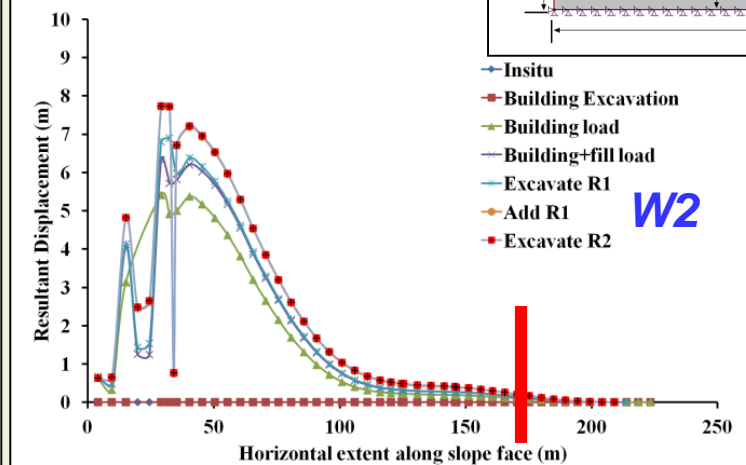
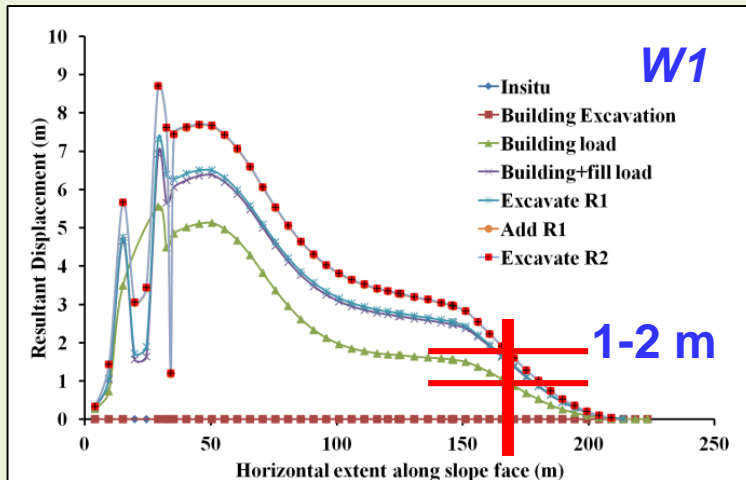
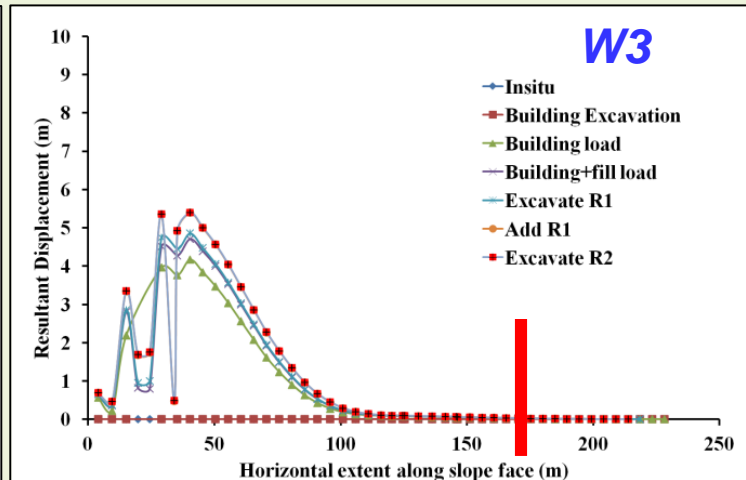
24-Colony  
Location

- Displacement along the hillslope

W1 seems to be the  
most probable WT  
location, given that  
it produces some  
deformation  
around 24 colony

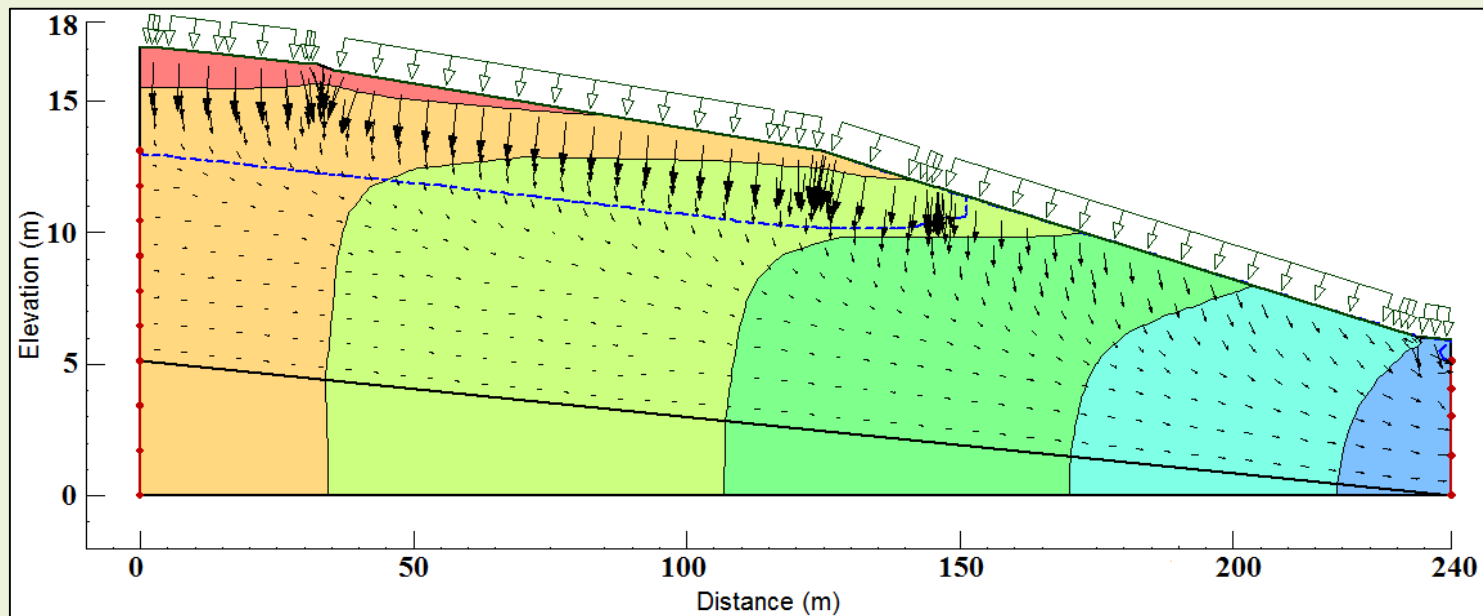
- What happened to water seeping out from slope face behind the 24 colony → Question still looms !
- Inclusion of rainfall and rainwater infiltration in the SEEP/W analysis
  - ❖ *Prevalent infiltration during the monsoons*
    - $5.4 \times 10^{-8}$  m/s (estimated from climatic and meteorological data)
  - ❖ *Modeled as constant head of water over the entire slope*

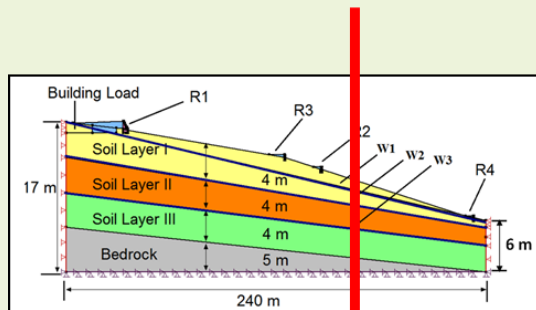
**24-Colony  
Location  
170 m from  
Workshop  
building**

- ❖ *Intersection of WT at the slope face near the 24 colony (160-180 m from left)*

- Denoted by achievement of zero or negative water flux at the slope face
  - Water comes out of the slope face at the prescribed location
- Time duration of the rise of WT to intersect: Approximately 3-6 h of rain
  - Coincidentally, the same was reported from the field that the first slide behind the colony was noted after an initial 3-4 hr of rainfall around October 2015
