# CE504 Slope Stability and Retaining Structures

## Failure of a Marginally Stable Hillslope: A Forensic Investigation

**Dr. Arindam Dey**

## Landslide at Calcom Cement Plant, Umrangso, Assam **Forensic Geotechnology**

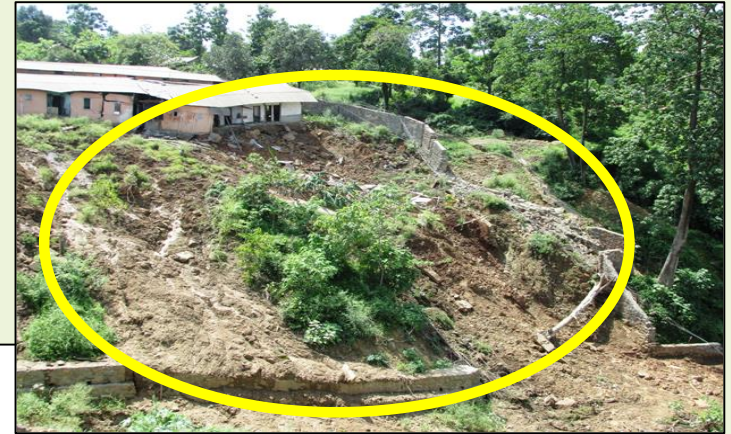
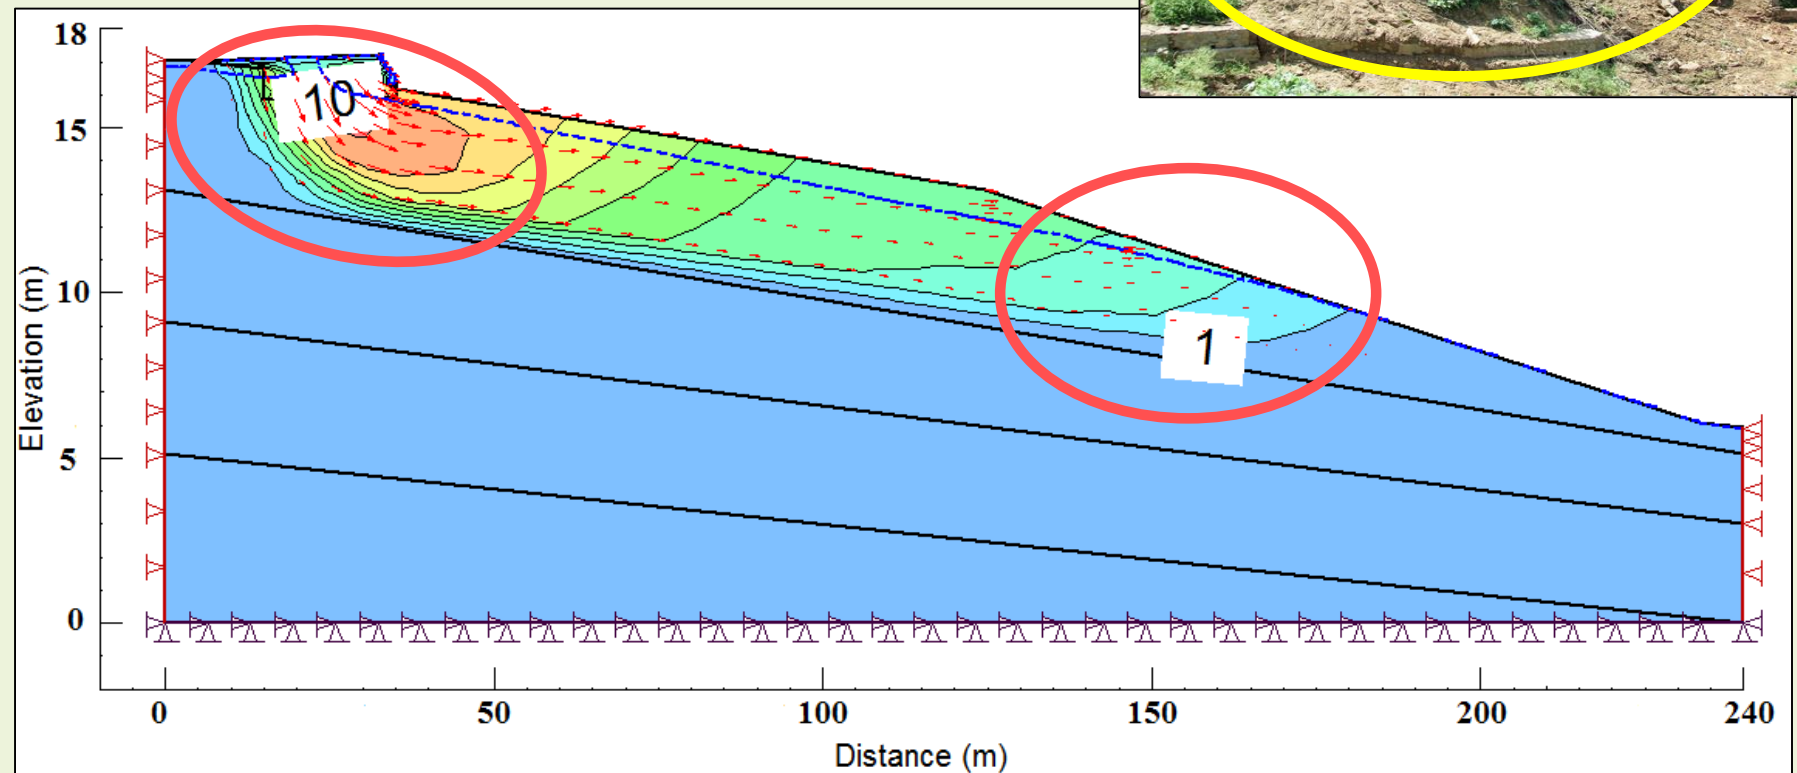
- Still, we were unhappy !!! ☹
  - ❖ *Why so less displacement behind the 24 colony, while the field displacement was maximum at that location !?*
    - Max displacement around building???

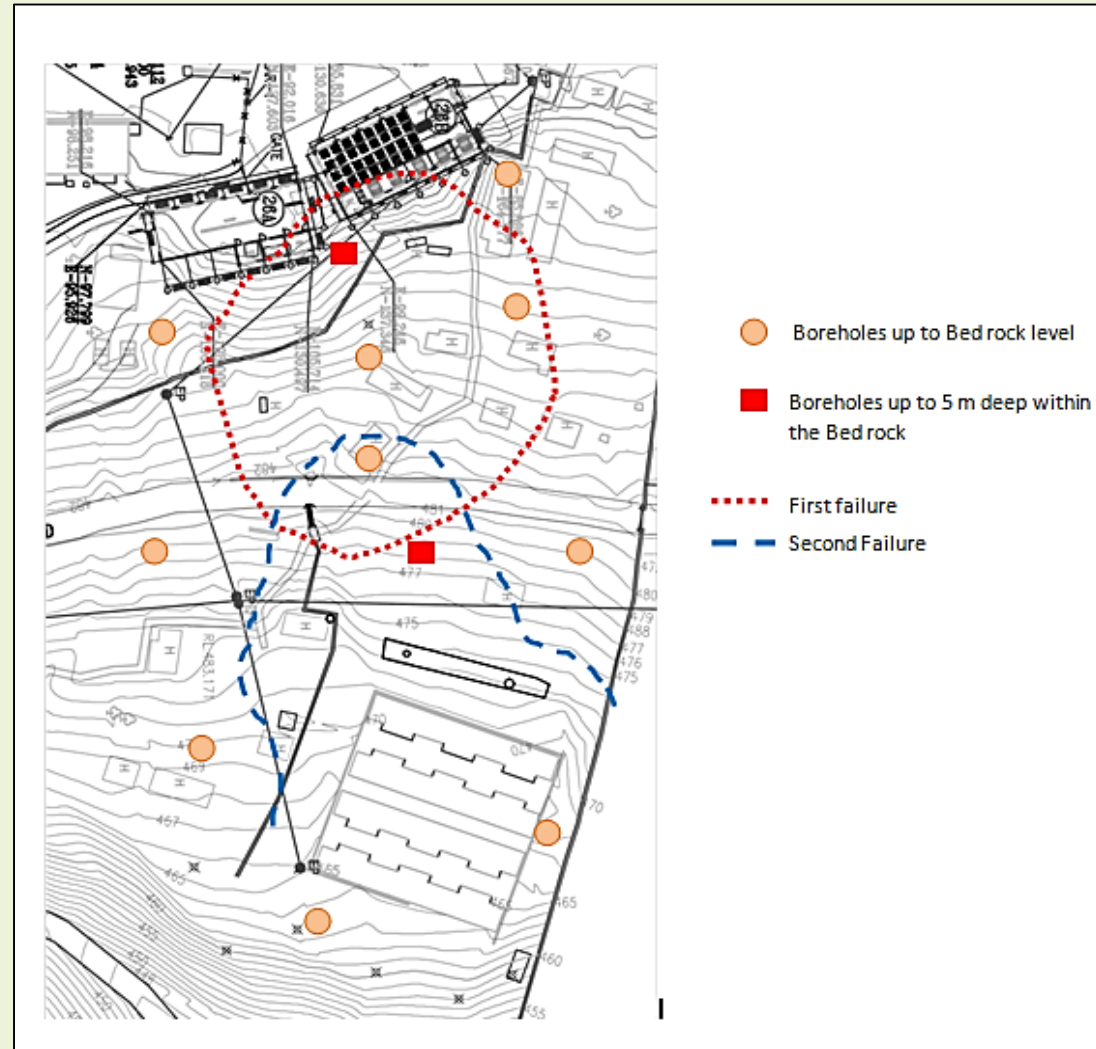
- Yes !! They were not really from failure site
  - It is possible that our assumption of soil stratigraphy and even some of the soil parameters are incorrect ☹

- Conduct few more borehole surveys at the landslide site itself
  - Site was accessible? – Yes !!

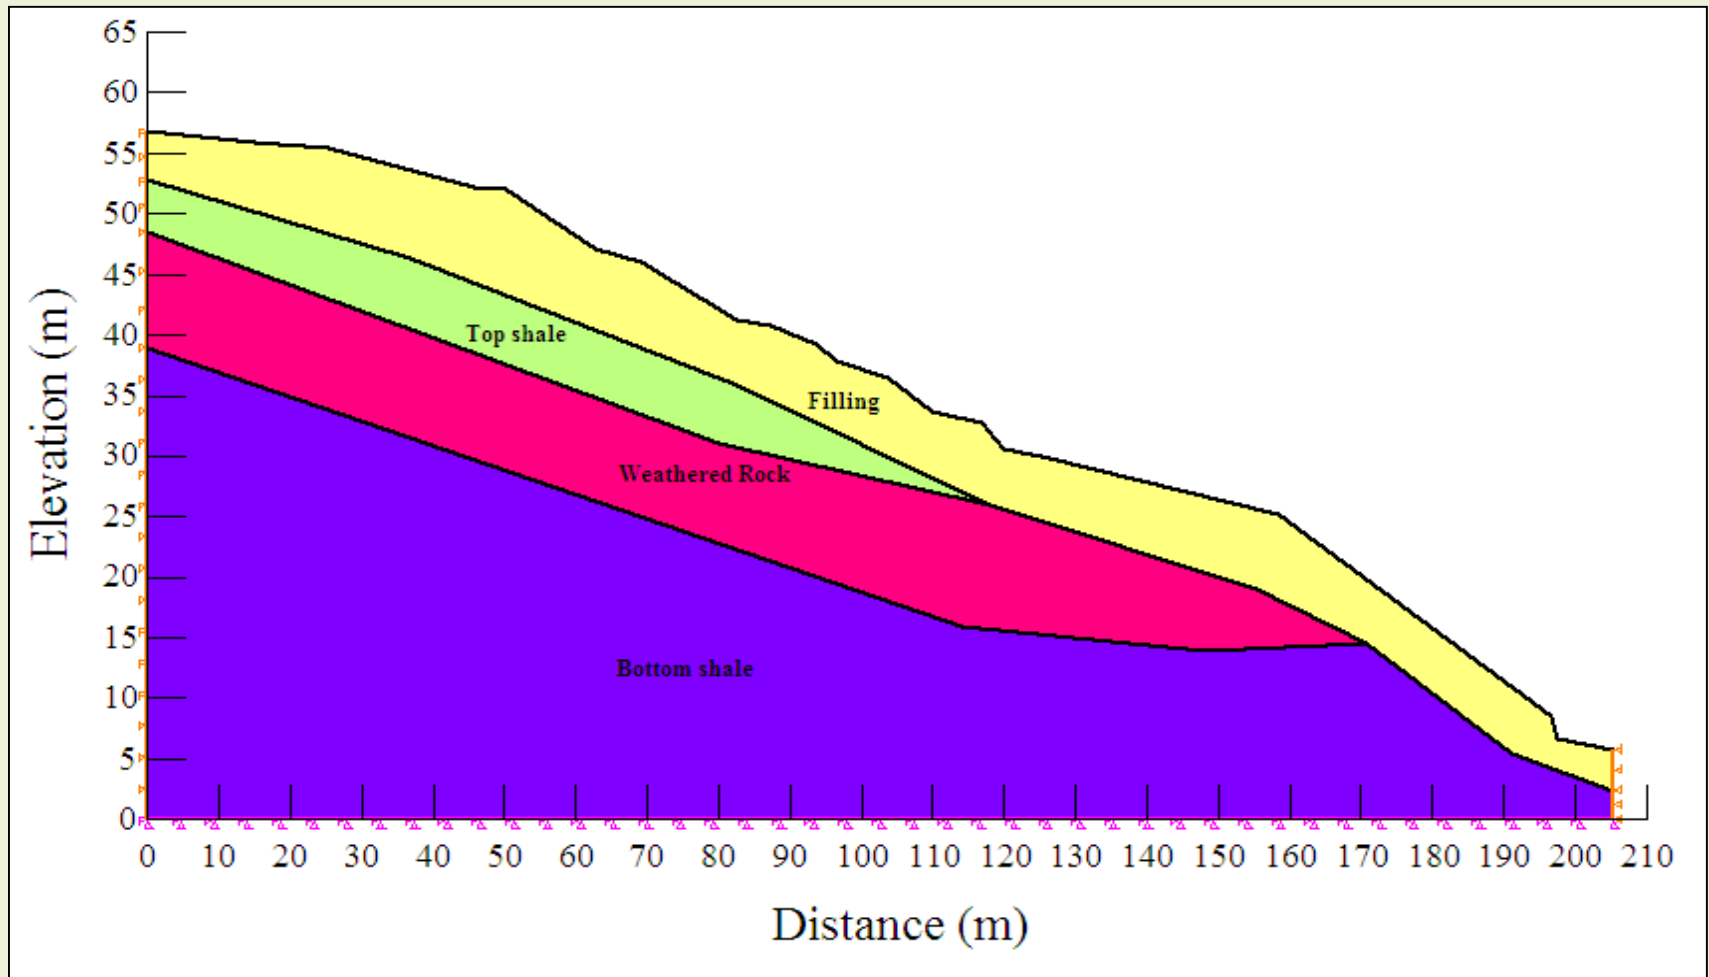
- A new numerical model is developed

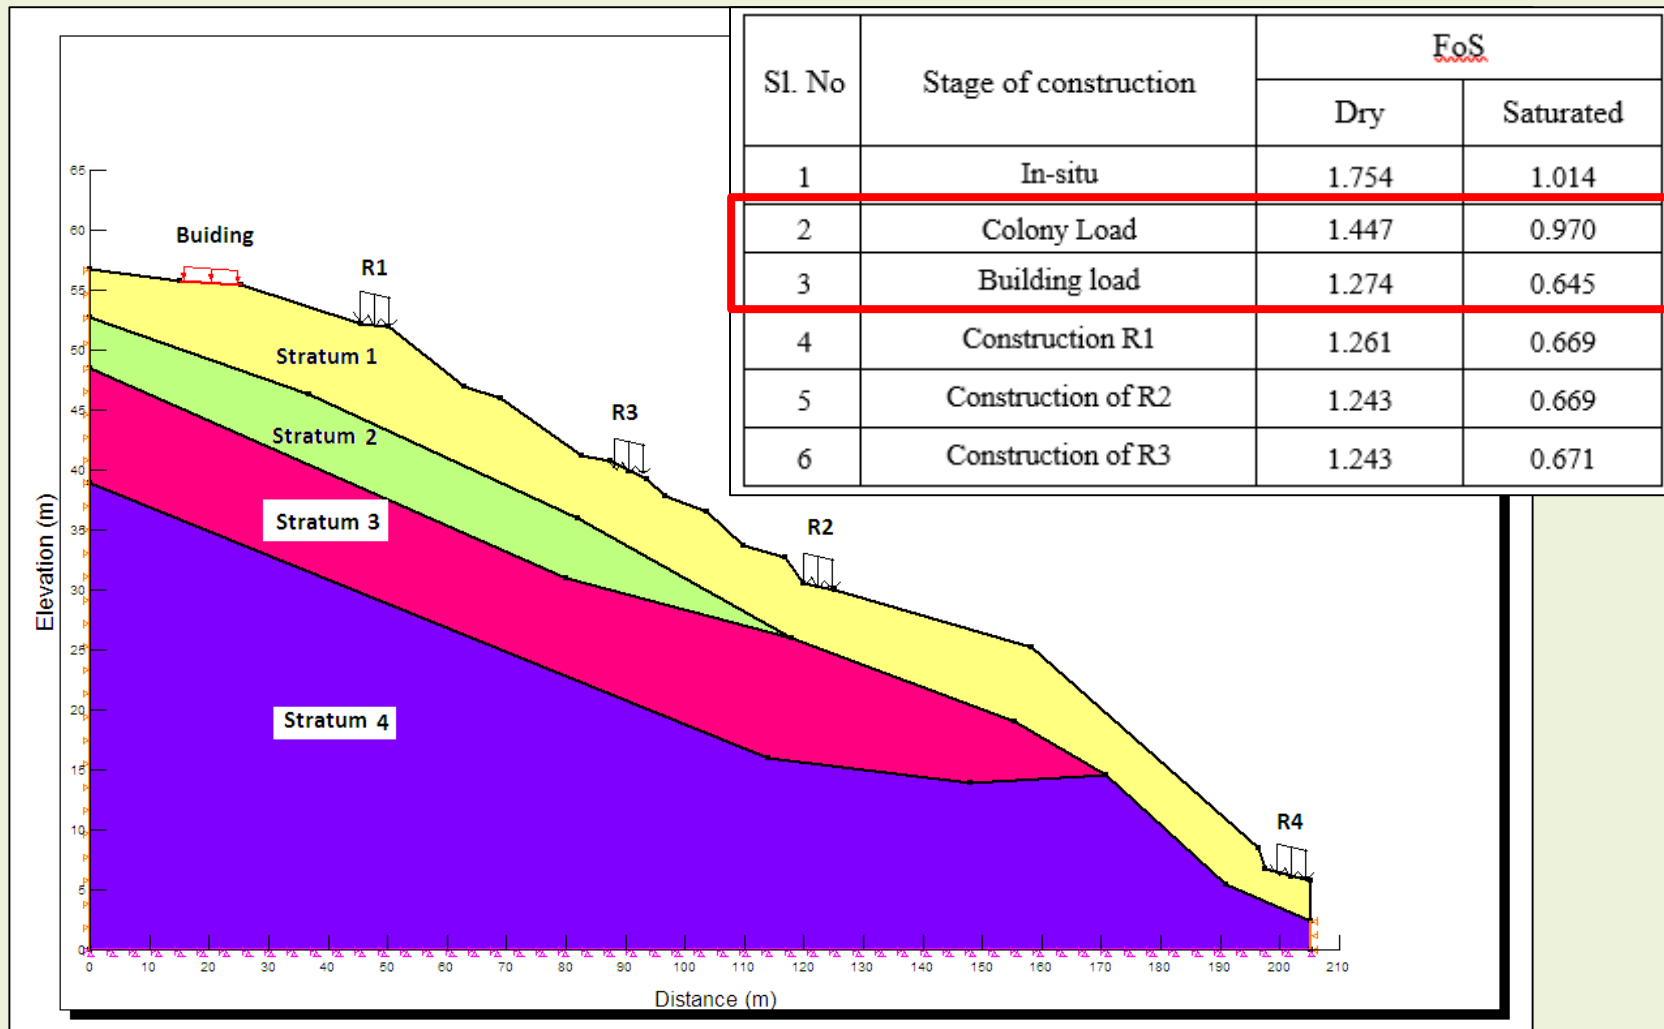
- Application of various loads in stages (as earlier)

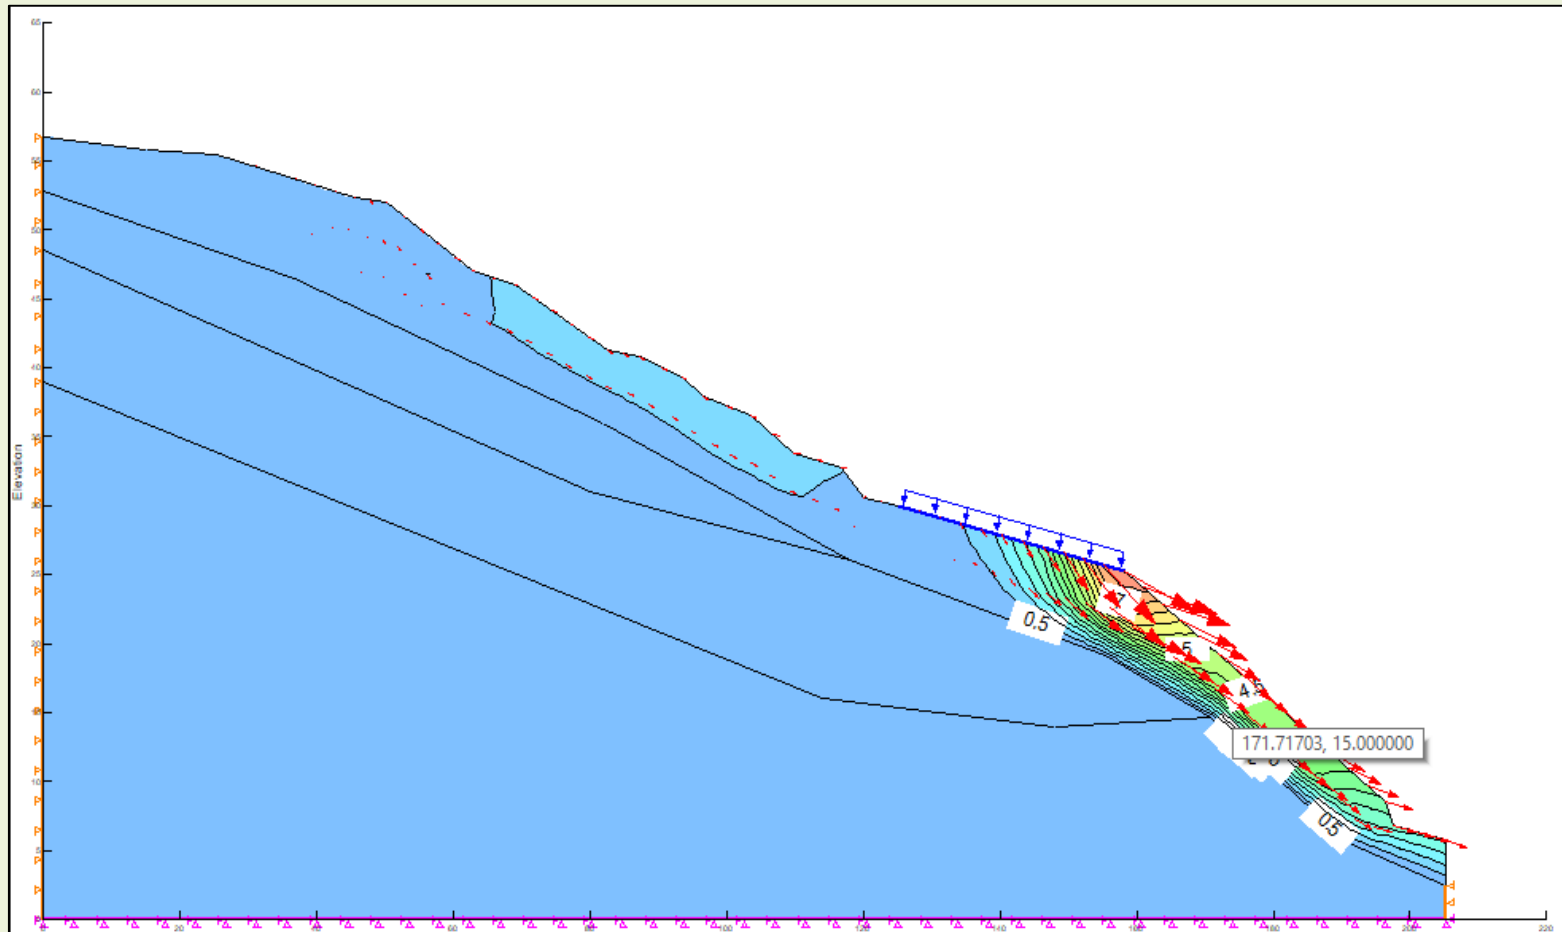
- Application of colony load
  - ❖ *Invokes sufficient displacement in saturated stage*

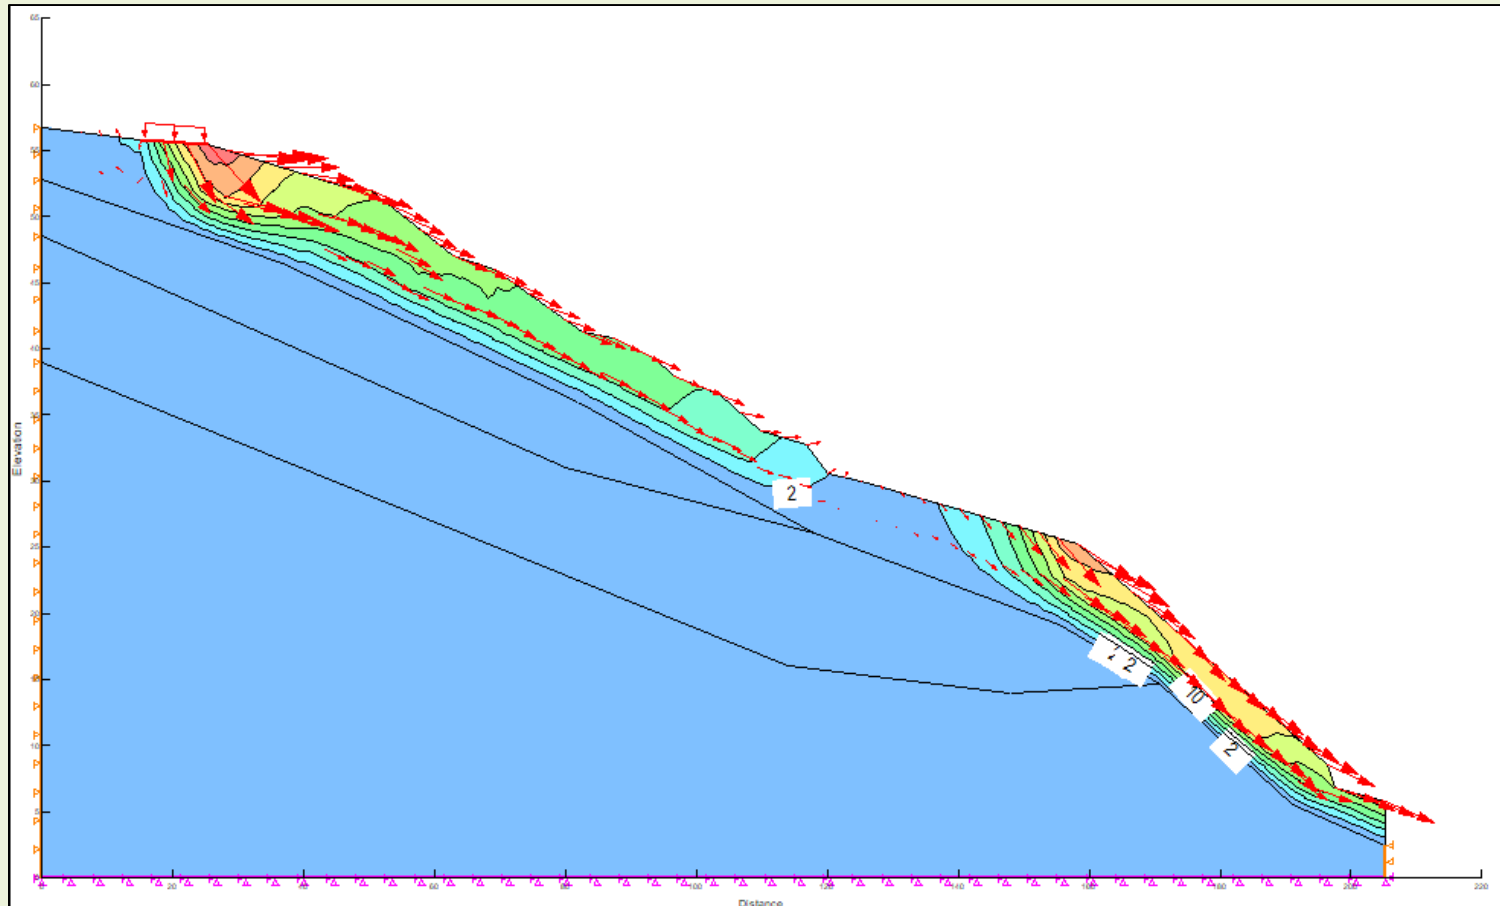
- Application of building load
  - ❖ *Another slip deformation zone is initiated*

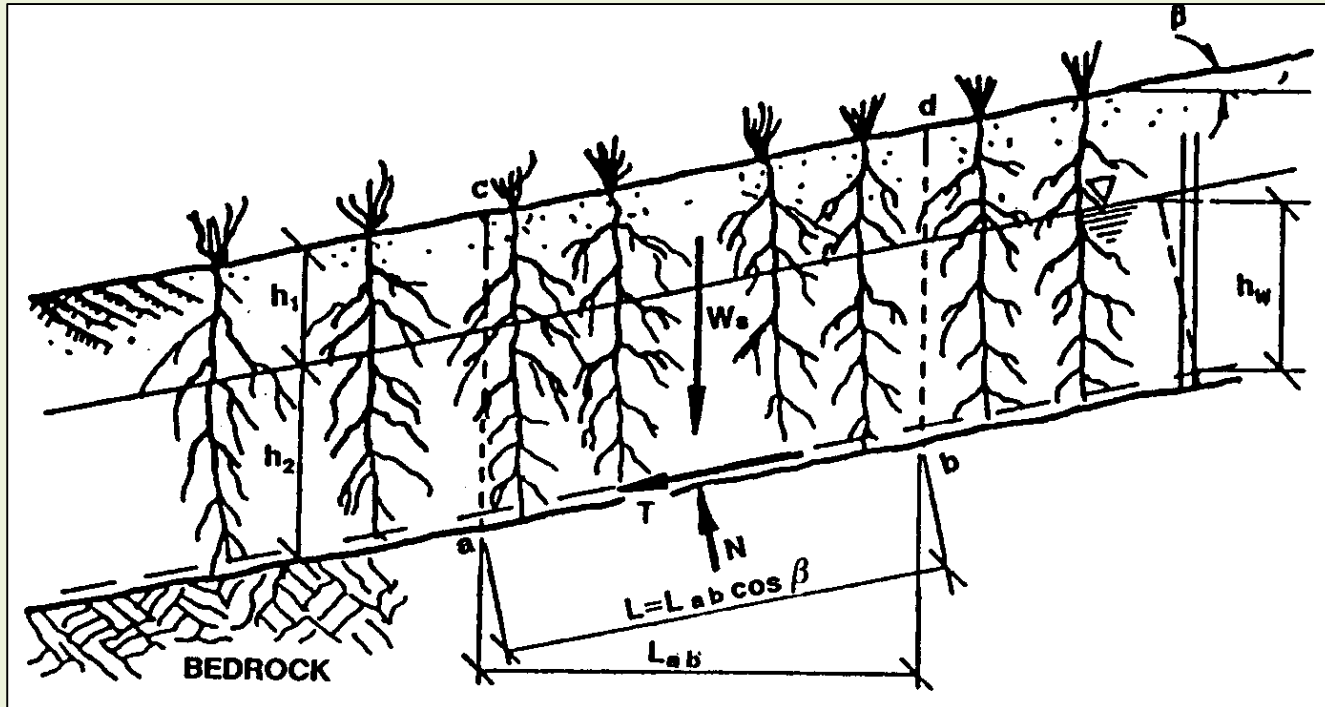
- Several stabilization schemes were proposed
  - ❖ *Stabilization by vegetative cover*
